Fuel-quantity Miscalculation Cited In Ditching of Boeing Stratoliner

The crew planned a test flight of the recently restored vintage airliner based on fuel-gauge readings and the airplane's average fuel consumption. An engine problem prompted the crew to abort the test flight, and the landing was delayed by a landing-gear problem. All four engines failed because of fuel exhaustion during an approach over water.

FSF Editorial Staff

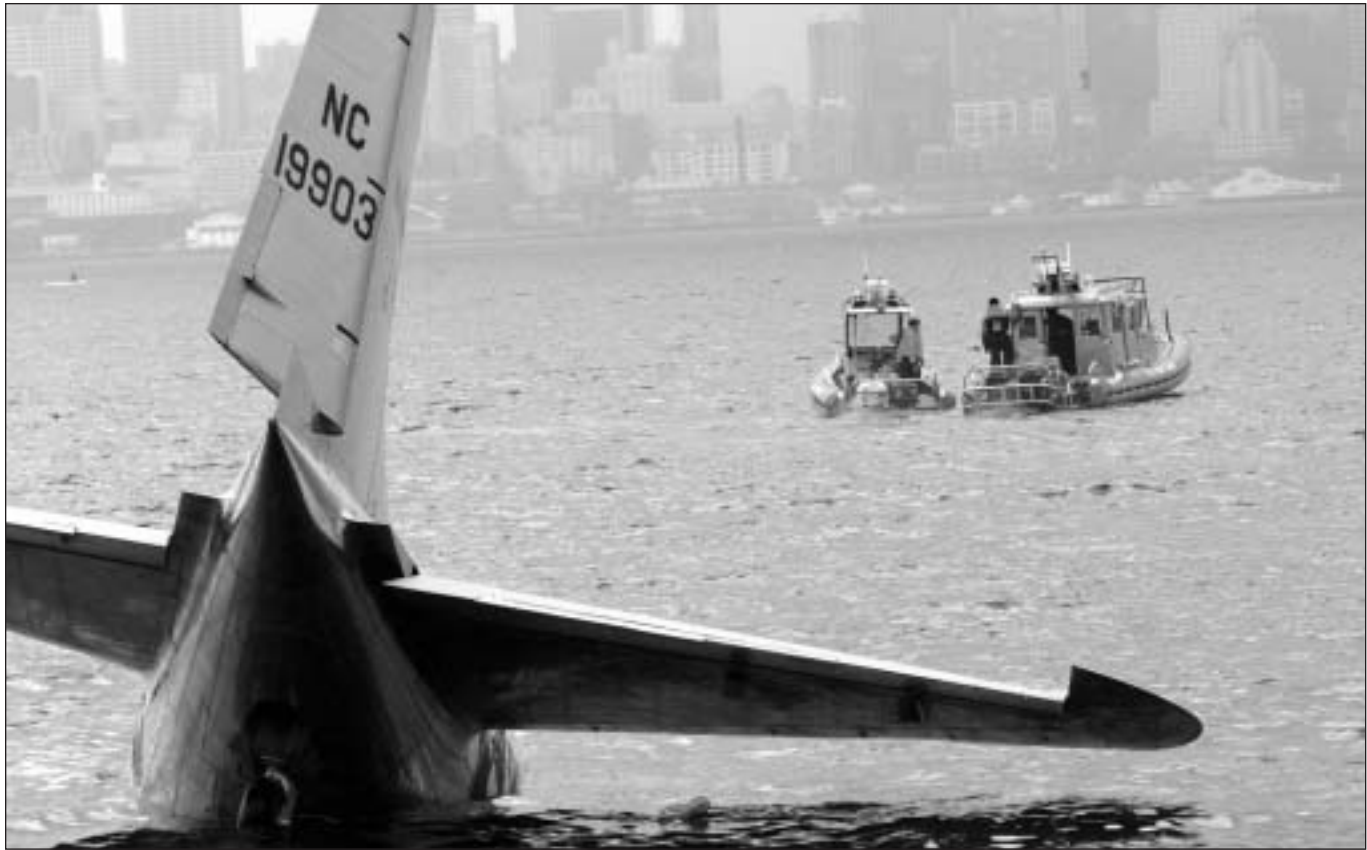
The four crewmembers were standing on a wing when U.S. Coast Guard vessels arrived. The airplane later sank partially while being towed to shore. (Photo: U.S. Coast Guard, Sarah Foster-Snell)

“The airplane was subsequently towed to shallower water by a Seattle Police Department boat before it partially sank in the water just offshore,” the report said.

Examination of the wreckage showed that the landing gear had separated from the airplane on impact and that sections of airframe skin had separated from the lower surfaces of the wings and fuselage.

“The empennage belly section displayed extensive hydrodynamic damage and tearing of skin,” the report said. “The right wing trailing edge near the wing root was severely torn and deformed.”
