Improvised GPS Approach Procedure And Low Visibility Set Stage for CFIT

—
FSF Editorial Staff

About 1505 local time Jan. 31, 2003, an Ilyushin IL-76TD that was being operated on an unscheduled cargo flight struck terrain during an approach in instrument meteorological conditions (IMC) to Runway 14 at Cakung Airport near Baucau, Timor-Leste [East Timor]. The airplane was destroyed by the impact and postaccident fire. The six occupants — the captain, first officer, flight engineer, navigator and two loadmasters — were killed.

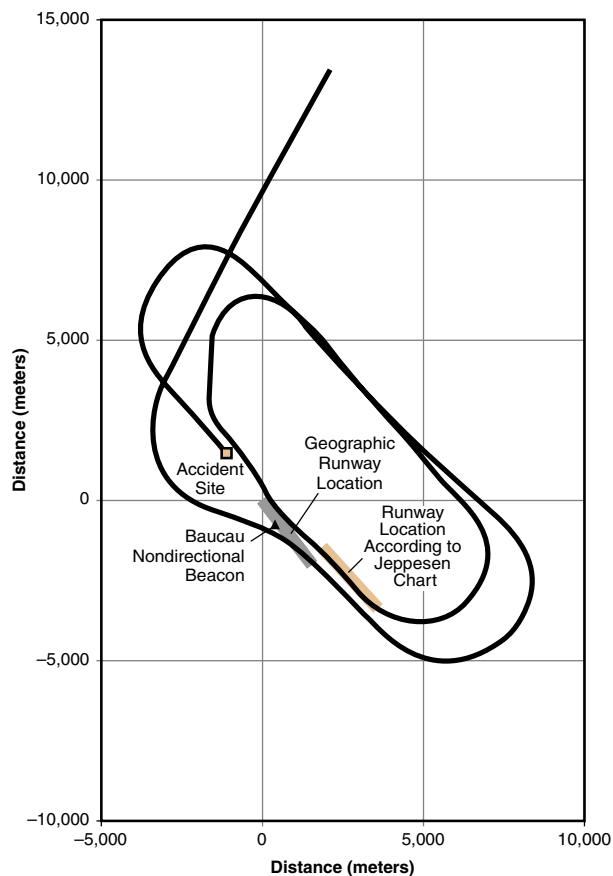
Figure 1

The airplane was on a southwesterly heading as it neared the airport (Figure 1, page 4). The navigator recommended that the captain conduct an overflight of the airport before conducting an approach. The captain agreed and said that he would conduct the overflight on a heading of 135 degrees (the magnetic heading for Runway 14 published on the Jeppesen airport chart). The 135-degree heading did not coincide with the published NDB Runway 14 final approach course, which was 146 degrees. The captain did not brief the other flight crewmembers on how low he would fly the airplane during the overflight or during the approach.

The waypoint coordinates were derived from information published on the Jeppesen airport chart and NDB Runway 14 approach chart. The report said that the charts inaccurately depicted the NDB as being located northwest of Runway 14; the NDB actually was located off the right side of Runway 14. As a

Flight Path of Ilyushin IL-76; Baucau, Timor-Leste; Jan. 31, 2003

result, the waypoint entered into the GPS navigation equipment was about 2.5 kilometers (1.4 nautical miles) southeast of the runway threshold.

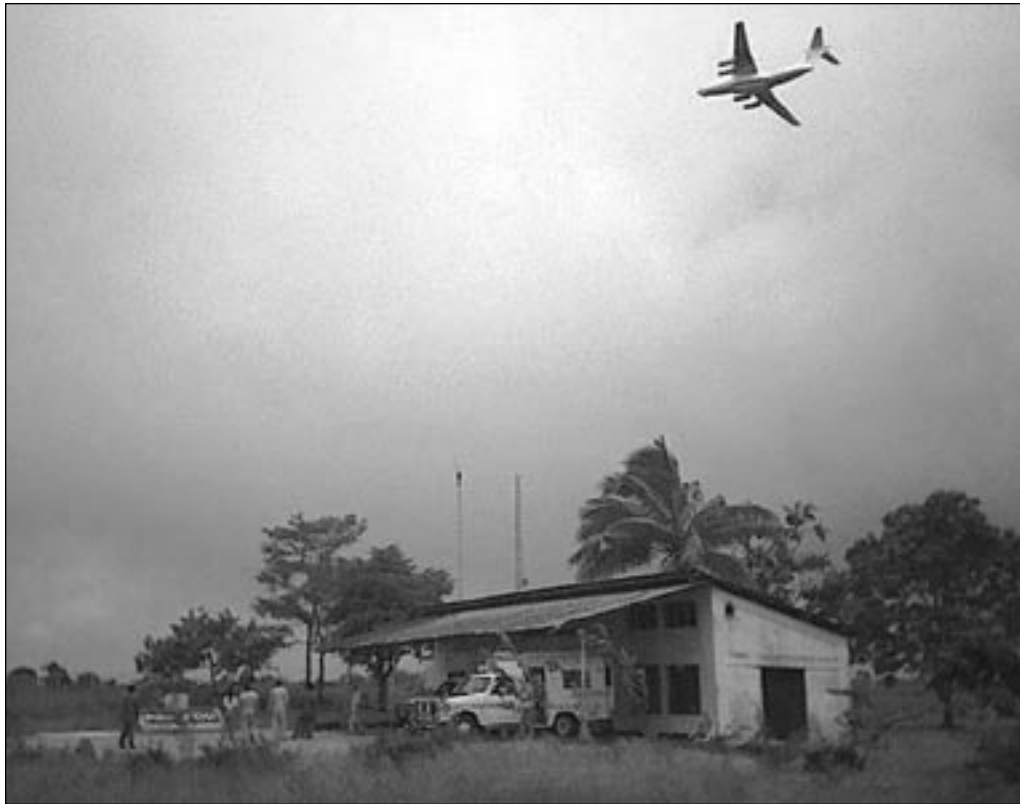
The flight crew conducted the overflight with the airplane's landing gear and flaps retracted (see photo, page 5). The airplane was 13.7 kilometers (7.4 nautical miles) from the NDB at 1451, when the captain said that he was maintaining an altitude 400 meters (1,312 feet) above airport elevation. The report said that at this time, the airplane was 178 meters (584 feet) below the published minimum safe altitude for the area.

An airport building is shown in the foreground of a photograph taken during the flight crew's initial overflight of the airport. (Australian Transport Safety Bureau Photo)
