Sudden Aileron Lock Sends Cargo Turboprop Plummeting to the Ground

Improperly rigged ailerons turn a routine left bank into a fatal maneuver.

ACCIDENT PREVENTION

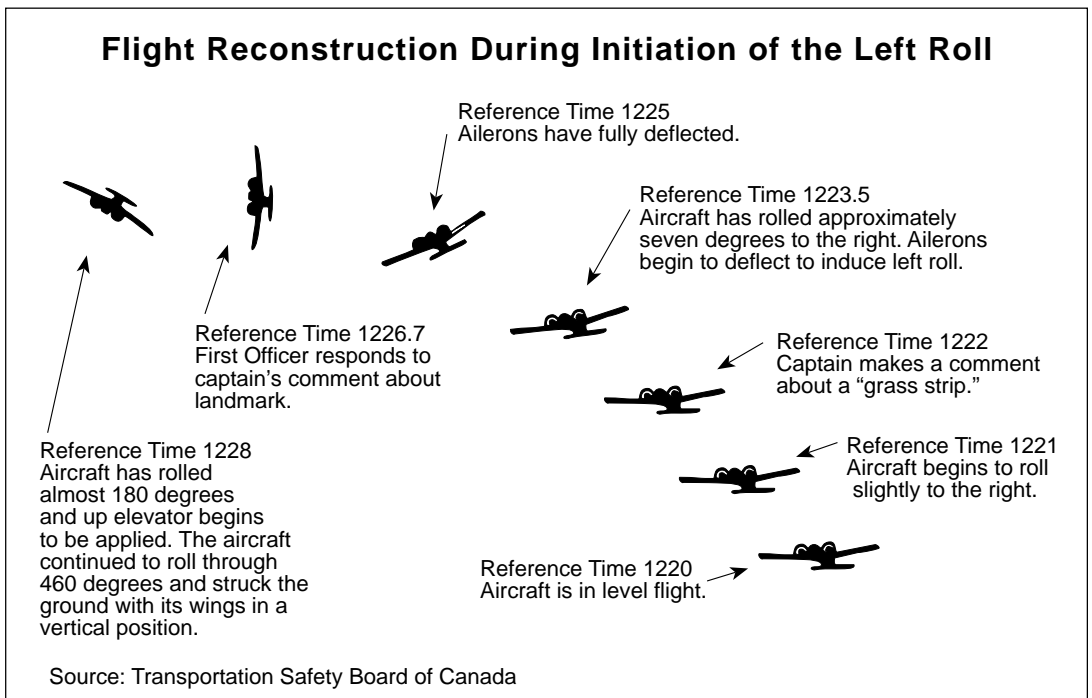
Figure 1

a landmark. According to the TSB report, the FDR recorded a "full-up deflection of the left aileron and a full-down deflection of the right aileron and the aircraft began a roll to the left at a high rate." (Figure 1)

The report added: "The right aileron remained at the fully-deflected position for a period of three seconds and then, over the next seven seconds, the deflection gradually decreased by about five degrees. During the same 10-second period, the left aileron remained nearly fully deflected for the first eight seconds ... and decreased about five degrees in the next two seconds. By this time the aircraft had rolled through approximately 460 degrees and the aircraft nose had dropped to 30 degrees below the horizon. At this point, the ailerons suddenly returned to about the neutral position and remained there for the last three seconds of flight."

The time from the initial aileron deflection to ground impact was 18 seconds.
