## Bird Strike during de Havilland Dash 8's Approach Disables Left-engine Instruments, Brakes and Nose-wheel Steering

*The flight crew shut down the left engine after the aircraft struck an eagle. They continued flying near the destination airport for 31 minutes while troubleshooting a landing-gear-unsafe warning. The crew then lost directional control of the aircraft during an attempted single-engine, crosswind landing.*

On May 17, 1996, a de Havilland Canada Dash 8 (DHC-8) ran off the right side of Runway 10 while landing at the Broome, Australia, airport. The aircraft was damaged substantially. The final report on the accident by the Australian Bureau of Air Safety Investigation (BASI) did not say whether any of the occupants were injured.

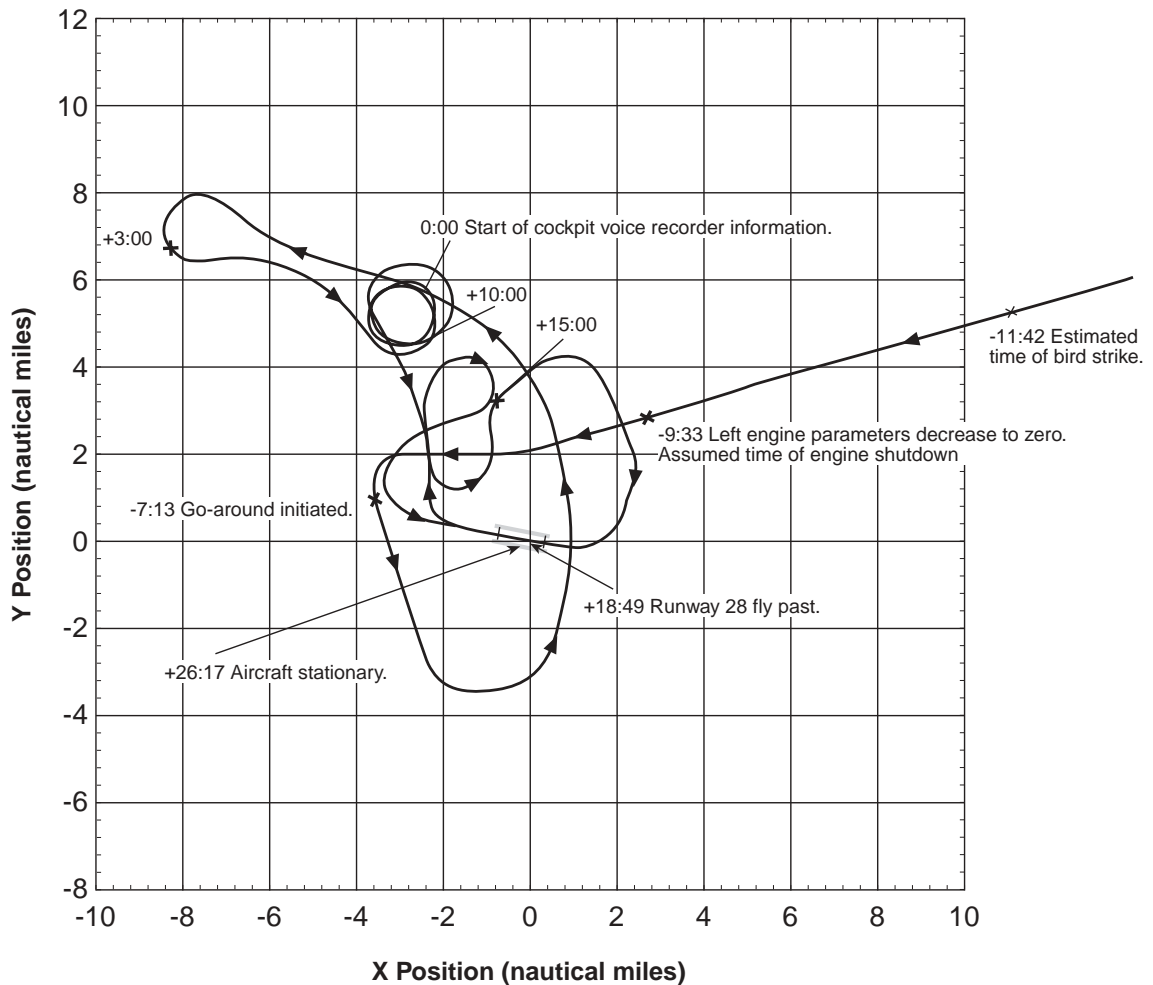
**Figure 1**

“Nine of the turns during the holding, including four orbits, were to the left, into the failed engine, and three turns were to the right. Three of the orbits during the holding were conducted at bank angles which produced a rate of turn greater than rate one [three degrees per second].” Figure 1 (page 3) shows the aircraft’s flight path.

## Flight Path of de Havilland Dash 8; Broome, Australia; May 17, 1996
