Double Engine Failure Leads to Ditching of Cessna 402C

FSF Editorial Staff

ACCIDENT PREVENTION

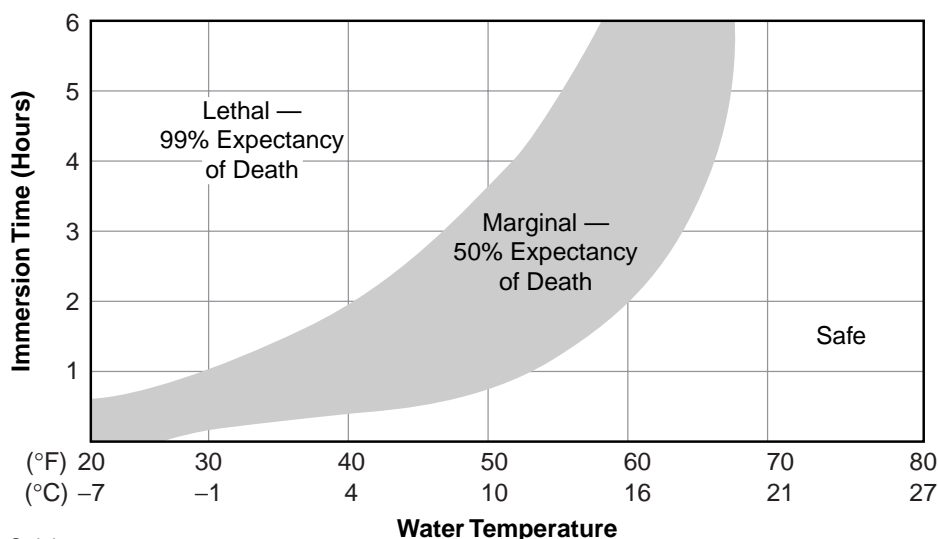
“Expert medical opinion was that swimming and efforts to stay afloat would have become impossible for immersed swimmers without life jackets in approximately 15 minutes, given the sea state and temperature of 9 degrees C,” the report said. “Survival for longer than this period would have required the use of a life jacket. Without life jackets, and with the quite-light clothing worn by most passengers, hypothermia would have presented an increasing risk to survival after approximately 40 minutes (see Figure 1).”

Figure 1 shows the time for body-core temperature to decrease below 34 degrees C (93 degrees F), which is the body-core temperature associated with moderate hypothermia.

Life Expectancy of Uninjured Survivors Immersed in Seawater at Various Temperatures
