Descent Below Minimum Altitude Results in Tree Strike During Night, Nonprecision Approach

After descending below the published minimum descent altitude for the nondirectional beacon (NDB) approach, the commander began a missed approach as the aircraft struck trees. A three-foot section of the right wing was torn away; the crew diverted the aircraft to another airport, where they landed safely.

Accident Prevention

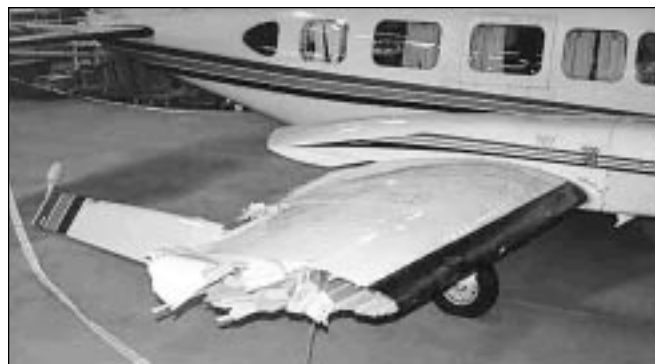
About one meter (three feet) of the Piper Chieftain's right wing separated during the tree strike. The aileron was torn from its hinges but remained attached to the wing by its actuating rod.
(Photo: Swedish Board of Accident Investigation)

The airplane was at about 600 feet when its right wing struck trees about 3.5 kilometers (1.9 nautical miles) north of the airport.

“Pieces of the wing tip were recovered at the site, but the majority of the wing section that was torn off was found about ... 20 kilometers [11 nautical miles] south of the impact site,” the report said. “Signs of impact on spruce [trees] and pine trees, at a height of about 20 meters [66 feet] above the ground, were found at the accident site.”

About one meter (three feet) of the right wing separated from the airplane. The aileron separated from its hinges but remained attached to the wing by an actuating rod.

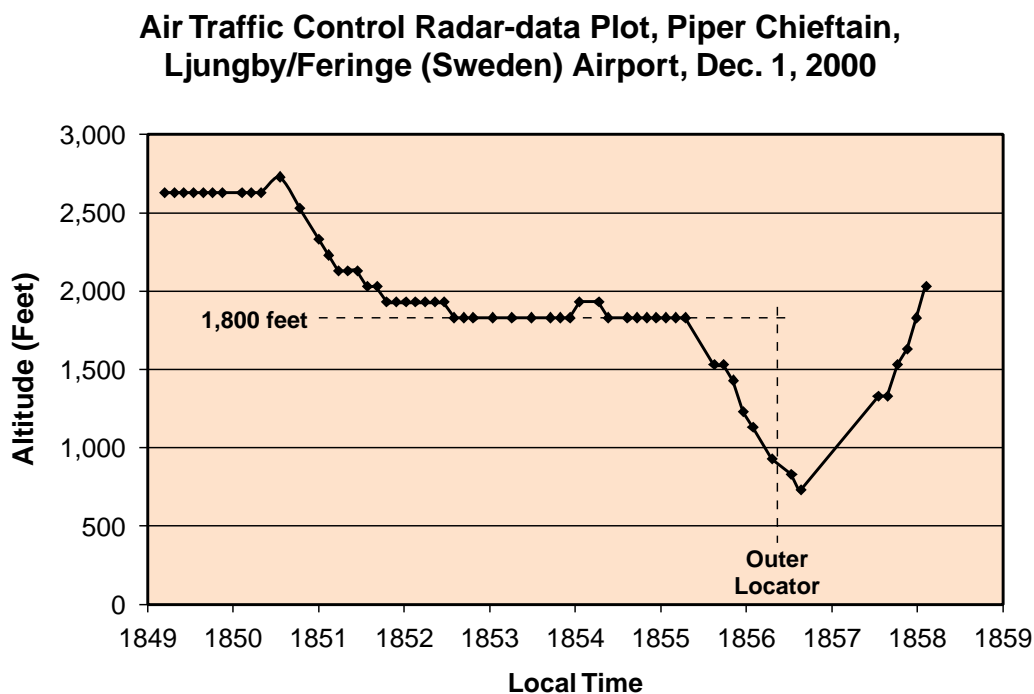
Figure 1

ATC radar data indicated that the airplane began to descend from 1,800 feet about 2.5 kilometers (1.4 nautical miles) from the outer locator (see Figure 1).
