Propeller Failure Precipitated Wright Flyer Control Loss

The first fatal accident involving a powered, heavier-than-air aircraft occurred during a demonstration flight in September 1908 for the U.S. Army Signal Corps. The pilot, Orville Wright, was seriously injured; his passenger, Lt. Thomas Selfridge, was killed.

Accident Prevention

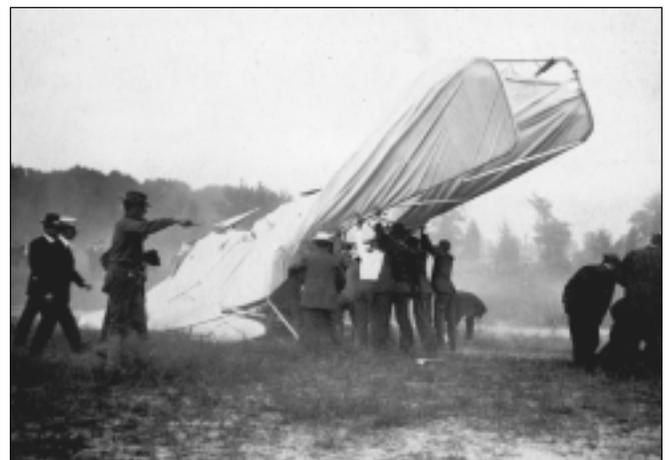
Selfridge is extricated from the wreckage while Signals Corps personnel and spectators at right attend to Wright. (Photo: Wright State University)
