## Unstabilized Approach, Icing Conditions Lead To Commuter Tragedy

*When the crew of the Jetstream commuter decided to salvage a missed approach in hazardous weather conditions, they set an error chain in motion that left them few recovery options. An investigation revealed that poor vectoring by air traffic control and tail plane icing contributed to the fatal crash.*

*Editorial Staff Report*

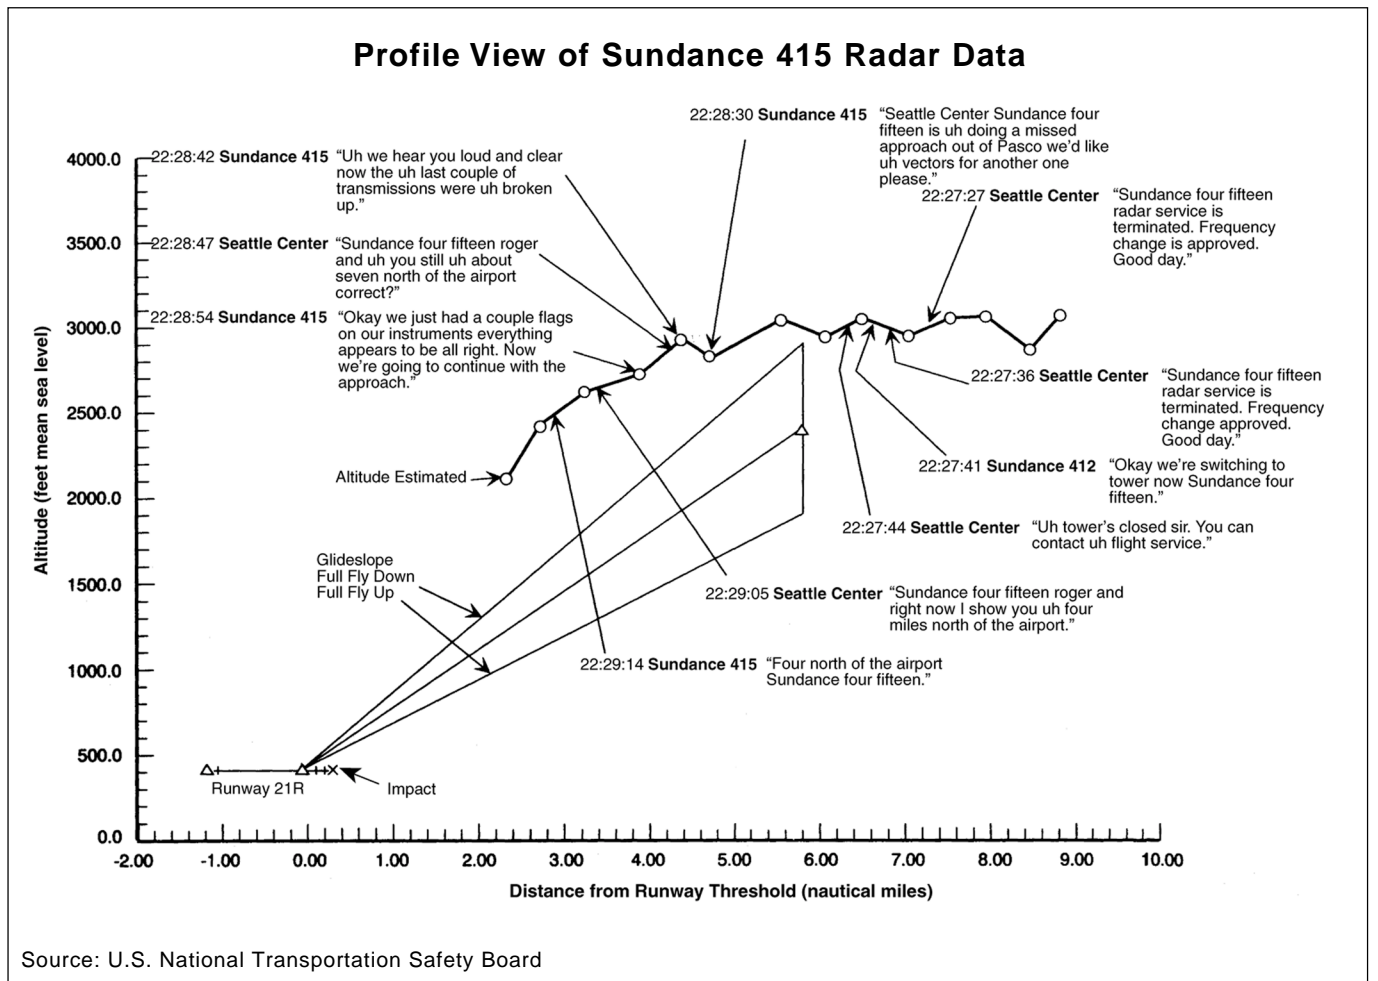
Figure 1

When the flight crew acknowledged their position to Seattle Center as four miles north of the airport, the aircraft was still at an altitude of 2,500 feet (2,000 feet AGL), a situation "that would have presented a full-scale fly-down deflection on the glideslope indicator in the cockpit." (Figure 1, page 5)

Investigation revealed that an average glidepath of about seven degrees was required for the aircraft to reach the runway threshold from its last radar-targeted position. This angle is more than twice the glidepath angle used for a normal ILS approach. Investigators also found that the flight crew could lose ILS glideslope guidance (with warning flags) after initiating a steep descent from a position well above the glideslope.
