## Different Altimeter Displays and Crew Fatigue Likely Contributed to Canadian Controlled-flight-into-terrain Accident

*The official Canadian accident report said that the nonflying pilot's altimeter, course track indicator and heading settings had not been set accurately to enable accurate monitoring of the nonprecision night approach.*

### *Editorial Staff Report*

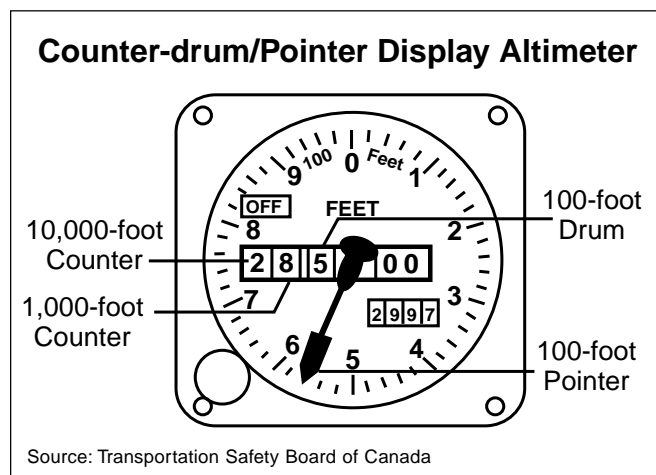
Figure 1

The cockpit of the accident aircraft was equipped with two different altimeter displays, the report said. The altimeter on the left side of the instrument panel was a counter-drum/pointer display (Figure 1), but the altimeter on the right side of the instrument panel was a three-needle display (Figure 2, page 6), the report said. The three-needle display altimeter was used in the company’s Piper Navajo.

The report noted: “Without adequate monitoring by both crew members, there would have been an increased risk that the PF might misread the altimeter. This risk would have been elevated

because of his previous experience using needle-type displays, and because he would have been accustomed to monitoring the needle, rather than the drum portion, of the altimeter presentation.”

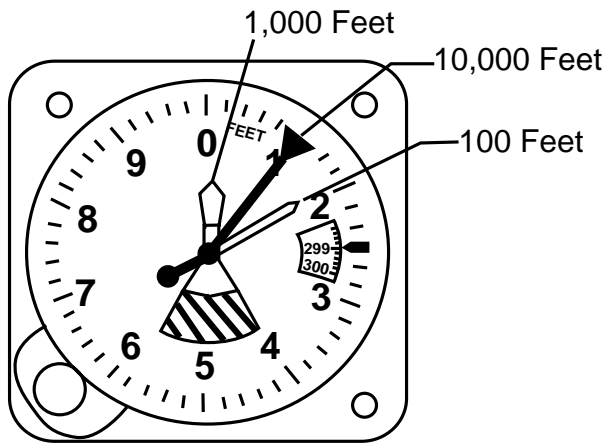
**Figure 2**

### Three-needle Display Altimeter
