## Hidden, Smoky Fire in MD-87 Aft Cabin Forces Emergency Evacuation After Landing

*All the passengers and crew members evacuated the aircraft at the gate without injury, but the fire would have posed a far greater safety threat if the fire had occurred in flight, the official Danish accident report said.*

### ACCIDENT PREVENTION

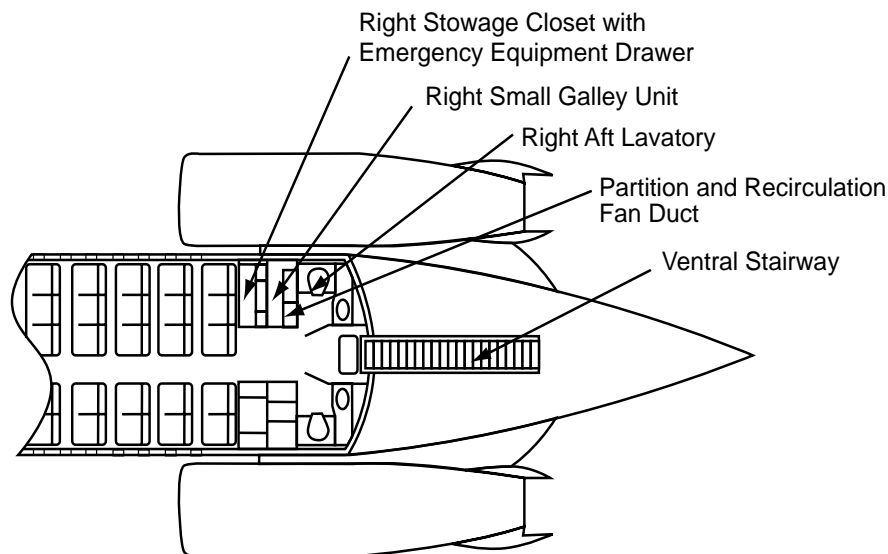
**Figure 1**

The report noted that the cabin configuration “with a stowage closet, a galley, a partition and a lavatory installed in the right-hand and left-hand side of the aft cabin [Figure 1, page 3] is unique to the aircraft delivered to SAS.”

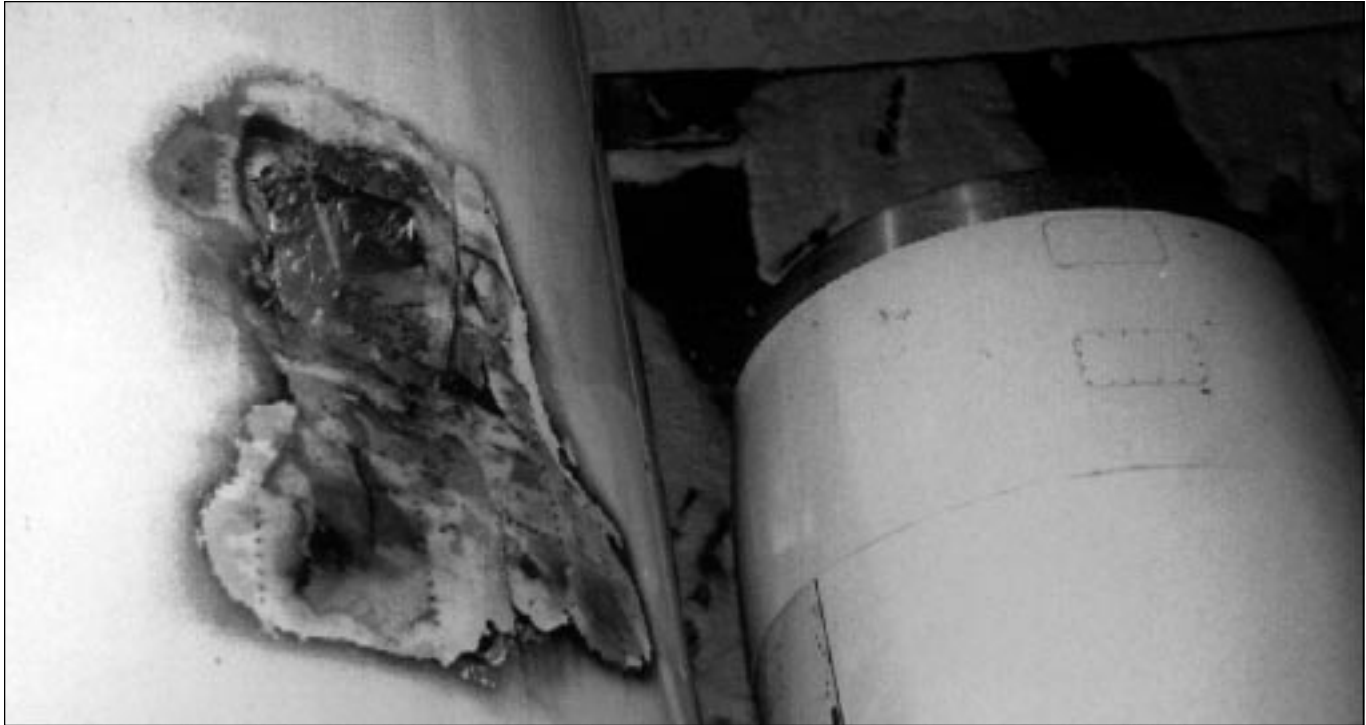
The report said that the fire “destroyed major parts of all of the equipment installed in the [aft right-hand side of the cabin]. The extreme heat development destroyed the fuselage skin and structure over a large area on the aft right-hand side of the aircraft. Additionally ... seats, partitions, galleys, lavatories and paneling were severely damaged by smoke and heat. This ... damage extended as far forward [as the] cockpit and cockpit equipment. The underfloor equipment and compartments were severely damaged by soot and residue from fire-fighting agents, which ... had drained down through the cabin floor to the bottom of the aircraft.”

*Fire in the aft cabin of an SAS McDonnell Douglas MD-87 burned through the fuselage adjacent to the right engine, at Copenhagen Airport Kastrup, Nov. 24, 1993.*

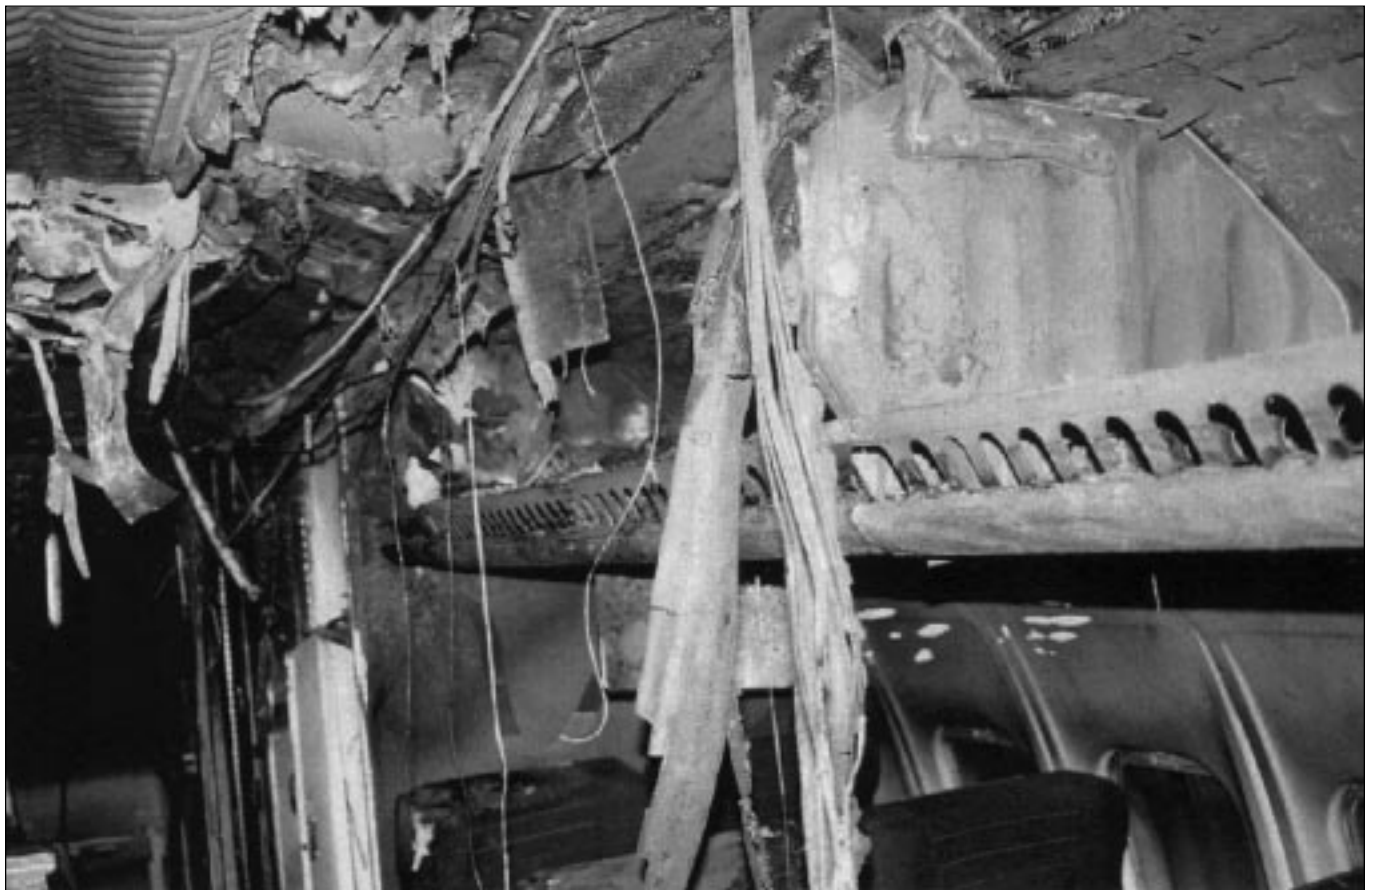
*Fire that began on the right side of the SAS McDonnell Douglas MD-87 spread to the left side (shown here) and destroyed the aft cabin, at Copenhagen Airport Kastrup, Nov. 24, 1993.*
