MD-88 Strikes Approach Light Structure in Nonfatal Accident

The collision occurred on a daylight, visual approach over water to Runway 13 at LaGuardia Airport, New York, New York, U.S., when visual illusions and the pilot's monovision contact lenses caused him to misperceive the aircraft's altitude and rate of descent, the report said.

—
FSF Editorial Staff

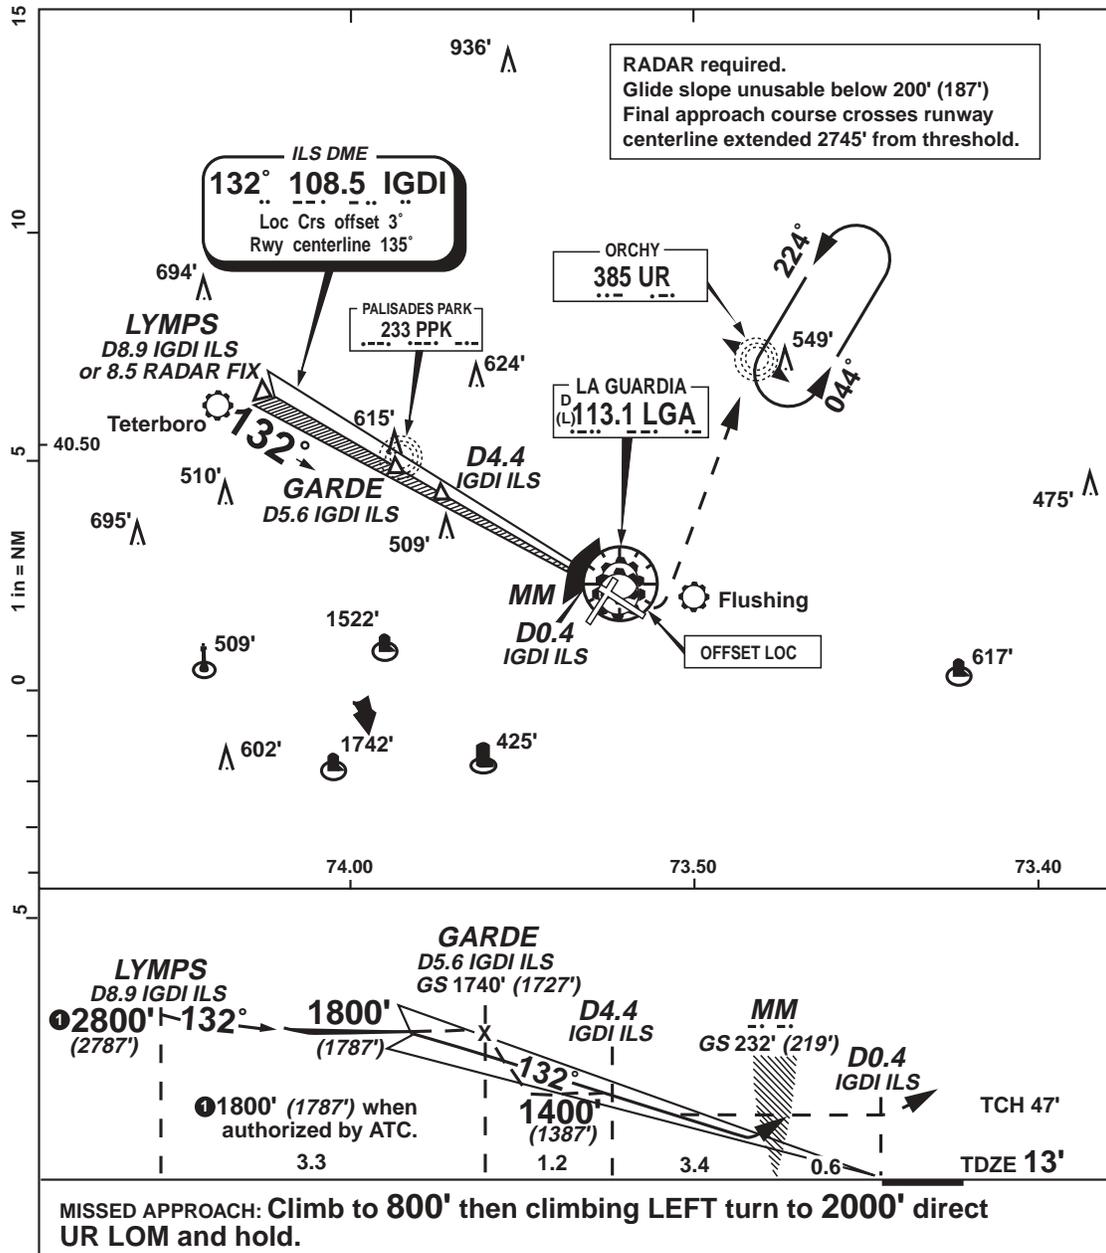
Figure 1

Beginning about 1610, the pilots began to receive radar vectors for the ILS DME approach to Runway 13 (Figure 1, page 3). They completed the descent checklist and, five minutes later, completed the approach checklist. During that time, the captain briefed the approach; he and the first officer discussed the published three-degree difference between the localizer heading and the runway heading, the location of the point where the final approach course crosses the runway centerline, the unreliability of the ILS glide slope below 61 meters and the missed-approach procedure.

Instrument Landing System (ILS) Distance Measuring Equipment (DME) Approach to Runway 13 at LaGuardia Airport, New York, New York, U.S., at the Time of the Accident

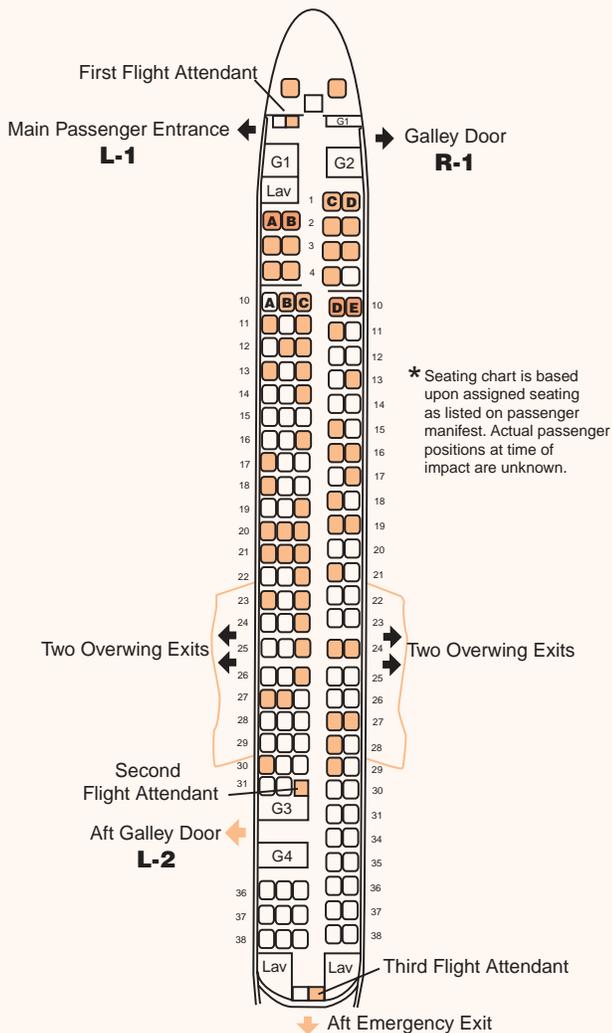
Figure 2 shows the accident McDonnell Douglas MD-88 diagram and seating chart. At the time of the accident, the flight-attendant-in-charge was seated in the aft-facing jumpseat, next to the L-1 door (left side, forward). The second flight attendant was seated in the forward-facing jumpseat on the left side of the aircraft, and the third flight attendant was seated in the forward-facing rear cabin jumpseat.

MD-88 Passenger Cabin Delta Flight 554, Oct. 19, 1996
