## Business Jet Overruns Wet Runway After Landing Past Touchdown Zone

*Recorded radar data showed groundspeeds of more than 160 knots when the Cessna Citation 500 was on final approach. The aircraft struck a navigational-aid-support structure, terrain and two mobile homes off the departure end of the runway. The three occupants were injured during the impact, but they exited the aircraft before it was destroyed by fire.*

—  
*FSF Editorial Staff*

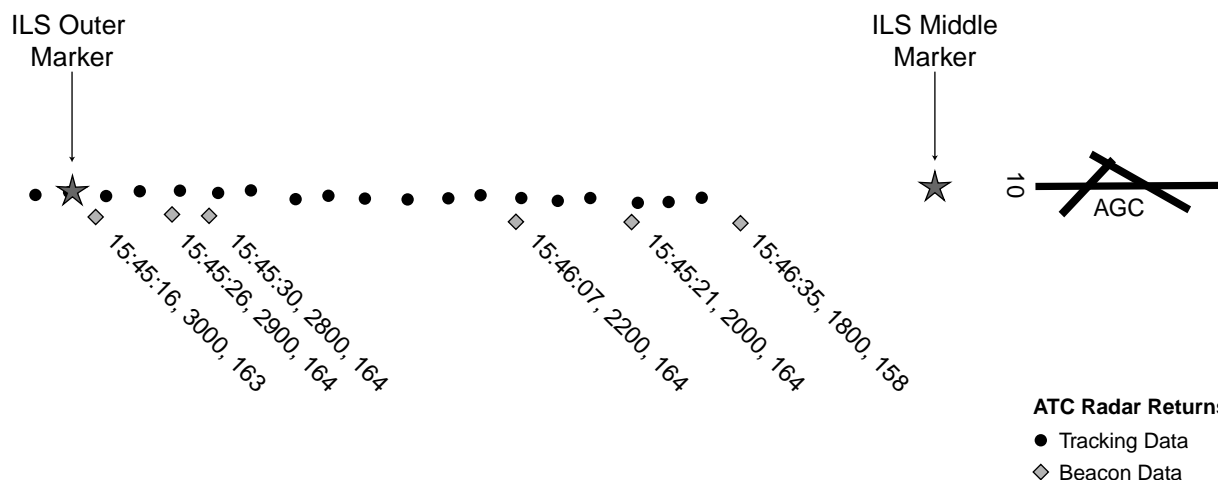
**Figure 1**

The passenger said that he saw an indicated airspeed of 160 knots when the aircraft was at about 700 feet AGL. Data recorded by Pittsburgh Approach showed that the groundspeed was more than 160 knots on final approach (see Figure 1, page 4).

“The data revealed that the airplane crossed the outer marker [an ILS navigational fix 5.3 nautical miles (9.8 kilometers) from the runway threshold] at a groundspeed of 163 knots and maintained a groundspeed of 164 knots until about 1.8 nautical miles [3.3 kilometers] from the approach end of Runway 10, at which time the groundspeed dropped to 158 knots,” the report said. “The airplane was unable to be tracked below an altitude of 1,800 feet ... due to surrounding terrain.” [Airport elevation is 1,252 feet, and decision altitude was 1,452 feet.]

## Air Traffic Control Radar Data; Cessna Citation 500; West Mifflin, Pennsylvania, U.S.; Jan. 6, 1998

Note: ATC radar beacon data returns are labeled with corresponding local time (hours:minutes:seconds), altitude (feet), and calculated groundspeed (knots). ATC radar did not track the aircraft below 1,800 feet.
