Inadequate Response to Flight-control Problem, Misuse of Autopilot Cited in Falcon 900B Upset

The aircraft was descending to land in Bucharest, Romania, when the autopilot disengaged and several pilot-induced pitch oscillations occurred. Seven passengers, who were not wearing seat belts, were killed; one passenger and the flight attendant were seriously injured.

—
FSF Editorial Staff

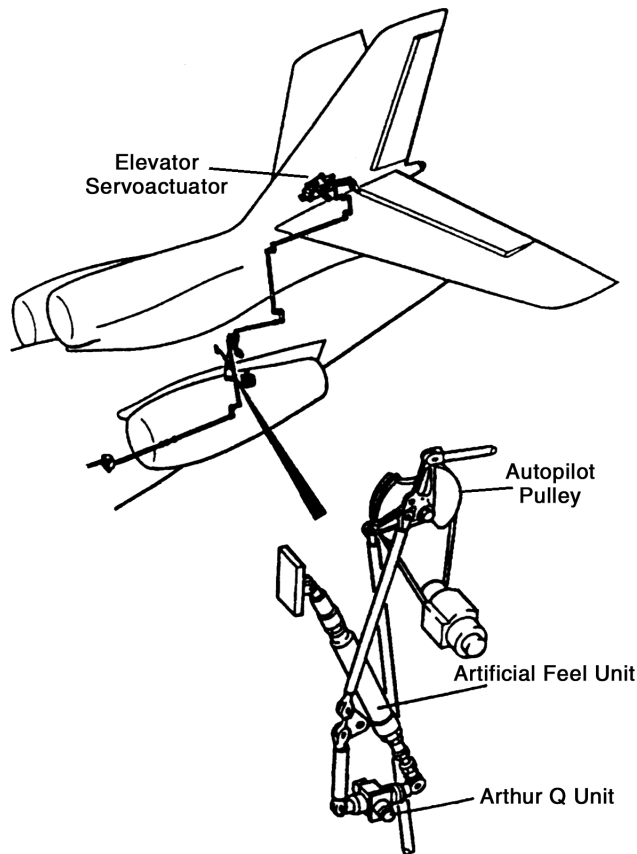
Figure 1

Falcon 900B Elevator-control System
