MD-82 Overruns Runway While Landing In Proximity of Severe Thunderstorms

The investigation of the approach-and-landing accident generated several recommendations, including improvement of standard operating procedures regarding the use of airplane spoiler systems, autobrake systems and reverse thrust on wet/slippery runways.

At 2350 local time June 1, 1999, American Airlines Flight 1420, a McDonnell Douglas MD-82, overran Runway 4R while landing at Little Rock (Arkansas, U.S.) National Airport. The airplane struck several frangible¹ tubes extending outward from the left edge of an instrument landing system (ILS) localizer array, passed through a chain link security fence, descended over a rock embankment to a flood plain 15 feet (five meters) below the runway and struck an approach-light-support structure. The captain and 10 passengers were killed; the first officer, three flight attendants and 41 passengers received serious injuries; one flight attendant and 64 passengers received minor injuries; and 24 passengers were not injured.

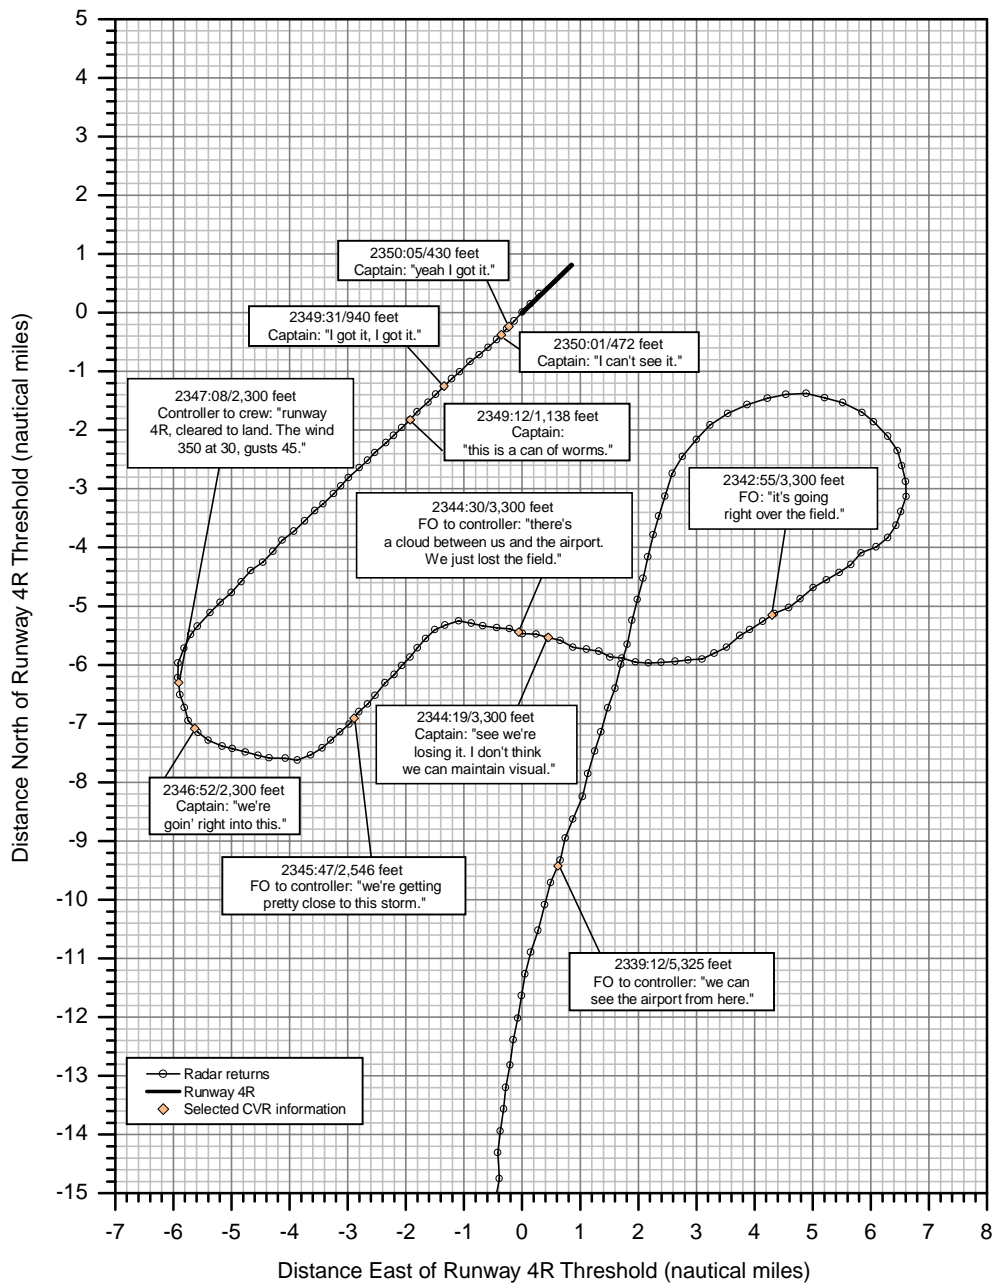
Figure 1

At this time, the airplane was about nine nautical miles (17 kilometers) south of the airport (see Figure 1, page 4), and heavy rain had begun to fall at the airport. Heavy rain is defined by NWS as 0.03 inch (0.08 centimeter) of rain within six minutes.

Flight Path of American Airlines Flight 1420, McDonnell Douglas MD-82, Little Rock (Arkansas, U.S.) National Airport, June 1, 1999
