U.S. Accident Report: Failure of Propeller Control System Downs Aircraft

A sudden, violent roll sent an Embraer EMB-120 plunging to the ground while on landing approach. A U.S. National Transportation Safety Board report determined that a failure in the left-engine propeller control unit caused an unrecoverable loss-of-control.

Editorial Staff Report

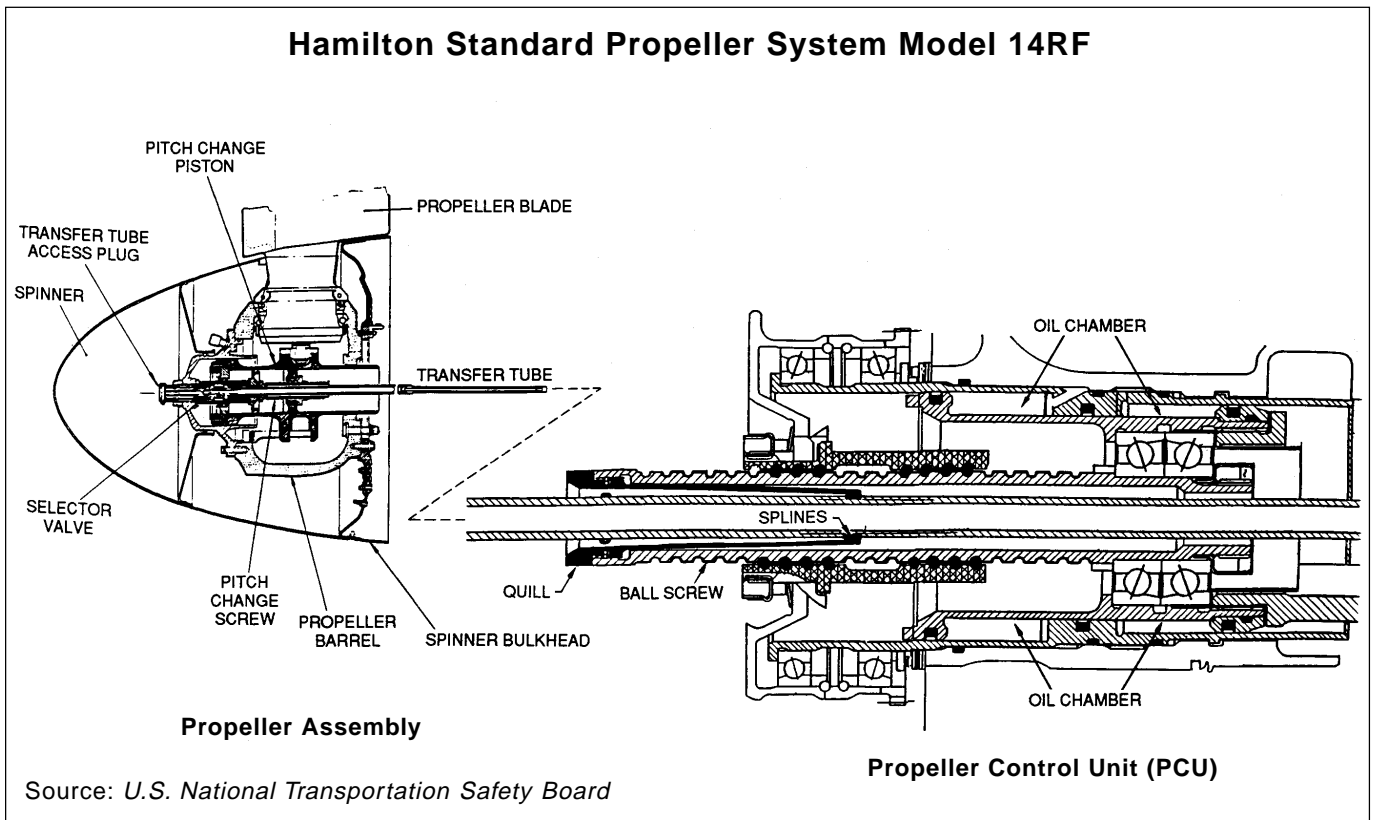
Figure 1

The Hamilton Standard 14RF-9 propeller is a flange-mounted, controllable-pitch, dual-acting, full-feathering, reversible, four-blade propeller with composite blades. The propeller and PCU are mounted on a common centerline and connected through the propeller shaft by the oil transfer tube. The transfer tube provides high-pressure oil from the gearbox-mounted main oil pump to the propeller hub. The PCU governor provides metered oil pressure to operate a ballscrew drive that imparts rotary motion to the transfer tube by means of a splined quill. The transfer tube turns an acme screw in the pitch assembly. The acme screw positions the pitch change selector valve, which directs oil to the “increase pitch” or “decrease pitch” side of the piston.] (Figure 1)

“The PCU ballscrew position was measured on both units,” the NTSB said. “The measurements indicated that the PCU ballscrew position for the left propeller was in a location that would coincide with a PCU-commanded propeller blade angle of 79.2 degrees, which is the feathered position. The PCU ballscrew position for the right propeller corresponded to a commanded propeller blade angle of 24.5 degrees.”

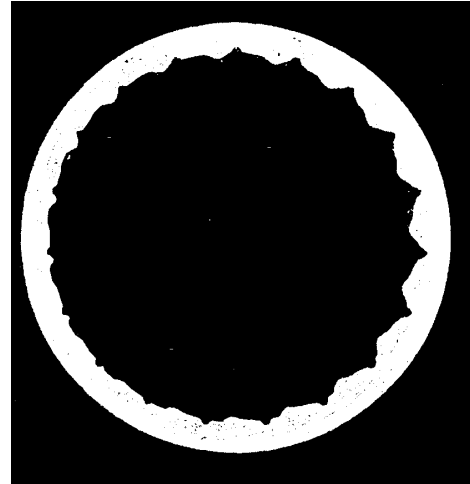
Left Engine Quill

The NTSB added: “The discrepancy in the propeller control unit was found to have been extreme wear on the PCU quill spline teeth that normally engaged the titanium-nitrided splines of the propeller transfer tube. It was found that the titanium-nitrided surface was much harder and rougher than the nitrided surface of the quill. Therefore, the transfer tube splines acted like a file and caused abnormal wear of the gear teeth on the quill.”

According to the NTSB, ballscrew quills from both PCUs had severely worn internal splines. (Figure 2, page 5)

“The spline teeth on the left quill were almost entirely worn away, and the wear pattern was slightly off the axial centerline. The right quill spline wear was more eccentric with a heavy wear pattern on one side and relatively little wear on the opposite teeth.”

Based on the number of worn quills found (including those in the accident aircraft), the manufacturer issued an alert service bulletin “that advised all operators to inspect PCUs for worn quills and began a fleet campaign to remove from service the titanium-nitrided transfer tubes and to replace them with the original nitrided tubes.” The alert detailed recommended inspection intervals and quill wear limits.

A month later, the FAA issued an emergency airworthiness directive (AD), based on the service bulletin, that required inspection at a maximum of 500 hours of service of the PCU ballscrew quill installations that had titanium-nitride transfer tubes.

The FAA issued another emergency AD two weeks later reducing the initial time-in-service inspection to a maximum of 200 hours and reducing wear limits and repetitive inspection hours for quills returned to service.
