Cargo Airplane Strikes Frozen Sea During Approach in Whiteout Conditions

The pilots descended below minimums during an NDB approach to a remote Canadian airport. They were heads-up, seeking visual references, when the de Havilland Twin Otter struck the ice in a controlled, shallow descent.

On March 19, 1999, a de Havilland DHC-6-300 Twin Otter, operated by Provincial Airlines on a cargo flight, was destroyed when it struck the frozen surface of the Labrador Sea during a nondirectional beacon (NDB) approach to Davis Inlet (Newfoundland, Canada) Airport. The captain received serious injuries; the first officer was killed.

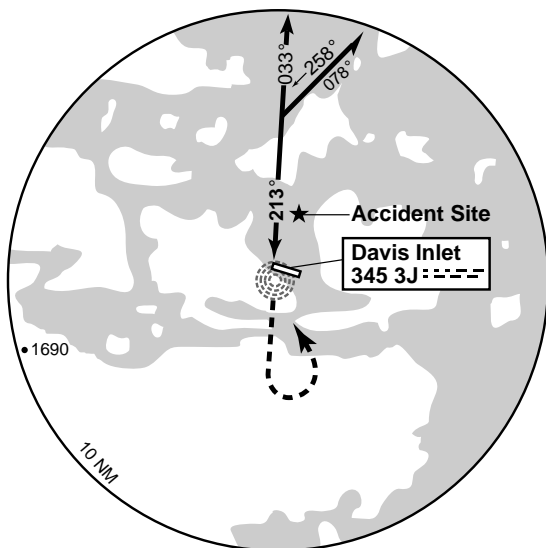
Figure 1

The airport has one instrument approach — an NDB approach that terminates with a missed approach or with a circling approach to the runway (see Figure 1, page 2). The MDA is 1,340 feet, and the published advisory visibility¹ is three statute miles (five kilometers).

“The approach procedure is to the north-northeast of the airport and, for the most part, over the ocean,” the report said. “The missed approach point is at the NDB [about 0.2 nautical mile (0.4 kilometer) south-southwest of the airport].”
