## Loss of Engine Power Sets Stage For Ditching on a Moonless Night

*The left engine failed and the right engine malfunctioned when a Piper Chieftain was being flown over a gulf in Australia. The airplane did not have — and was not required to have — life vests aboard for the scheduled flight. None of the eight occupants survived the ditching.*

—  
*FSF Editorial Staff*

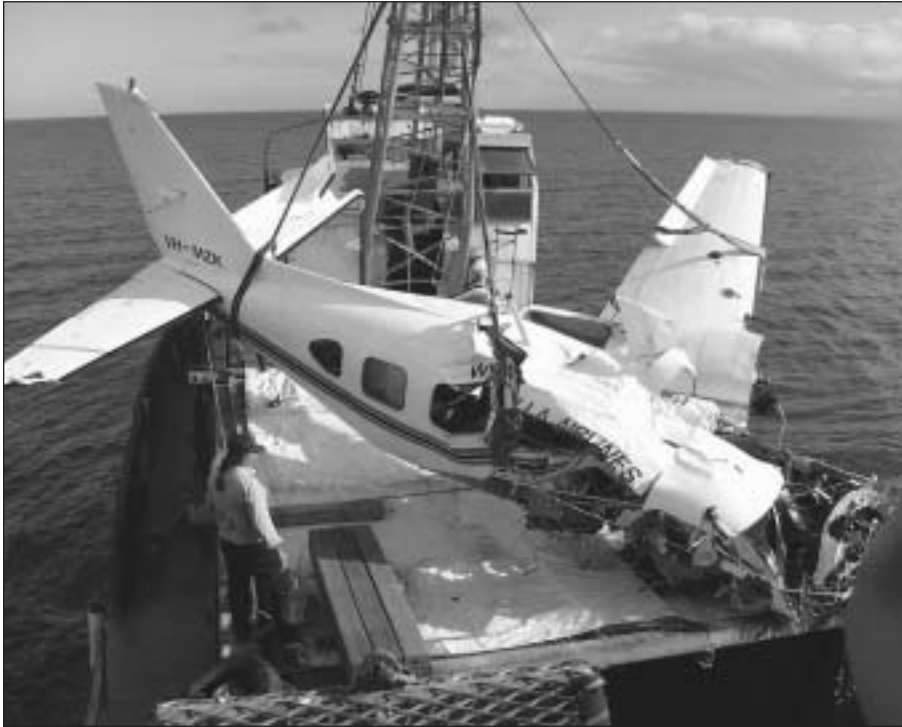
The examination indicated that the airplane was in a shallow nose-down attitude and that the wings were level or banked slightly right on impact. The outboard section of the right wing struck the water first.

“Contact with the water caused disintegration of the nose section and the cockpit area,” the report said. “Rapid and forceful ingress of water is considered to have further aggravated the initial impact damage and contributed to rapid sinking.

“A combination of fuselage deformation and inrushing water forced the doors, most windows and the emergency escape hatch to come out of their respective retaining frames. Both engines ... were torn from their wing nacelles.”

*Examination of the wreckage indicated that the airplane likely slewed right severely after the right wing struck the water and was torn off. (Photo: Australian Transport Safety Bureau)*
