## Stall and Improper Recovery During ILS Approach Result in Commuter Airplane's Uncontrolled Collision with Terrain

### Editorial Staff Report

#### ACCIDENT PREVENTION

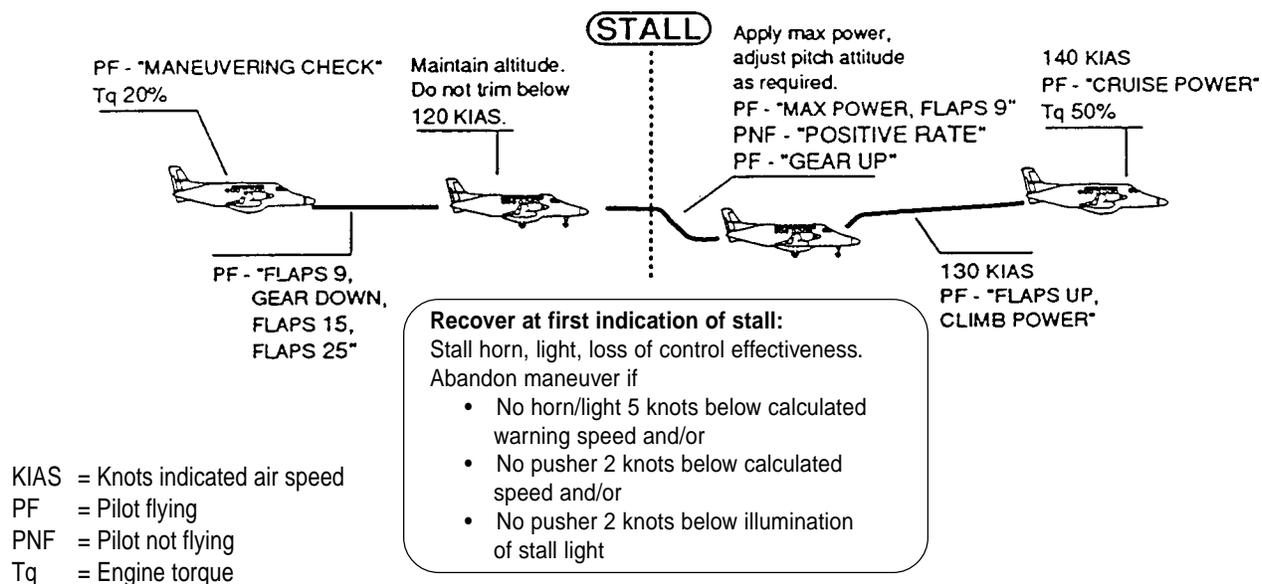
**Figure 1**

## Approach to Stall — Landing Configuration (From Atlantic Coast Airlines Training Manual)

Investigators examined ACA company manuals and found that the manuals did not contain a definition for a stabilized approach. Nevertheless, said the report, “The ACA training manual did depict an approved ILS approach procedure for the J-4101. The procedure depicts the airplane with engine torque at 30 percent and airspeed at 180 knots before reaching the initial approach fix (IAF) and after the approach checklist is complete. It suggests a speed of 160 knots during the initial procedure with no flaps. ... The procedure depicts the airplane as configured with the landing gear down and flaps set to 15 degrees before the final approach fix/point (FAF/FAP). At the FAF/FAP, the flaps should be lowered to 25 degrees with a minimum speed of 130 knots and engine torque at 30 percent.”

The report noted: “The accident flight attained neither the configuration nor the other guidelines specified in the chart. ...
