Learjet MEDEVAC Flight Ends in Controlled-flight-into-terrain (CFIT) Accident

The Canadian accident-investigation board determined that the flight crew had apparently mis-set one or both altimeters, resulting in lower-than-prescribed altitudes for the descent profile. The flight crew and medical-team passengers were killed when the Learjet was unknowingly flown into the water.

—
FSF Editorial Staff

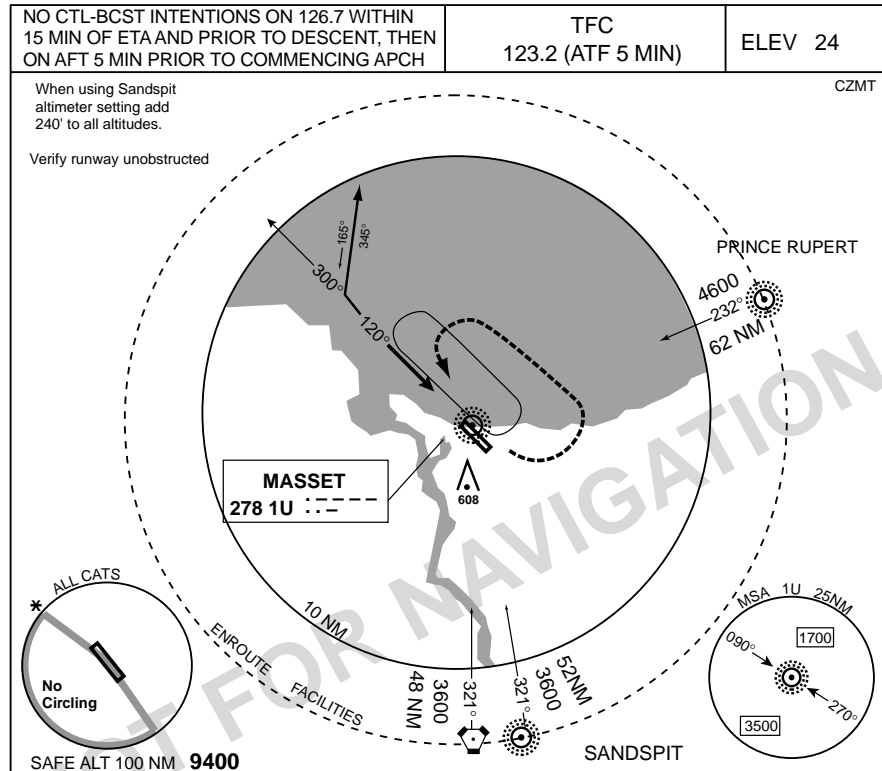
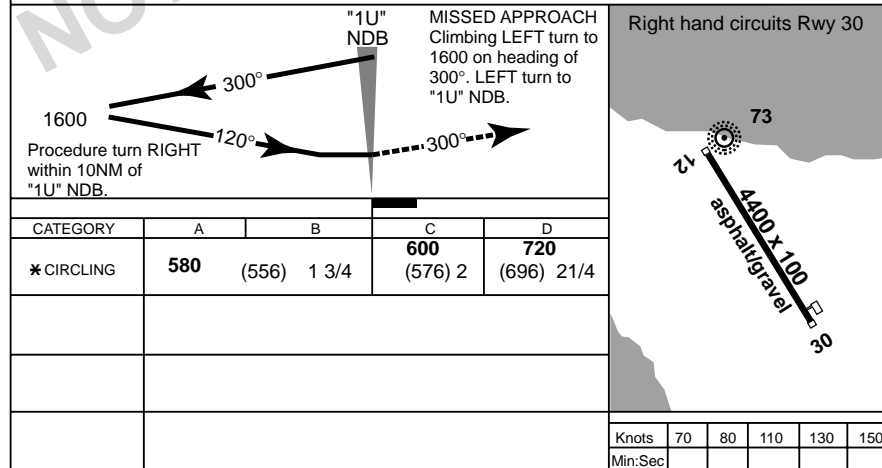
Figure 1

The route was from Vancouver direct to the Sandspit very high frequency omnidirectional radio range (VOR) at an altitude of 39,000 feet (11,895 meters), then 48 nautical miles (89 kilometers) direct to the Masset NDB. At 0144, the flight crew reported to air traffic services (ATS) that they were “outbound” from the Masset NDB on the published NDB “A” instrument approach to Runway 12 (Figure 1, page 3).

The TSB said that an aircraft conducting the Sandspit transition to the Masset NDB "A" nonprecision approach to Runway 12 (Table 1, page 5) "would initially cross the Masset NDB at an

altitude of 3,600 feet [1,098 meters] ASL and proceed outbound on a track of 300 degrees magnetic. It would then enter the procedure turn and maintain 1,600 feet [488 meters] ASL, before descending on the final inbound track to the minimum descent altitude (MDA) of 600 feet [183 meters] for Category 'C' aircraft; the Learjet was a Category 'C' aircraft. In accordance with the remote altimeter setting procedures, 240 feet [73 meters] must be added to these altitudes as minima."

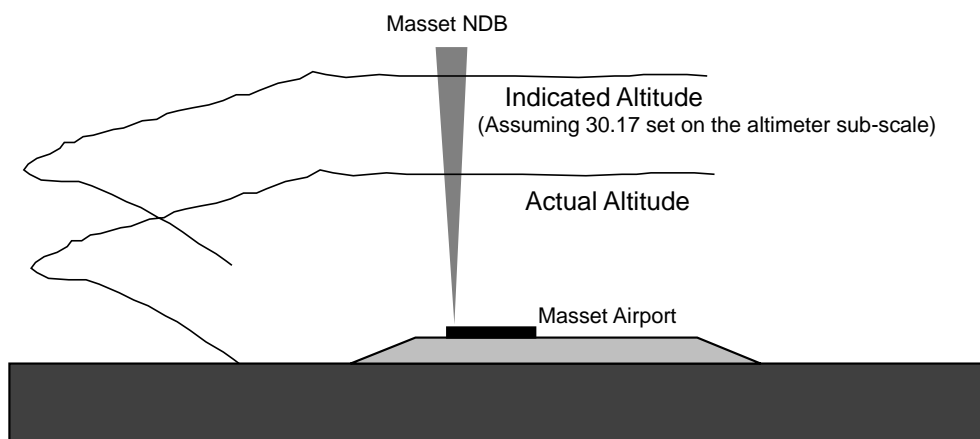
Figure 2

The third scenario assumed that the approach was flown with the altimeter incorrectly set at 30.17 in. Hg, but in compliance with the remote altimeter requirement of 240 feet (Figure 2).

“The initial level-off for the Sandspit transition was at an indicated altitude of 3,650 feet, after which the aircraft maintained an indicated altitude of about 3,850 feet [1,174 meters],” the report said. “This last altitude nearly corresponds to the 3,840-foot remote transition altitude required. The profile is consistent with the pilot erroneously leveling off at the 3,600-foot minimum before recalling his obligation to add 240 feet because of the remote altimeter requirements.

“The subsequent procedure turn level-off at an indicated altitude of 1,650 feet, followed by a quick climb to an indicated altitude of 1,900 feet, was also consistent with the pilot

descending to the original approach plate-profile minimum, before quickly climbing back up to the 1,840 feet required. The inbound descent would have progressed until water contact at an indicated altitude of about 1,000 feet.”

The report concluded: “The scenario that best fits the available information is that the crew mistakenly set 30.17 on the sub-scale of their altimeters. Why neither crew member detected the error could not be determined.”
