## Attempted Go-around with Deployed Thrust Reversers Leads to Learjet Accident

On July 15, 1997, a Gates Learjet 35A struck terrain during an attempted go-around at Avon Park (Florida, U.S.) Municipal Airport. Several witnesses saw the aircraft touch down on the runway, then lift off and fly at a slow airspeed and at a low altitude before striking power lines and coming to rest in a farm field. The pilot and copilot — the sole occupants of the aircraft — sustained minor injuries. The aircraft was destroyed.

The U.S. National Transportation Safety Board said, in its final report, that the probable causes of the accident were “a loss of engine power as a result of the thrust reversers being deployed and [the] subsequent in-flight collision with wires.”

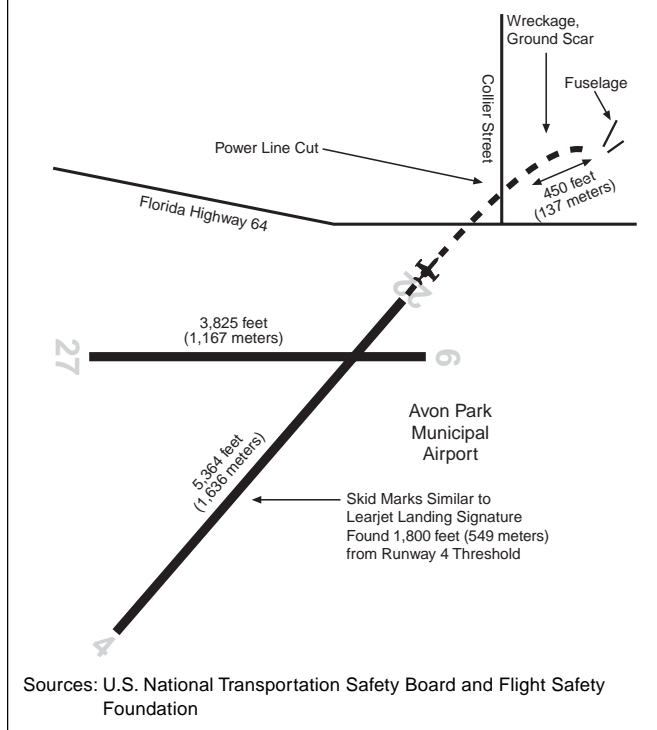
**Figure 1**

## Flight Path of Gates Learjet 35A, N19LH, Avon Park, Florida, U.S., July 15, 1997
