# Accident Prevention

July 2000

## Pilot Loses Control of Twin Turboprop During ILS Approach in Low Visibility

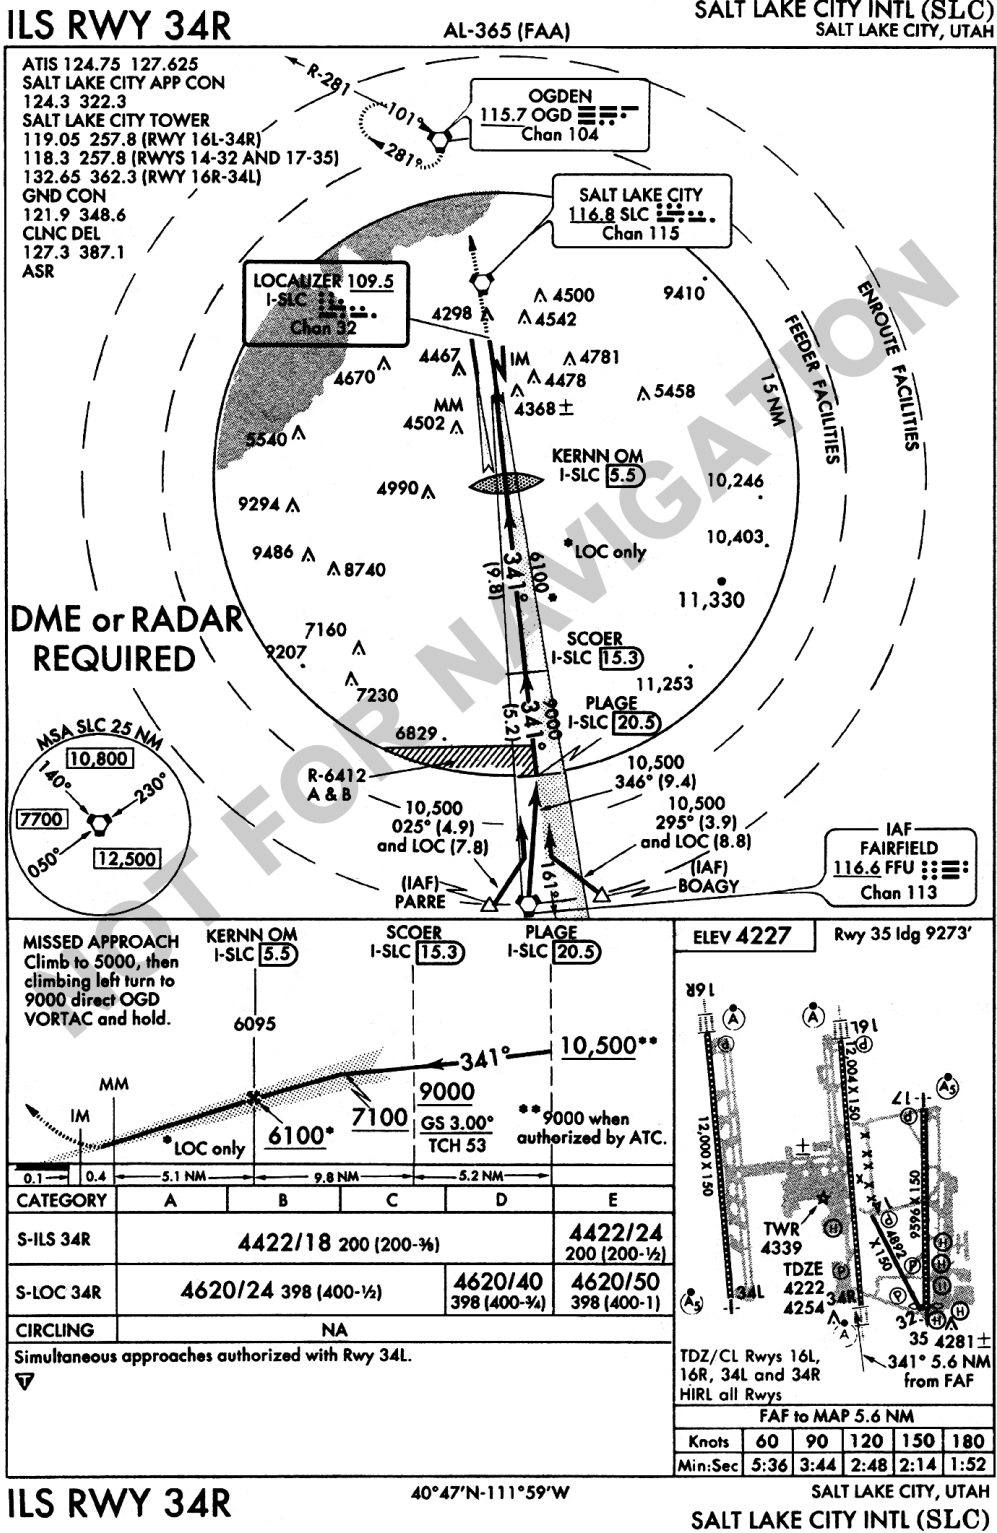
**Figure 1**

Figure 1 shows that at the time of the accident, DME or ATC radar service was required to conduct the ILS Runway 34R

approach. The PLAGÉ, SCOER and KERNN intersections were defined by distances from a DME ground station located 0.1 nautical mile (0.2 kilometer) south of the Runway 34R threshold. The DME frequency was paired with the localizer frequency.

Investigators found a current ILS Runway 34R approach chart among the wreckage but also found that the switch on the aircraft's flight director system that controls the DME display on the pilot's horizontal situation indicator (HSI) was set to a navigation receiver tuned to the Salt Lake City VORTAC frequency. The VORTAC is 4.7 nautical miles (8.7 kilometers) north-northwest of the ILS/DME ground station.
