## Captain's Failure to Establish Stabilized Approach Results in Controlled-flight-into-terrain Commuter Accident

*Inadequate grounding between radome and fuselage could have resulted in unreliable glideslope indications, official U.S. report says.*

## ACCIDENT PREVENTION

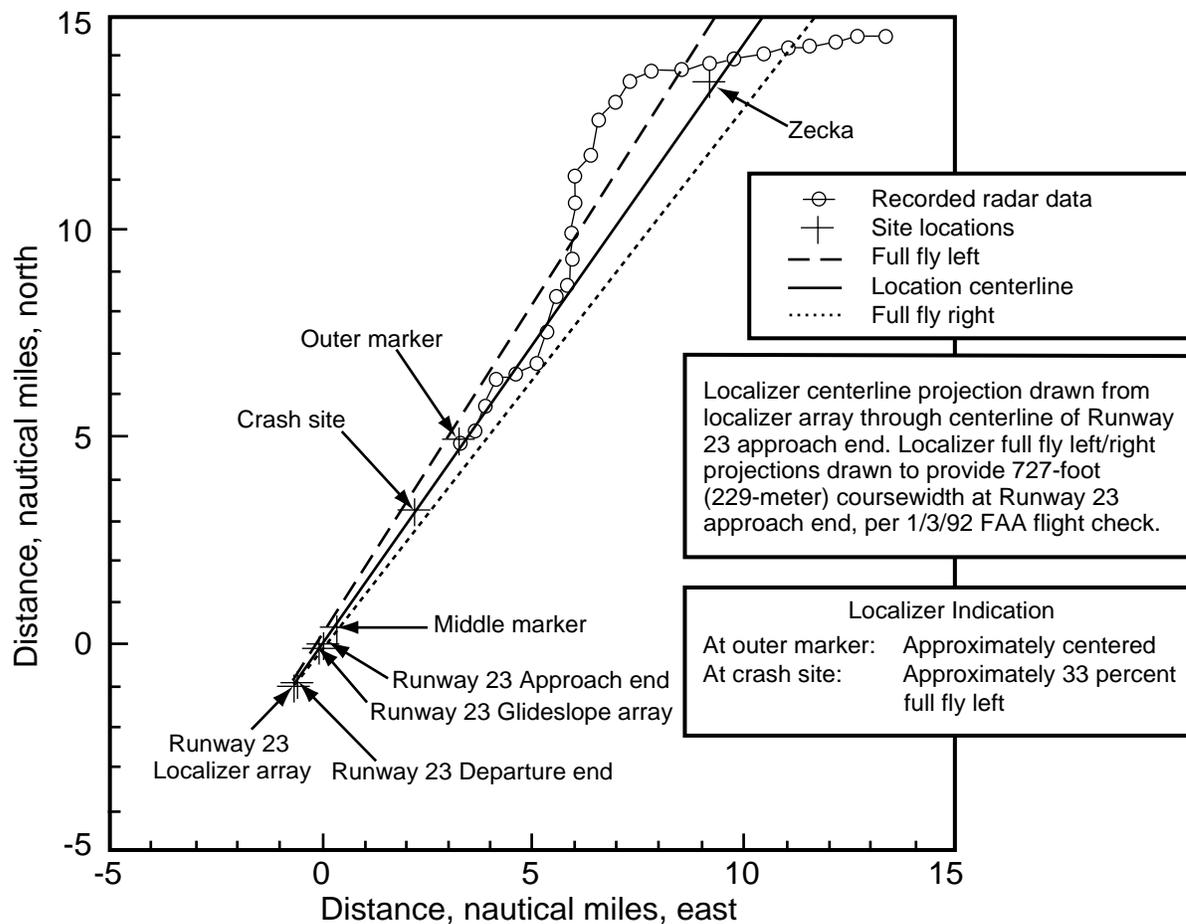
**Figure 1**

The report said the crew was navigating to Zecka via the 274-degree radial of the Plattsburgh very high frequency omnidirectional radio range (VOR). The airplane maintained course through Zecka, and beyond the localizer course. The airplane then turned left, at which point it was approximately 15.8 nautical miles (25.4 kilometers) from the runway threshold, the report said.

“After the initial turn, radar data showed an intercept angle that re-entered the localizer limits approximately 11 miles [17.7 kilometers] from the runway, descending through 5,400 feet [1,647 meters] mean sea level (MSL),” the report said. “With a seven-second exception, the intercept course was maintained as the airplane passed through the localizer 9.4 miles [15.1 kilometers] from the threshold.”

The report continued: “The flight turned right as the airplane approached the ‘fly right’ localizer limit at 8.4 miles [13.5 kilometers] from the threshold, descending through 4,600 feet [1,403 meters]. The airplane turned left as it approached the full ‘fly left’ limit again at 7.5 miles [12.1 kilometers], and was descending through 4,000 feet [1,220 meters]. The localizer path was crossed twice more in the last three radar returns.”

The report said the airplane descended through 3,600 feet (1,098 meters) before crossing the outer marker, 5.86 miles (9.4 kilometers) from the runway threshold. (The minimum crossing altitude at the outer marker is 3,600 feet.) The airplane was approximately 5.8 miles (9.3 kilometers) from the runway threshold, and to the right of the localizer when the last radar return was recorded, the report said.

## Radar Track of CommutAir Flight 4821, Accident Flight of Jan. 3, 1992
