Racing Balloon Is Shot Down by Air Force Attack Helicopter in Belarus

The balloon crew may have been suffering from the combined effects of hypoxia and fatigue and, therefore, failed to react to the sounds of the helicopter and machine-gun fire, the official report said.

—
FSF Editorial Staff

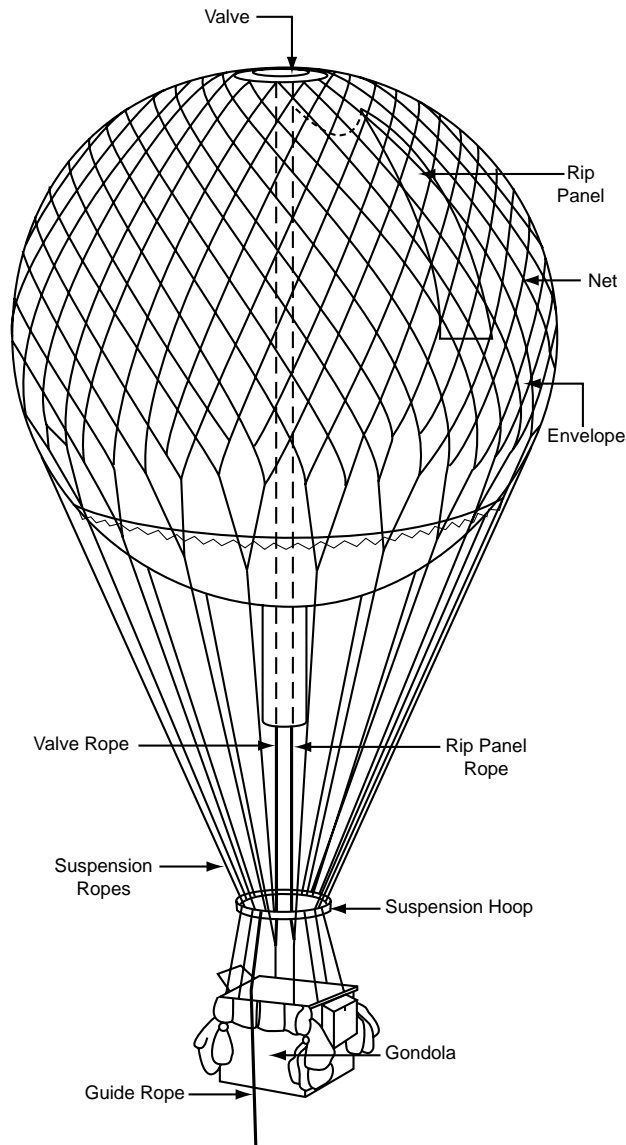
Figure 1

Structural Diagram of the D-Caribbean Racing Balloon
