After Beech 1900D Lifts off from Runway, Stall Warning Prompts Crew to Reject Takeoff

FSF Editorial Staff

In its final report on the accident, the U.S. National Transportation Safety Board (NTSB) said that the probable causes of the accident were:

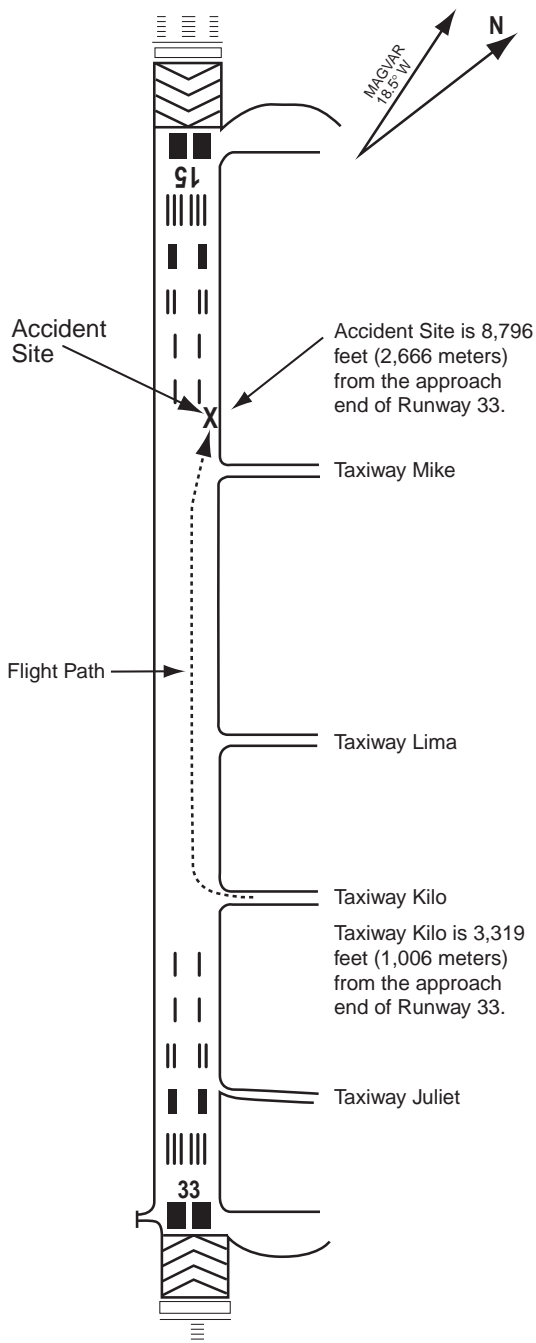
Figure 1 (page 6) shows the aircraft’s path. “The airport authority determined that the airplane touched down 7,200 feet [2,189 meters] from the approach end of Runway 33, with the right main landing gear 35 feet [11 meters] to the left of the runway centerline,” said the NTSB. “The track determined from the airplane’s left main gear departed the plowed portion of the runway at 7,802 feet [2,364 meters] at an angle of 329 degrees magnetic.” The measured runway heading was 339 degrees.

The nose gear separated as the aircraft traveled 819 feet [248 meters] in the unplowed portion of the runway. The propeller blades then separated from both engines. The NTSB said that at least one of the propeller blades from the right engine contacted the fuselage behind the first passenger seat.

Note: Diagram is not to scale. Runway 33 was 11,439 feet (3,466 meters) long and 300 feet (91 meters) wide. The runway was cleared of snow for its full length; snow had been cleared 150 feet (46 meters) east of the centerline and 75 feet (23 meters) west of the centerline, for a total cleared width of 225 feet (68 meters).

The aircraft stopped 8,796 feet [2,666 meters] from the approach end of Runway 33. “From the determined touchdown [point] to final stop, the airplane traveled 1,596 feet [484 meters],” said the NTSB. “Although the tracks indicate the airplane departed the plowed portion of the runway, the tracks indicate the airplane did not depart the runway.”
