Fatal Scenic Tour Flight Blamed on Poor Pilot Judgment, Inadequate Background Checks

Editorial Staff Report

ACCIDENT PREVENTION

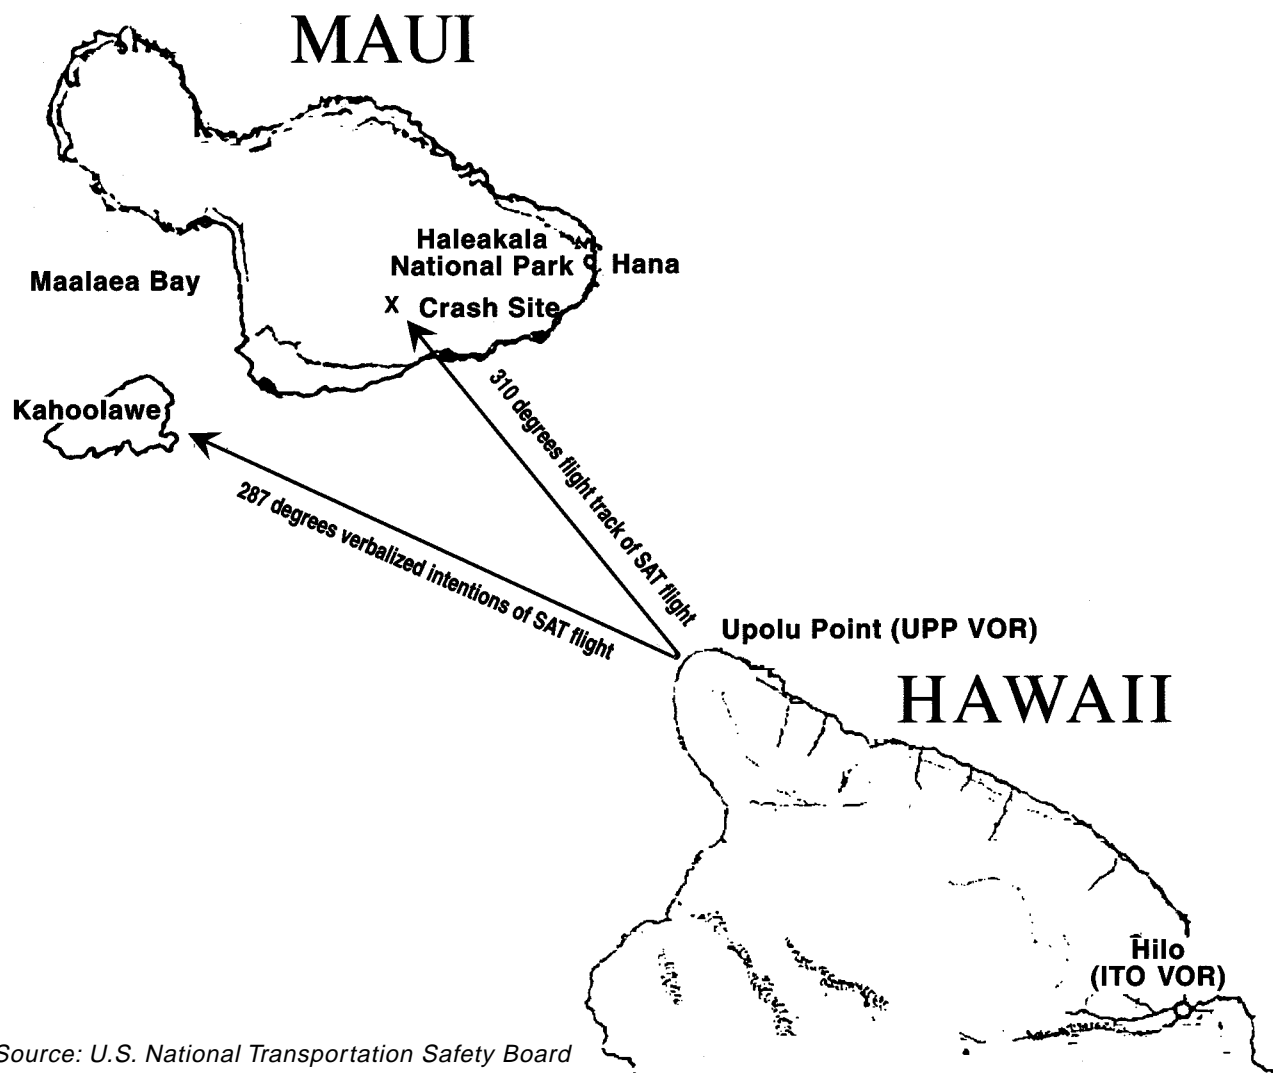
Accident Flight Track of Scenic Air Tours Flight 22

The post-crash examination devoted considerable attention to the pilot’s apparent unintentional deviation from his planned flight route, about 23 degrees between planned and actual flight track. The NTSB said the disparity “should have been apparent to the captain” if he were following standard operational procedures.

The report described the Safety Board’s explanation for the accident: “... the most plausible explanation for the unintentional routing is a failure of the captain to turn the [navigation receiver’s] omni bearing selector (OBS) to the desired course radial while tracking outbound on the UPP VOR [Upolu Point very high frequency omni-directional radio]. Radar data indicate that when the airplane was passing the UPP VOR, it turned from a westerly heading to a northwesterly heading toward Maui. The accident site is on the 310 [-degree] radial of the UPP VOR at the 39 DME [nautical miles from UPP VOR/distance-measuring equipment]. The radial from the UPP

VOR to R-3104 [Kahoolawe], the captain’s intended over-flight point, is approximately 287 [degrees], a difference of 23 degrees. The Safety Board tried to determine whether any similarities existed between accident flight and the captain’s previous flights. It was discovered that the bearing of the accident site from the UPP VOR (310 degrees) was identical to the radial that SAT pilots routinely follow when they are flying outbound from the Hilo Airport. The 310-degree radial from the ITO VOR is customarily used for guidance by company pilots on flights departing Hilo for a popular scenic attraction on the north shore of the island. The same 310-degree radial also provides the initial flight track for the northern route to HNL [Honolulu] via Hana. The captain was well acquainted with the routing to Hana and had used it four times in the 5-day period prior to the accident. It is quite possible that after the captain tuned in the frequency for the UPP VOR, he did not follow through with the course set procedure and use the OBS knob to select the appropriate 287-degree radial needed to navigate across the channel from the UPP VOR to R-3104.”
