Improperly Installed Electrical Wiring Causes In-flight Fire and Leads to Loss of Control by Learjet Crew During Attempted Emergency Landing

The operator of the accident aircraft failed to provide adequate quality control and oversight of the installation of special-mission power wiring for military use of the aircraft, the official U.S. report said.

FSF Editorial Staff

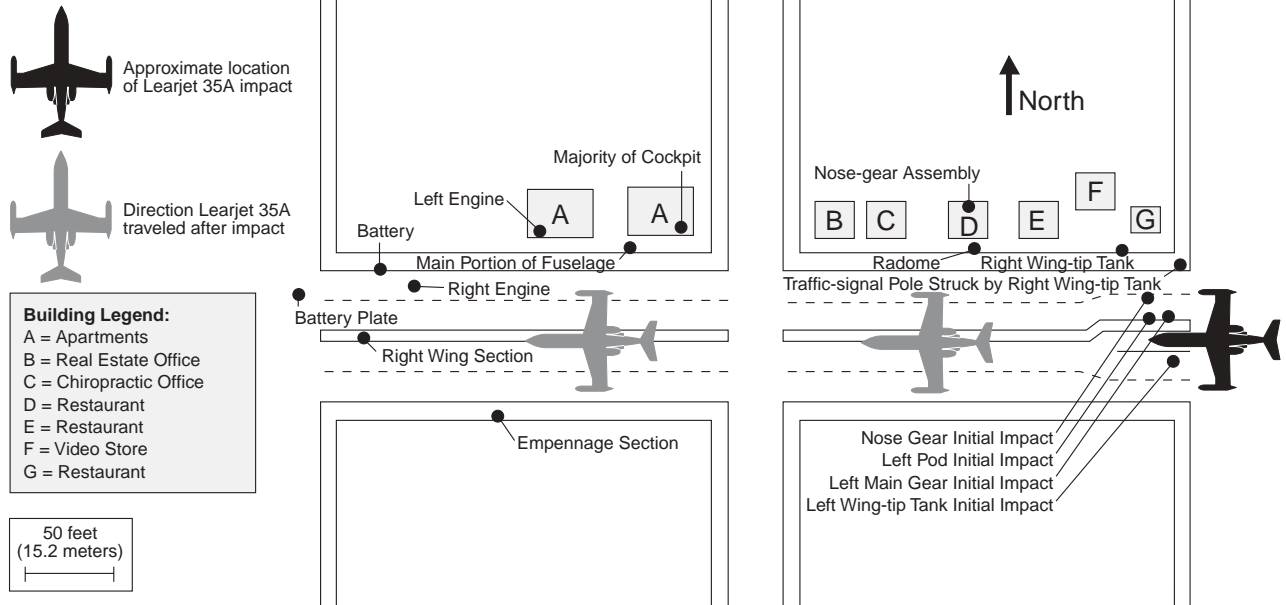
Figure 1

A review of the wreckage path (Figure 1, page 3) revealed that the right wing tip/fuel tank of the airplane struck a lamp pole and a traffic-signal pole on the north side of a street that was east-west oriented. The airplane then traveled west down the street for about 1,300 feet (396 meters). "Immediately after the right wing impacted the lamp pole, the left wing, all three landing gear and the fuselage of the airplane impacted on [the street]," the report said. "The left wing tip and its attached fuel tank impacted near the centerline of the [street]. Impact

Learjet 35A Wreckage Distribution, Fresno, California, Dec. 14, 1994

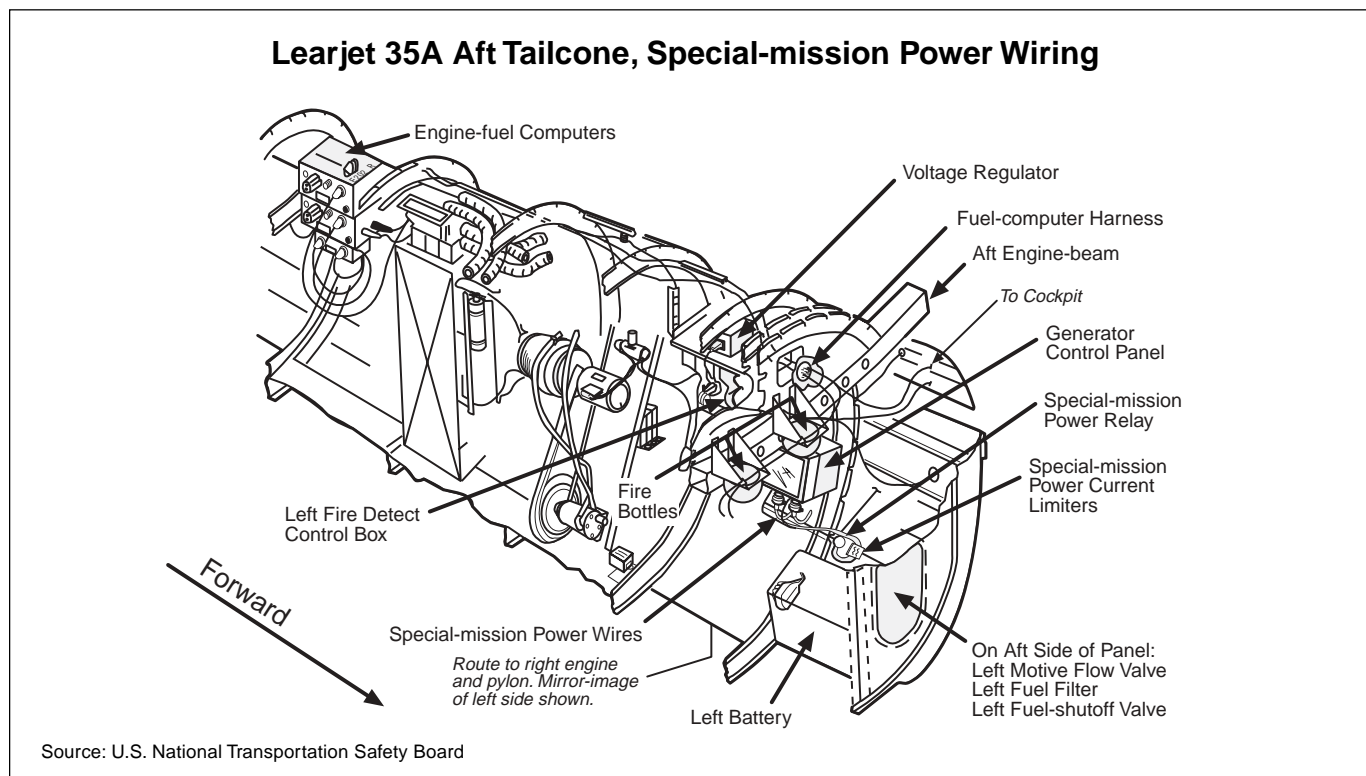
Figure 2

When the remaining wreckage was examined, “there was evidence of in-flight fire damage in the aft fuselage area of the electronics bay,” the report said. “Soot deposits were found around lightening holes in the vertical stabilizer. These holes were at the interface between the aft tailcone [Figure 2] and the interior of the forward portion of the vertical stabilizer.”

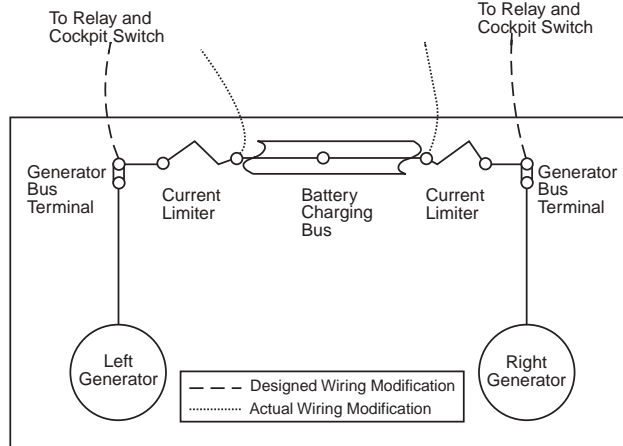
Figure 3

After examining the wreckage, investigators found that “the electrical power cables for the special-mission equipment had not been installed in accordance with specifications,” the report said (Figure 3). “The improper installation left portions of the wires unprotected by current limiters. The two large-diameter

Special-mission Power Wiring Modification, As Designed and As Modified in Accident Aircraft

DC [direct current] power wires that were retrieved from the wreckage showed evidence of arcing and they were ‘welded’ together in the area unprotected by current limiters. This evidence indicates shorting [short circuiting] and unlimited current flow for an extended period of time while the airplane was airborne. ...

“The evidence suggests that the arcing probably ignited wiring insulation and other combustible materials on the left side of the electronics bay. This caused damage to adjacent components. However, melting of the aft engine-beam, the loss of Teflon electrical insulation on the engine fuel computer harness and holes burned in the steel shield on the cabin air conditioning hose required an intense fire directed at these items that was farther to the left side of the airplane. ... A ‘torchlike’ flame from a pressurized fuel leak would be consistent with the fire damage noted”

As a result of its findings, the NTSB made the following recommendation to the FAA: “Publish an FAA Special Airworthiness Information Bulletin that describes the consequences of improper installation of the special-mission wiring, where electrical power wires were unprotected by current limiters. In addition, emphasize that all major aircraft repairs and alterations requiring an FAA Form 337 must be performed in strict accordance with the technical data contained in the FAA Form 337, and that it is unacceptable to use similar work done on other aircraft as a technical guide in lieu of the FAA Form 337.”
