Operations and Maintenance Audit Failures Cited as Factors in Two Fatal Accidents

The New Zealand Transport Accident Investigation Commission said that Civil Aviation Authority audits of two commercial operators failed to detect and/or correct conditions that might have contributed to a de Havilland Canada Dash 8 controlled-flight-into-terrain accident and a Beechcraft Baron 58 loss-of-control accident.

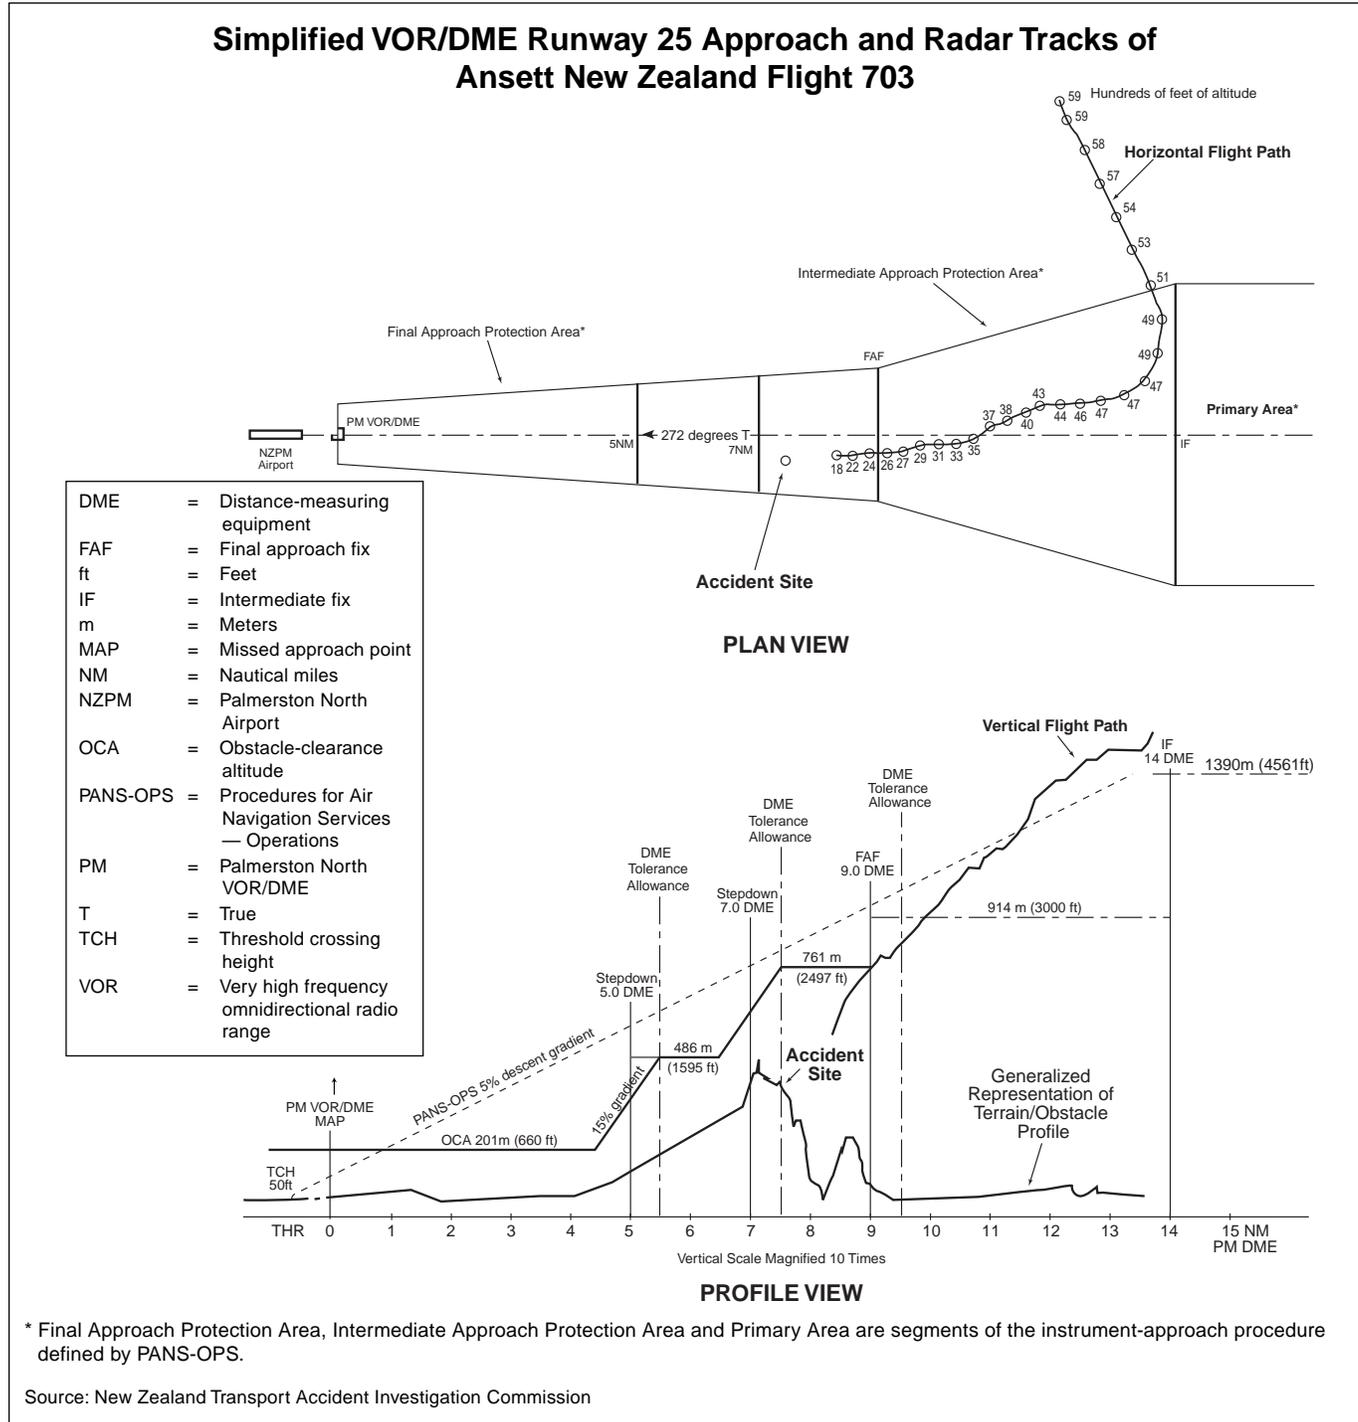
The descent rate was excessive. When the first officer said, "and on profile," the aircraft was slightly above the appropriate profile-descent altitude. The TAIC said, however, that the aircraft was descending at an excessive rate. Air traffic control radar showed that the steep descent continued until shortly before impact. Figure 1 shows the aircraft's descent path.
