Learjet Strikes Terrain When Crew Tracks False Glideslope Indication and Continues Descent Below Published Decision Height

The U.S. National Transportation Safety Board said that the flight crew did not follow standard operating procedures while conducting an instrument landing system approach. The investigation prompted the board to recommend acceleration of a proposed schedule for requiring installation of terrain awareness and warning systems in all turbine airplanes with six or more passenger seats.

On Jan. 13, 1998, a Gates Learjet 25B struck terrain approximately two nautical miles (3.7 kilometers) from the runway threshold during the flight crew's second instrument landing system (ILS) approach to Runway 26 at George Bush Intercontinental Airport (KIAH) in Houston, Texas, United States.

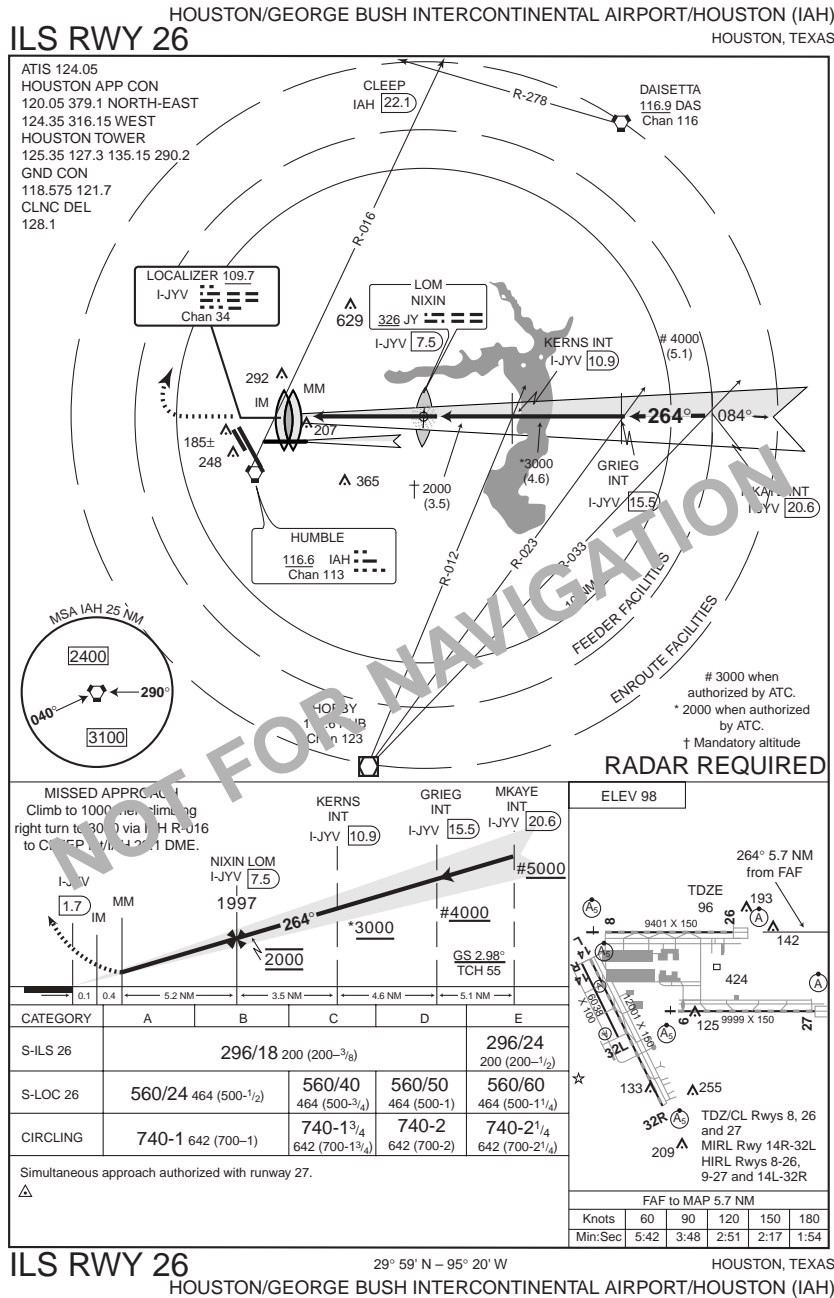
Figure 1 (page 4) shows that the published minimum visibility for the ILS approach to Runway 26 at KIAH was 1,800 feet runway visual range (RVR); the decision height was 296 feet, or 200 feet above the runway touchdown zone.

Instrument Landing System Runway 26 Approach, George Bush Intercontinental Airport, Houston, Texas, United States Jan. 13, 1998

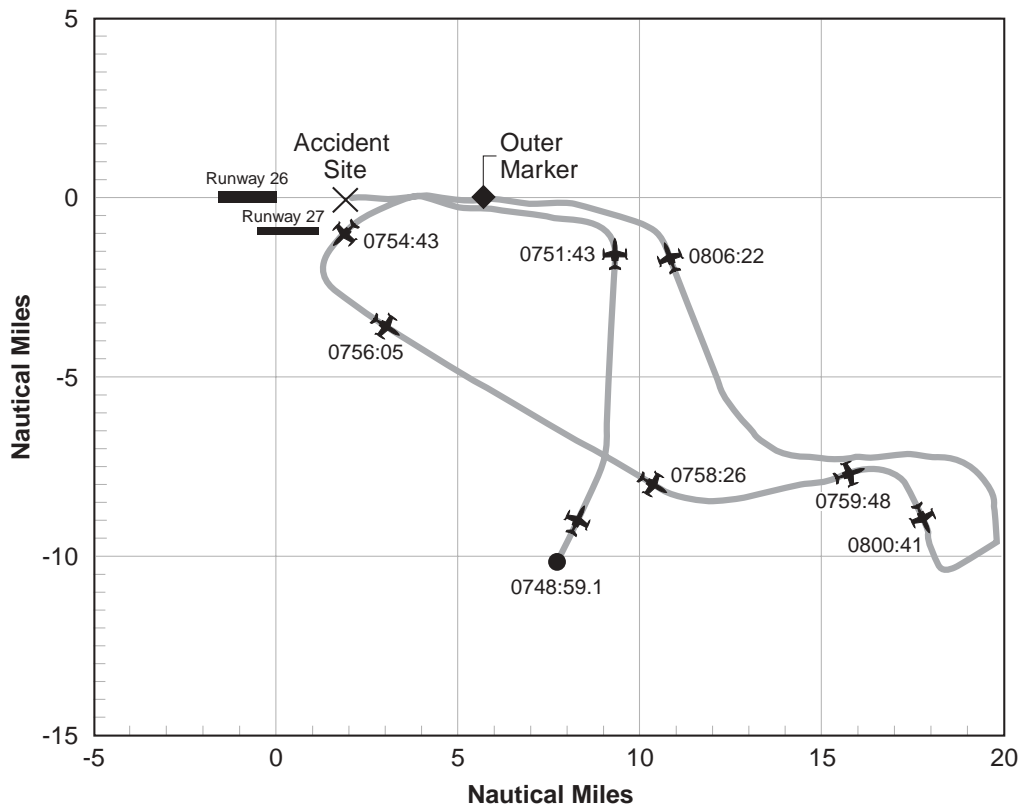
Figure 2 shows the airplane’s ground track. At 0749:49, the approach controller told the crew to descend to 2,000 feet and to turn left to a heading of 360 degrees. At 0751:43, the approach controller told the crew to turn to a heading of 280

The airplane began to fly away from the localizer course. The airplane maintained a ground track of approximately 239 degrees for approximately 50 seconds and descended to 700 feet.

Ground Track of Gates Learjet 25B, Houston, Texas, United States, Jan. 13, 1998
