Inadvertent Inflight Slat Deployment on MD-11 Results in Two Fatalities, 156 Injuries

Inadequate flap/slat handle design, lack of pilot training in recovery from high-altitude upsets and lack of seat-belt usage cited in U.S. official report.

by
Russell Lawton
Aviation Consultant

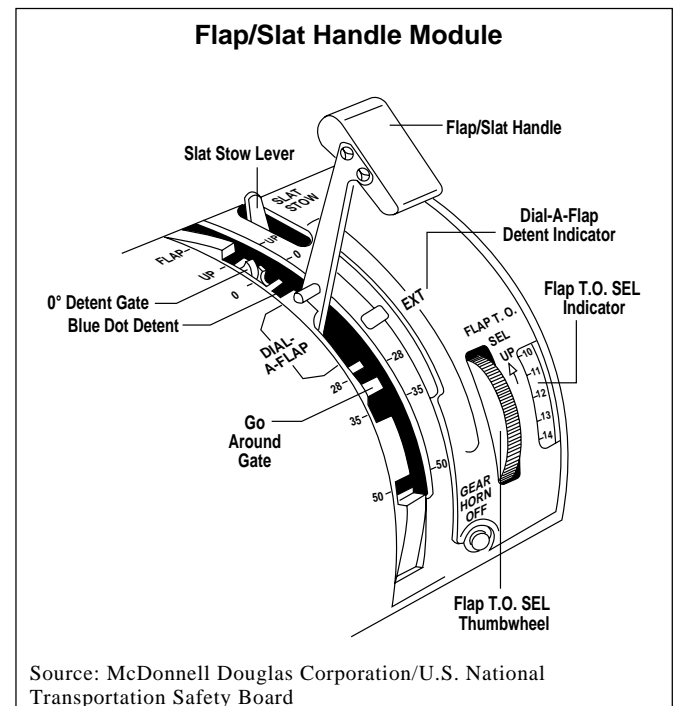
Figure 1

“the inadequate design of the flap/slat actuation handle by the Douglas Aircraft Company [DAC] that allowed the handle to be easily and inadvertently dislodged from the UP/RET position, thereby causing extension of the leading edge slats during cruise flight. The captain’s attempt to recover from the slat extension, given the reduced longitudinal stability and the associated light control-force characteristics of the MD-11 in cruise flight, led to several violent pitch oscillations.”

The report added: “Operation of the flaps and slats is accomplished by a single handle located on the right side of the cockpit center pedestal (Figure 1). To extend only the slats, the flap/slat handle is moved from the UP/RET detent to the 0/EXT detent. Further aft movement of the flap/slat handle will command the extension of the flaps, up to a maximum of 50 degrees.

of the UP/RET position. But the investigation did reveal that the flap/slat handle system, even with all the applicable modifications installed, could still be inadvertently dislodged by routine flight crew movements in the cockpit and could cause an undesired extension of the slats," the report said.

In response to these recommendations, the FAA issued an AD “that requires the installation of a retainer assembly on the upper pedestal flap/slat control module quadrant in the flight compartment. ... This AD is intended to prevent inadvertent slat deployment during flight at cruise altitude,” the report said.
