Pilot of Cessna 441 Incorrectly Taxis onto Active Runway and Aircraft Is Struck by McDonnell Douglas MD-82 on Takeoff Roll

FSF Editorial Staff

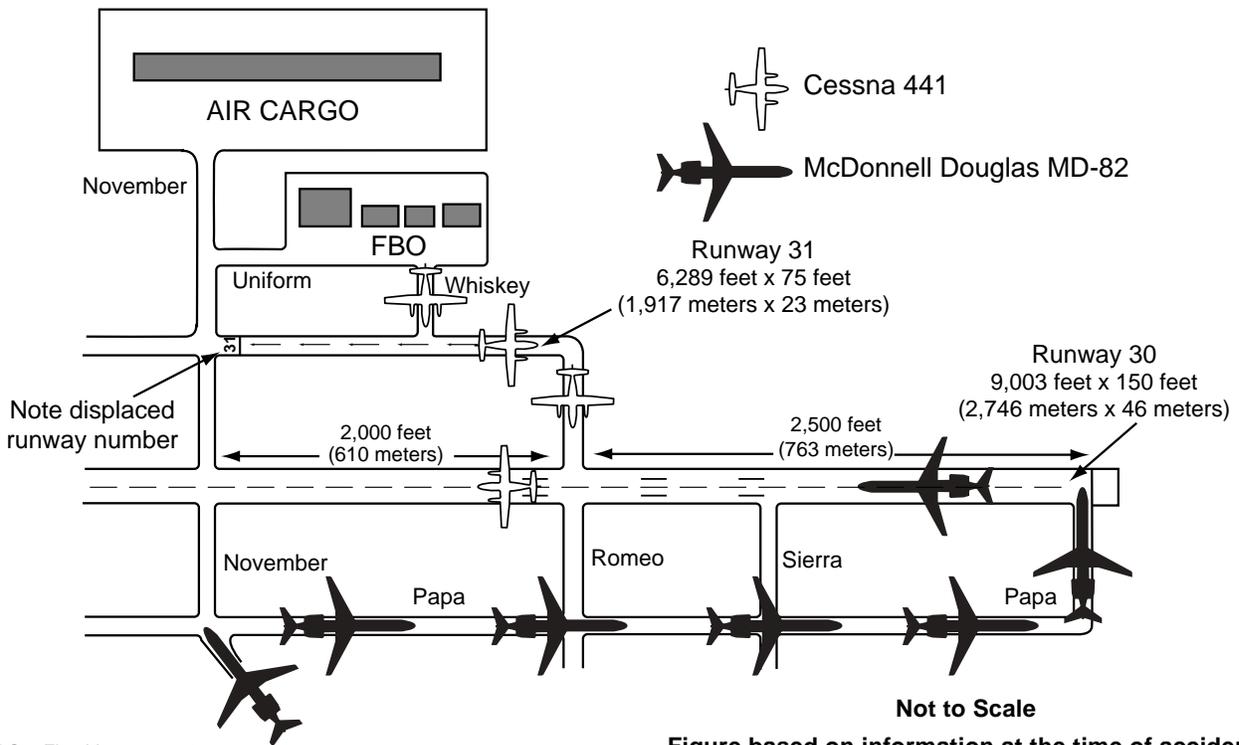
Figure 1

Paths of Accident Aircraft, Lambert–St. Louis International Airport

At 2201:23, the crew of a Trans World Airlines (TWA) MD-82 that was holding short of Runway 30R was cleared for takeoff by STL tower, the report said. The first officer of the MD-82 acknowledged the takeoff clearance, and the flight taxied onto Runway 30R. At 2202:29, the Cessna pilot told STL tower that he was “... ready to go on the right side,” the report said. The tower replied, “Roger, I can’t roll you simultaneously with the, uh, traffic departing the right. Just continue holding in position. I’ll have something for you in just a second,” the report said. The Cessna pilot had taxied onto Runway 30R from an intersecting taxiway that was 2,500 feet (762 meters) from the runway threshold (Figure 1).

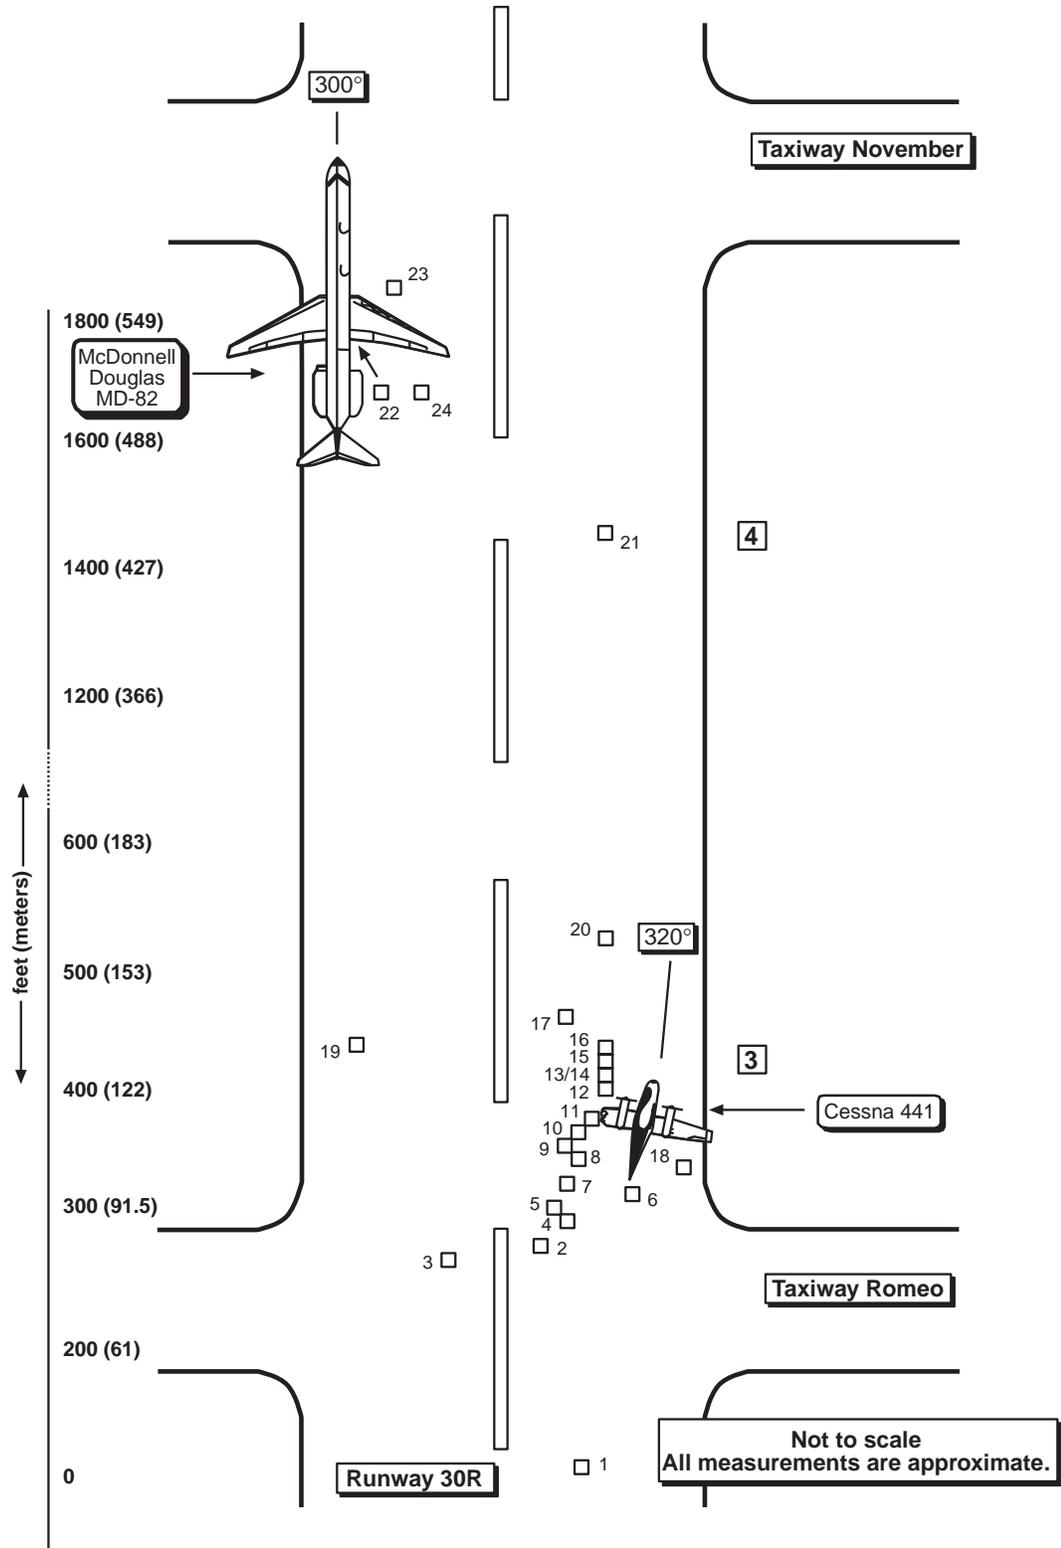
Figure 2

Examination of the Cessna wreckage indicated that it was almost directly on the runway centerline when the collision occurred, approximately 2,500 feet (763 meters) from the approach end, the report said. The wreckage path (Figure 2, page 5) began with a two-foot (0.6-meter) section of the

Location of Wreckage* Following Accident, Lambert–St. Louis International Airport

Cessna's rudder. The main portion of the Cessna was located on the north edge of the runway, approximately 350 feet (107 meters) farther, the report said.
