MD-88 Has Uncontained Engine Failure on Takeoff Roll Following Fan-hub Fracture

A defect in the fan hub was not detected by blue-etch anodize inspection following manufacture, nor was the resulting fatigue crack detected in a fluorescent penetrant inspection during maintenance at the airline facility.

—
FSF Editorial Staff

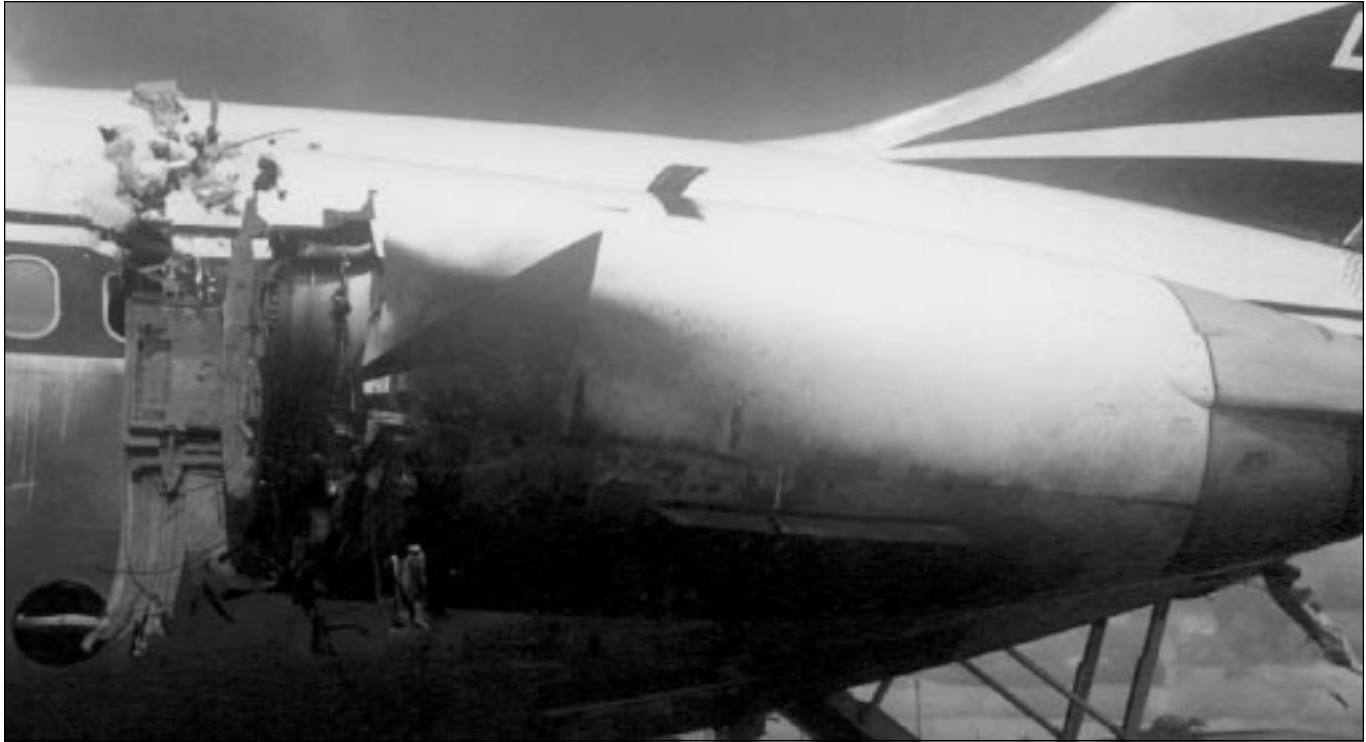
“The fan hub and blade assembly were separated from the left engine, and the surrounding engine outer case and cowl were ruptured, with torn and missing sections. The forward part of the stage-1.5 compressor disk was missing. The hub was separated at a 360-degree circumferential fracture located just forward of the stage-1.5 disk bore.”

The fan hub and blade assembly of no. 1 engine were separated from the engine in the accident. Debris from the engine penetrated the cabin, killing two passengers and seriously injuring another in the row adjacent to the failed engine. (Photo: U.S. National Transportation Safety Board)

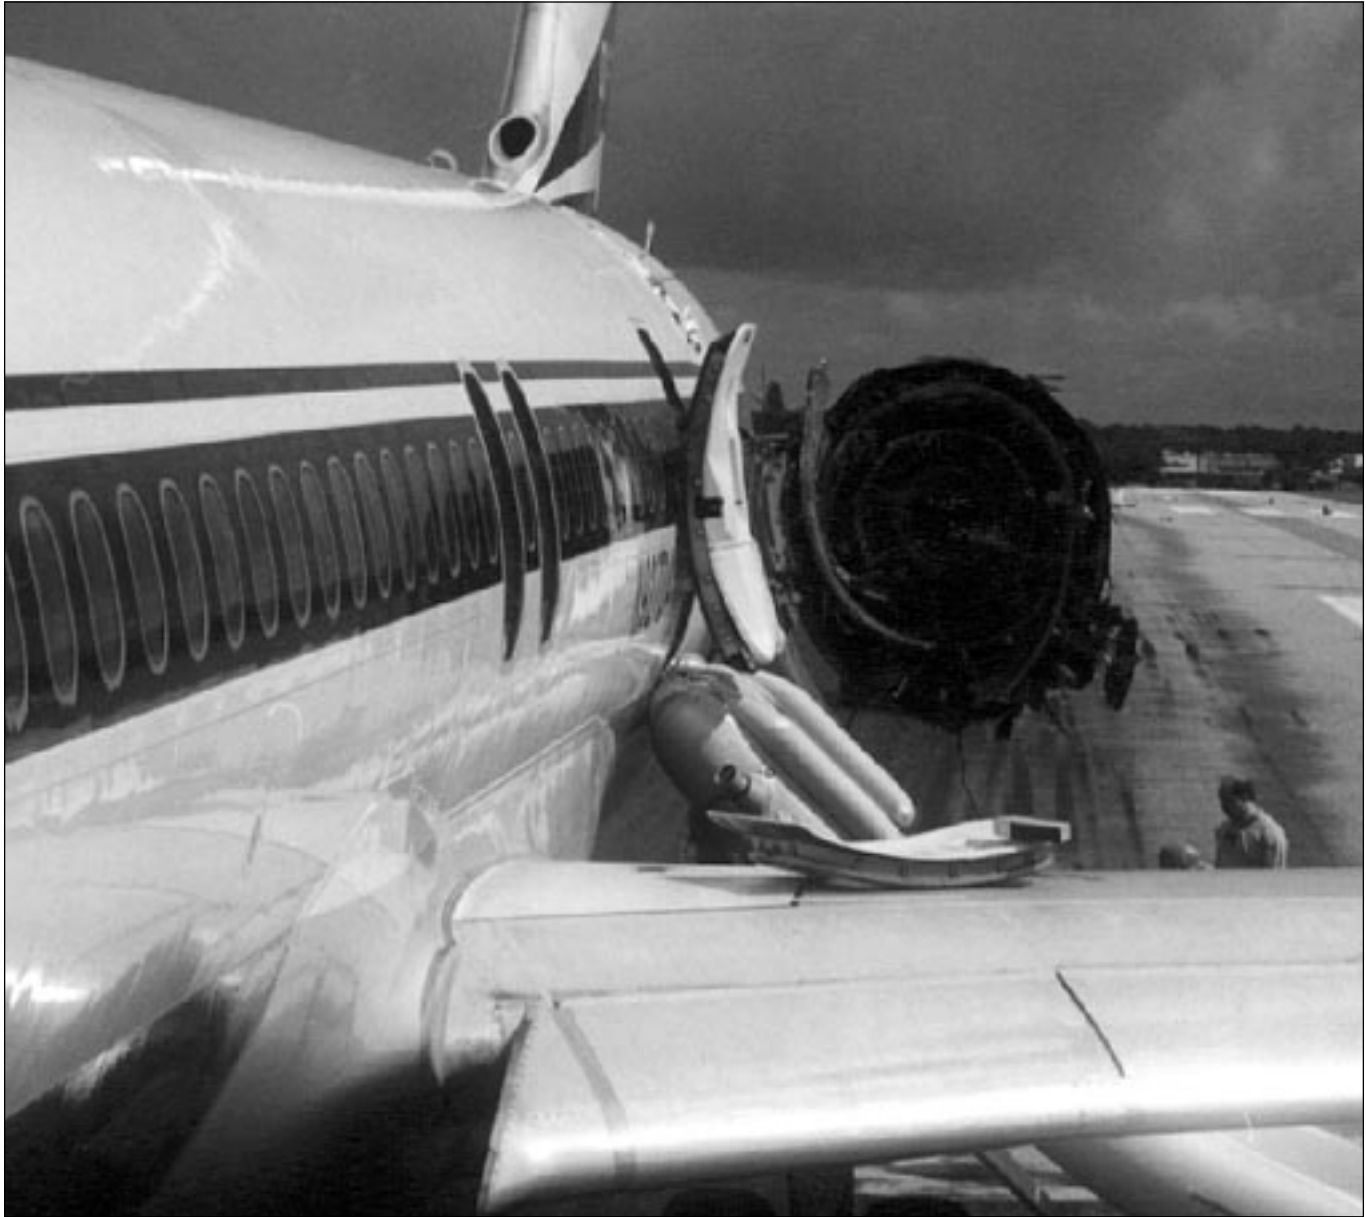
A flight attendant inflated the evacuation slide at the L-2 position, but saw fire on the no. 1 engine's forward cowling and immediately blocked the exit. Evacuating passengers were then directed forward. (Photo: U.S. National Transportation Safety Board)
