Ineffective Tail-strike Repair Preceded Boeing 747 Breakup

Investigators said that published procedures were not followed when the repair was performed more than 20 years before a structural failure occurred and the aircraft broke apart during flight.

FSF Editorial Staff

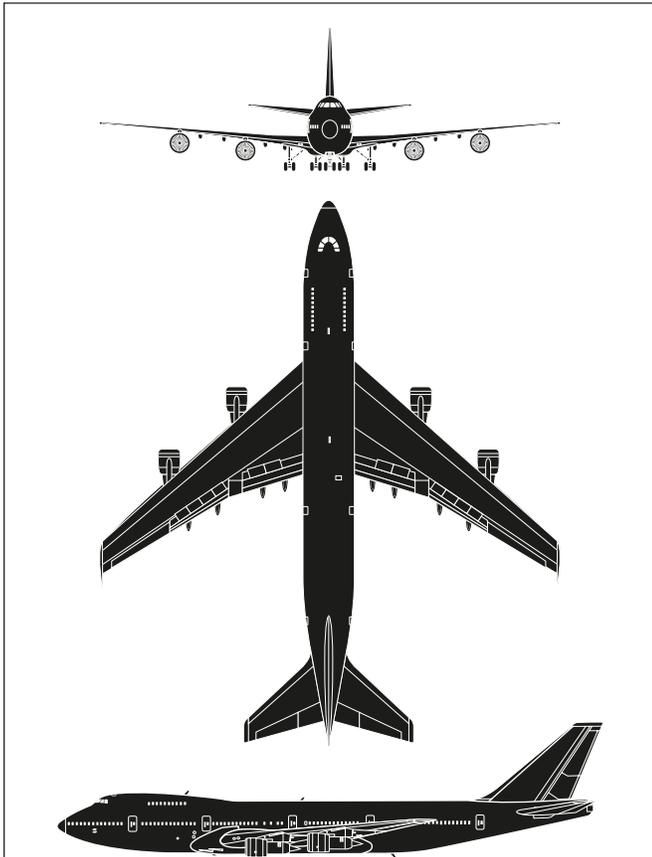
Boeing 747-200
