U.S. Report: No Conclusive Evidence Found To Explain Boeing 737 Crash

A routine approach in gusting wind conditions ended suddenly on final to a Colorado airport. An exhaustive U.S. National Transportation Safety Board investigation pointed to several possible factors but failed to determine a conclusive cause for the accident.

This article was adapted from NTSB report # AAR-92/06, United Airlines Flight 585 Boeing 737-291, N99UA Uncontrolled Collision with Terrain for Undetermined Reasons 4 Miles South of Colorado Springs Municipal Airport, Colorado Springs, Colorado. It can be obtained from the National Technical Information Service (NTIS), 5285 Port Royal Road, Springfield, Virginia 22161, U.S. Telephone: (703) 487-4600.

ACCIDENT PREVENTION

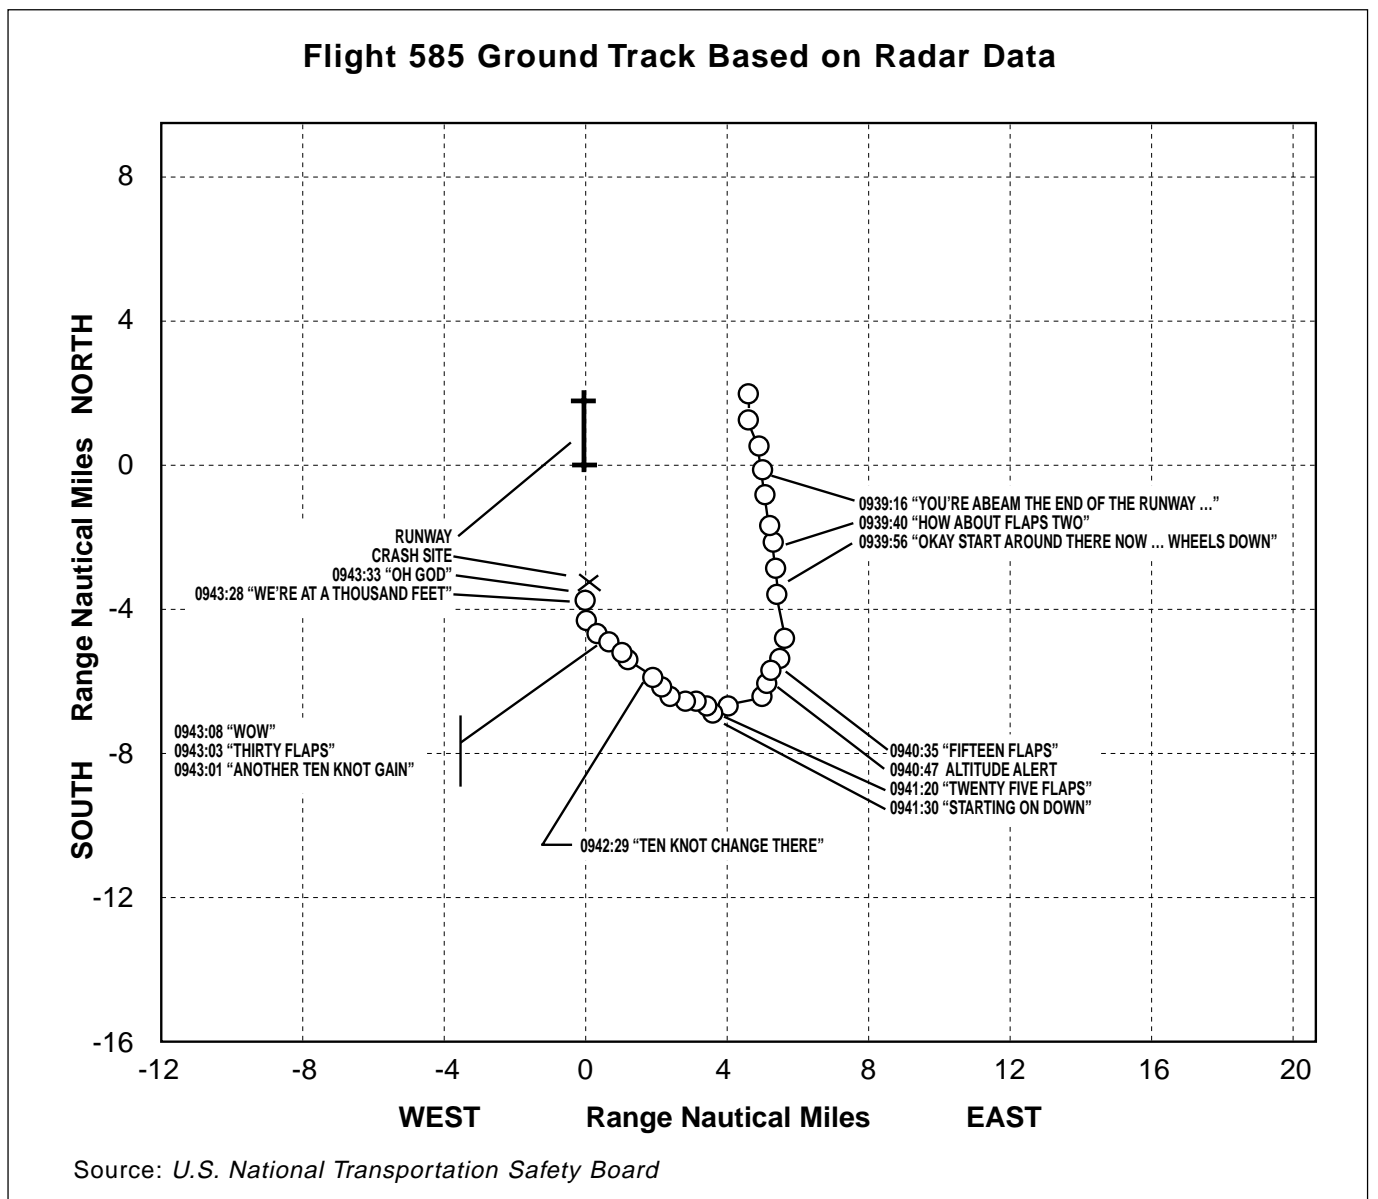
Figure 1

the glideslope at 0942:50 and started a normal descent,” the NTSB said. “However, about 10 seconds later, a deviation from steady flight began, just before the weak ‘wow’ comment was recorded on the CVR. The airplane descended below the glideslope for the next 30 seconds until lateral control was lost. At the time lateral control was lost, the airplane was about 400 feet [121 meters] below the glideslope. Evidence from the CVR indicated that the pilots were caught by surprise by a rapidly developing event during which control of the airplane was lost.” (Figure 1)
