## Rejected Takeoff in Icy Conditions Results in Runway Overrun

*The flight crew failed to comply with checklist procedures, leading to erroneous airspeed indications and a rejected takeoff at a speed exceeding  $V_1$ , the official U.S. accident investigation says.*

### Editorial Staff Report

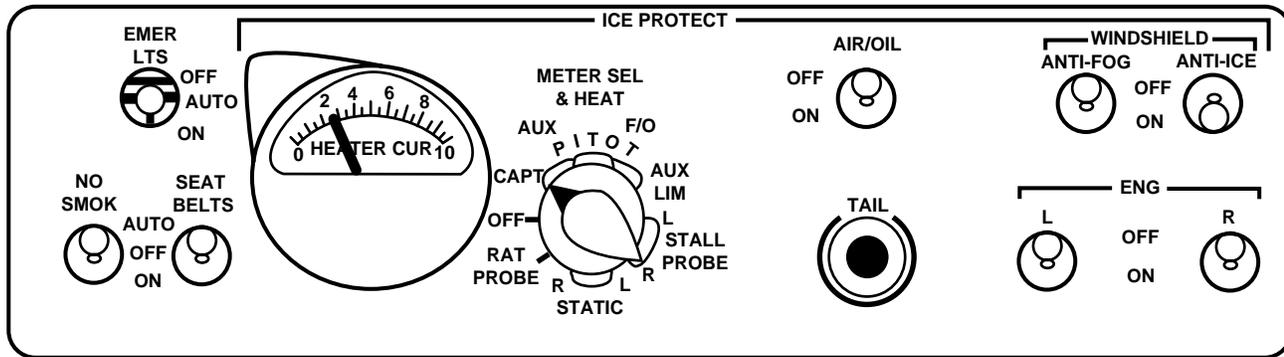
Figure 1

The pitot heating system is controlled by the METER SEL & HEAT knob located on the cockpit annunciator, with three positions (CAPT, AUX and F/O) to activate the heater systems (Figure 1, page 4). "When the switch is selected to any position except OFF, electrical power is supplied to all heaters at all times except the ram air temperature (RAT) probe heater ...," the report said.

## Pitot Heating System Control: Selector in CAPT Position

“The positioning of the METER SEL & HEAT knob to provide heat to the pitot tubes, static ports and [RAT] probe is a prestart checklist item,” the report said. “Because the prestart checklist was conducted before the CVR started recording, there was no positive confirmation that the checklist was properly accomplished. However, the captain stated that he placed the select knob in the CAPT position as part of the checklist.”

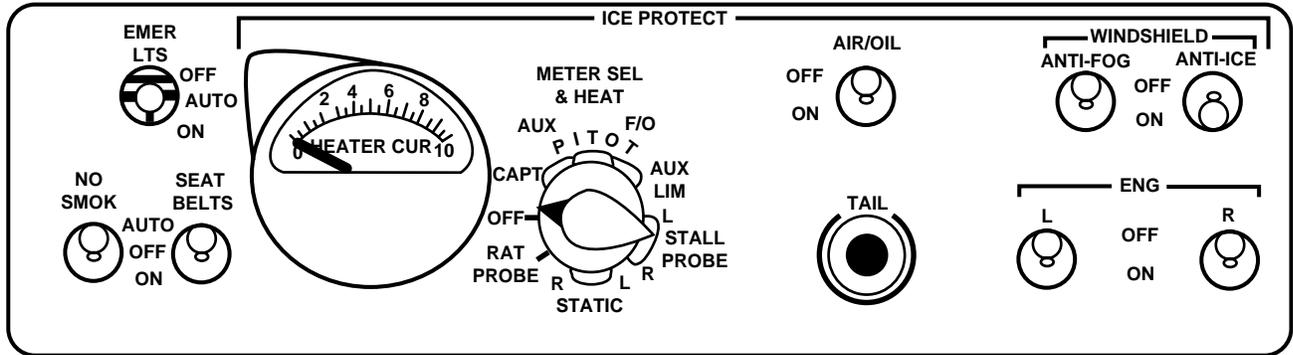
Figure 2

“To the contrary, the Safety Board believes that the most compelling evidence supports the conclusion that the pitot tube heating elements were not energized during the takeoff roll because the METER SEL & HEAT knob was improperly positioned in the OFF detent. The postaccident examination of

But the report did note that the select knob pointer for the pitot heat system “was positioned about a third of the distance between the OFF and the CAPT position, when the selector was in the OFF detent” (Figure 2, page 5).

The report said that investigators considered the possibility that the knob’s pointer misled the flight crew into believing the system was activated.

## Pitot Heating System Control: Position of Pointer When Selector in OFF Position
