Reduced Visibility, Mountainous Terrain Cited in Gulfstream III CFIT at Aspen

Darkness increased and weather conditions deteriorated as the pilots continued a nonprecision instrument approach below minimums without adequate visual references at the Aspen (Colorado, U.S.) airport. A delayed departure, a nighttime landing curfew and pressure from the charter customer to land were factors cited in the controlled-flight-into-terrain (CFIT) accident.

About 1901 local time on March 29, 2001, a Gulfstream Aerospace Gulfstream III operated by Avjet Corp. struck terrain approximately 2,400 feet (732 meters) from the runway threshold during a nonprecision instrument approach in instrument meteorological conditions (IMC) at Aspen–Pitkin County (Colorado, U.S.) Airport. The two pilots, the flight attendant and the 15 passengers were killed. The airplane was destroyed.

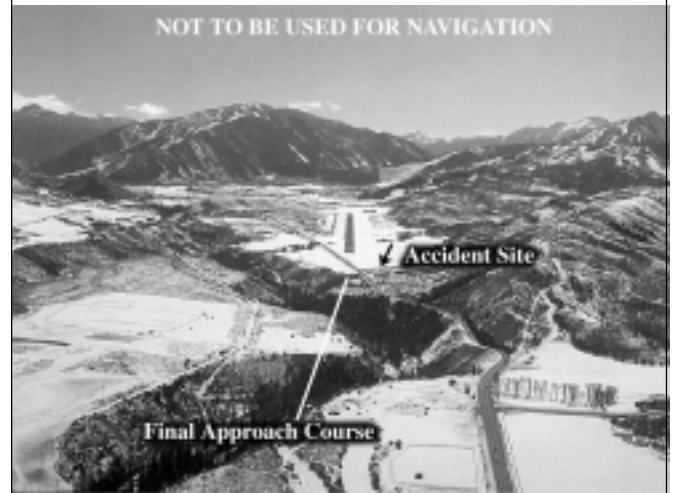
Figure 1

The Aspen airport, also known as Sardy Field, is at an elevation of 7,815 feet and is surrounded by higher terrain (see Figure 1). The VOR/DME-C approach procedure includes only circling approach minimums; straight-in approach minimums are not included because a straight-in approach would require a descent gradient of 700 feet per nautical mile between the final approach fix (FAF) and the runway threshold crossing height (see Figure 2, page 4). Among FAA's requirements for straight-in approach procedures is a maximum descent gradient of 400 feet per nautical mile between the FAF and the threshold crossing height.

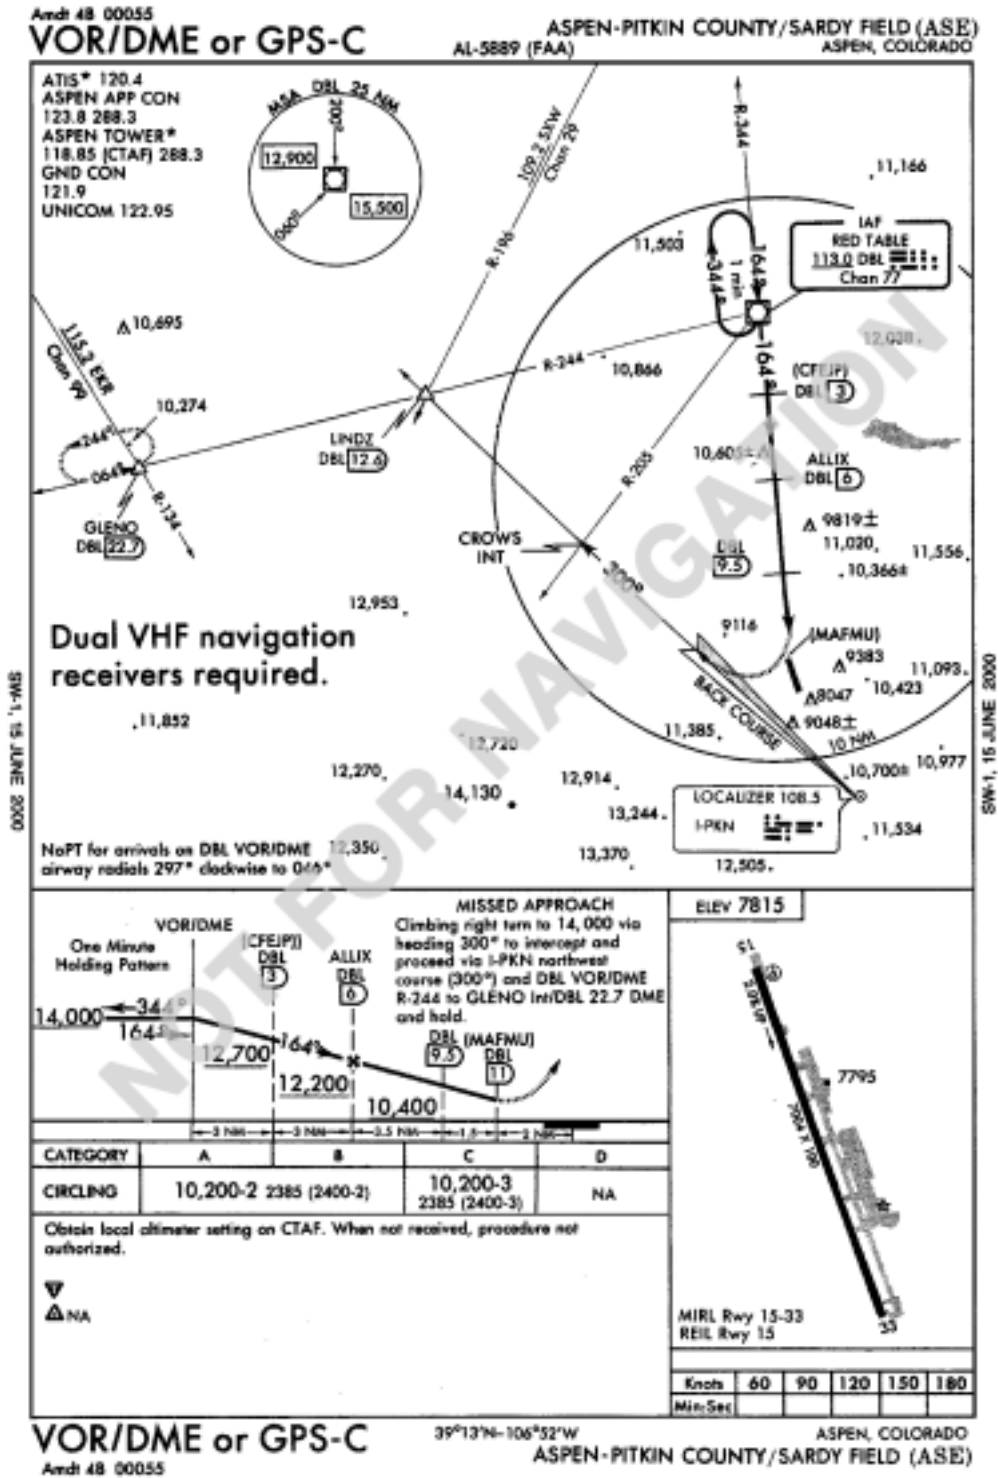
Figure 2

On March 27, 2001, FAA issued a NOTAM for the VOR/DME-C approach that stated "circling NA [not authorized] at night." The report said that "because of human error," a flight data communications specialist at the Denver (Colorado) Air Route Traffic Control Center did not send the NOTAM to the Aspen ATCT.

The report said that the NOTAM was vaguely worded.

"The NOTAM was intended to mean that the instrument approach procedure was no longer authorized at night, because only circling minimums were authorized for that procedure," the report said. "Thus, the NOTAM was vaguely worded because pilots could infer that [conducting] an approach without a circle-to-land maneuver to Runway 15 was still authorized."

On March 30, 2001, FAA revised the NOTAM to state "procedure NA at night."

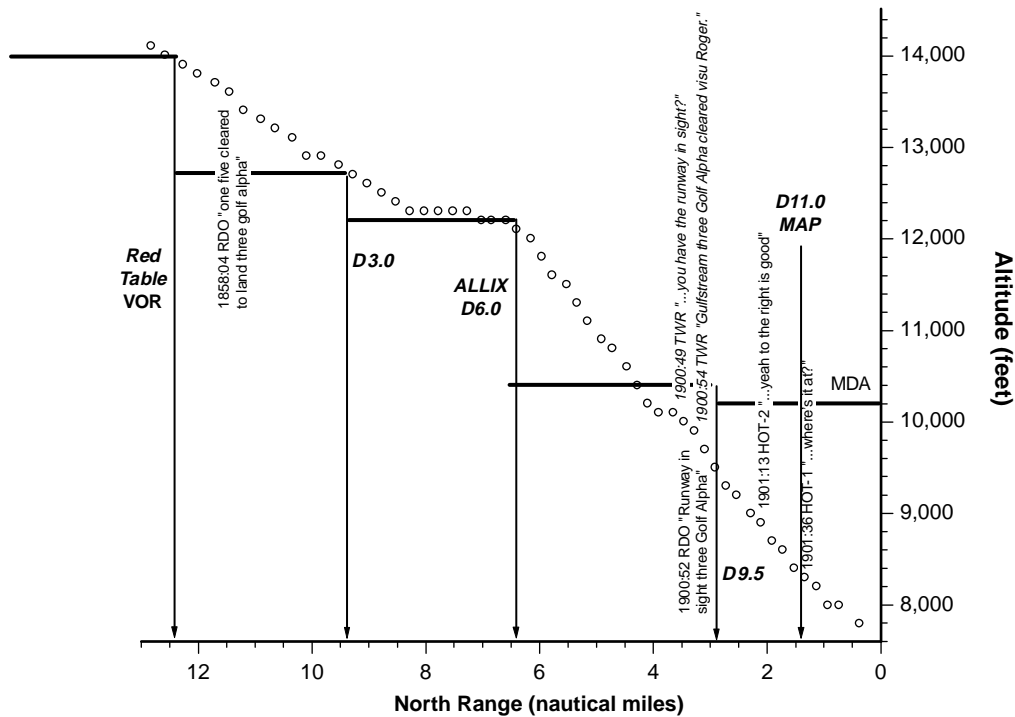
Gulfstream III Flight Path, Aspen–Pitkin County (Colorado, U.S.) Airport, March 29, 2001

The report said that the cloud tops were at about 16,000 feet and that “after descending through this altitude, the airplane was in and out of the clouds.”

The controller told investigators that she had observed the aircraft descend below 10,400 feet before reaching the 9.5-DME step-down fix.
