Noncompliance With Instrument Approach Procedures Cited in King Air CFIT Accident in Australia

The report said that dark night conditions during the emergency medical services positioning flight also were a significant factor in the fatal controlled-flight-into-terrain accident.

[FSF editorial note: This article, except where specifically noted, is based on Australian Transport Safety Bureau Aviation Safety Investigation Report BO/200105769, *Raytheon Beech 200C, VH-FMN, Mount Gambier, SA, 10 December 2001*. The 42-page report contains illustrations and appendices.]

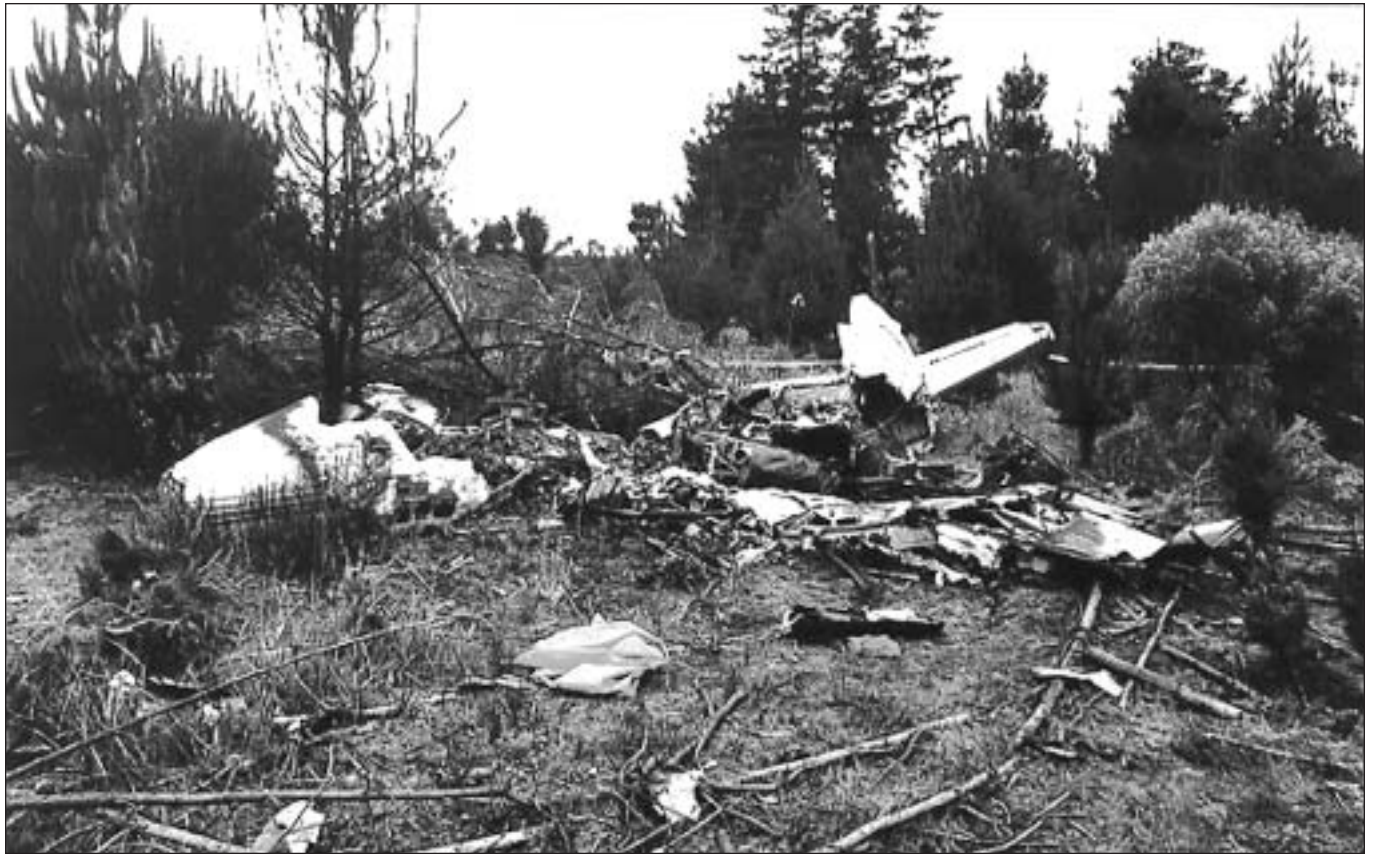
Wreckage of the accident airplane was found right of the Runway 18 extended centerline, “with a deviation to the right of about five [degrees] to 10 degrees,” the report said. The airplane struck the ground in a nose-low attitude, with the right wing slightly low; the landing gear had been extended, and the flaps had been extended to the approach configuration. Because of impact damage and fire damage, no information was obtained from cockpit instruments or flight control positions.

The report said that damage to the trees in the approach path indicated that the airplane’s approach angle had been about 10 [degrees] to 13 degrees.

The Raytheon Beech Super King Air 200C struck the ground 3.1 nautical miles (5.7 kilometers) from Runway 18 at the Mount Gambier airport. (Source: Australian Transport Safety Bureau)
