Improper Control Inputs Cited In ATR 72 Bounced Landing

The captain took control from the first officer after the airplane ‘skipped’ on touchdown but did not take appropriate recovery action or conduct a go-around, the report said. Injuries and substantial damage resulted when the airplane bounced twice and veered off the runway.

About 1450 local time May 9, 2004, an Avions de Transport Regional ATR 72 operated by Executive Airlines as American Eagle Flight 5401 skipped when it touched down on a runway at Luis Muñoz Marín International Airport in San Juan, Puerto Rico, U.S., bounced twice and veered off the runway.¹ The captain received serious injuries; the first officer, both flight attendants and 16 passengers received minor injuries; six passengers received no injuries. The airplane was substantially damaged.

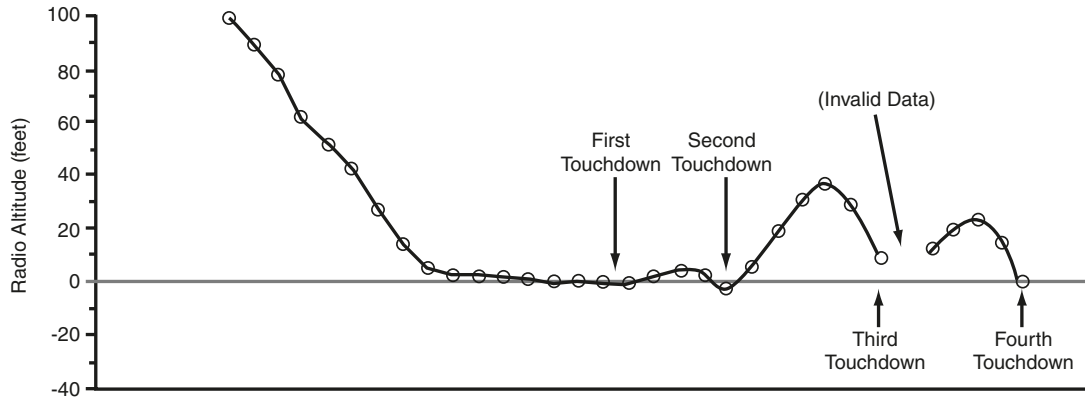
Figure 1

FDR data indicated that the airplane touched down 1,600 feet (488 meters) beyond the runway threshold at 1449:41 (Figure 1, page 4). Vertical acceleration (load) on the first touchdown was 1.3 g (i.e., 1.3 times standard gravitational acceleration), and the airplane skipped to four feet AGL.

At 1449:45, the CVR recorded the sound of a thump and one of the crewmembers saying, “God,” as the airplane touched down again about 2,200 feet (671 meters) from the runway threshold. Pitch attitude increased to nine degrees nose-up, and engine torque increased from 10 percent to 43 percent as the airplane bounced to 37 feet AGL. Pitch attitude then

Flight Path of Executive Airlines ATR 72; May 9, 2004

Bank angle was seven degrees left-wing-down when the airplane touched down the third time about 3,300 feet (1,007 meters) from the runway threshold at 1449:51. When the left main landing gear struck the runway, its vertical velocity was between 19 feet per second and 32 feet per second. The left main landing gear, which was designed to absorb energy equivalent to a maximum vertical velocity of 10 feet per second at maximum landing weight [47,068 pounds (21,350 kilograms)], failed from overload.

Pitch attitude increased to 11 degrees nose-up as the airplane bounced to 24 feet AGL. Pitch attitude was seven degrees nose-down at 1449:56, when the airplane touched down the fourth time about 4,000 feet (1,220 meters) from the runway threshold.

“During the last touchdown, when the most substantial damage to the airplane most likely occurred (especially to the left side of the cockpit), the left bank angle recorded by the FDR was 29 degrees left-wing-down,” the report said. “The average vertical loads experienced in the cockpit during the last touchdown
