Unaware of Strong Crosswind, Fokker Crew Loses Control of Aircraft on Landing

—
FSF Editorial Staff

Accident Prevention

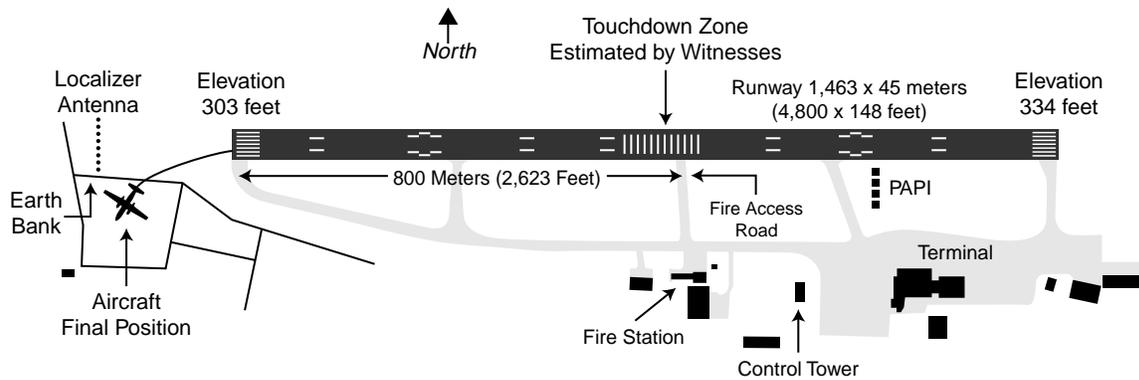
Figure 1

“They described the touchdown point as being opposite the fire-access road — that is, with 750 meters to 900 meters [2,459 feet to 2,951 feet] of runway remaining,” said the report. (See Figure 1, page 4.)

Ground Track of Fokker F27; Guernsey Airport, Channel Islands, United Kingdom; Dec. 7, 1997
