## Pilot Incapacitation by Hypoxia Cited In Fatal Five-hour Flight of Beech King Air

*The report said that the pilot apparently was unable physically to respond to air traffic control radio transmissions after the aircraft ascended above the assigned altitude, 25,000 feet. The aircraft likely continued flying on autopilot, with no input from the pilot, for several hours before it struck terrain.*

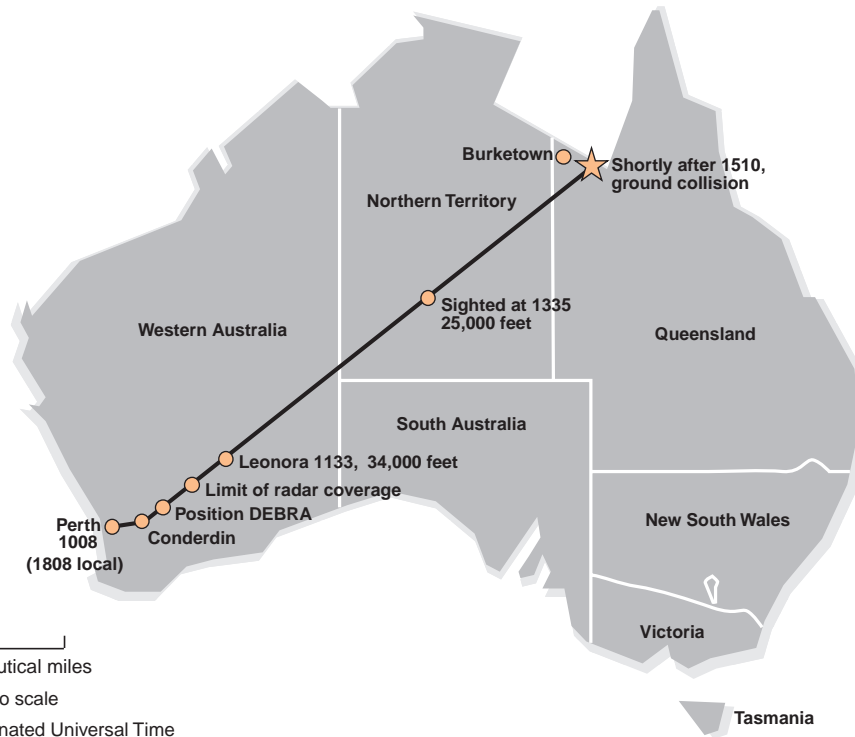
**Figure 1**

On the evening of Sept. 4, 2000, a Beech Super King Air 200 struck the ground near Burketown, Queensland, Australia, about five hours after departing on a charter flight from Perth to Leonora, both in Western Australia (see Figure 1, page 2). The pilot and the seven passengers were killed. The aircraft was destroyed.

## Horizontal Flight Path of Beech Super King Air 200, Sept. 4, 2000

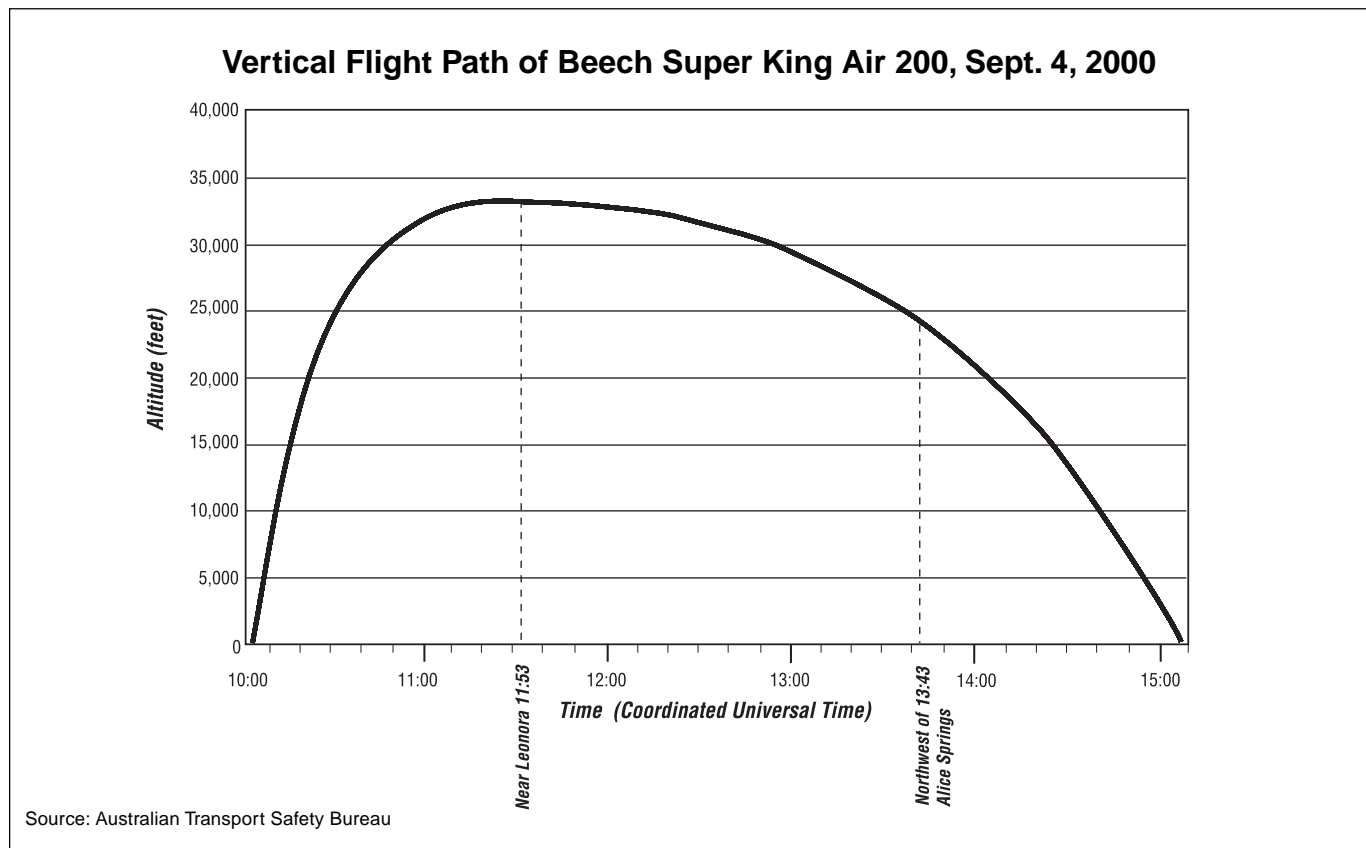
**Figure 2**

Recorded ATC radar data showed that the aircraft continued to climb to about 34,300 feet, which was approximately the aircraft’s service ceiling (see Figure 2). The report said that the continued climb and the absence of a distress call indicated that the pilot was not aware that the aircraft was unpressurized or depressurizing and that he likely did not don his oxygen mask.
