Improper Installation of Elevator Bolt Causes DC-8 Freighter to Pitch Up Uncontrollably

Absence of the bolt caused the right elevator control tab to become disconnected. The control tab then jammed as the flight crew began a night takeoff. During the crew's attempt to return to the airport, the aircraft struck the ground and was destroyed. All the crewmembers were killed.

About 1951 local time on Feb. 16, 2000, a McDonnell Douglas DC-8-71F operated by Emery Worldwide Airlines struck an automobile salvage yard soon after takeoff in night visual meteorological conditions from Sacramento Mather Airport in Rancho Cordova, California, U.S. The three flight crewmembers were killed. The airplane was destroyed.

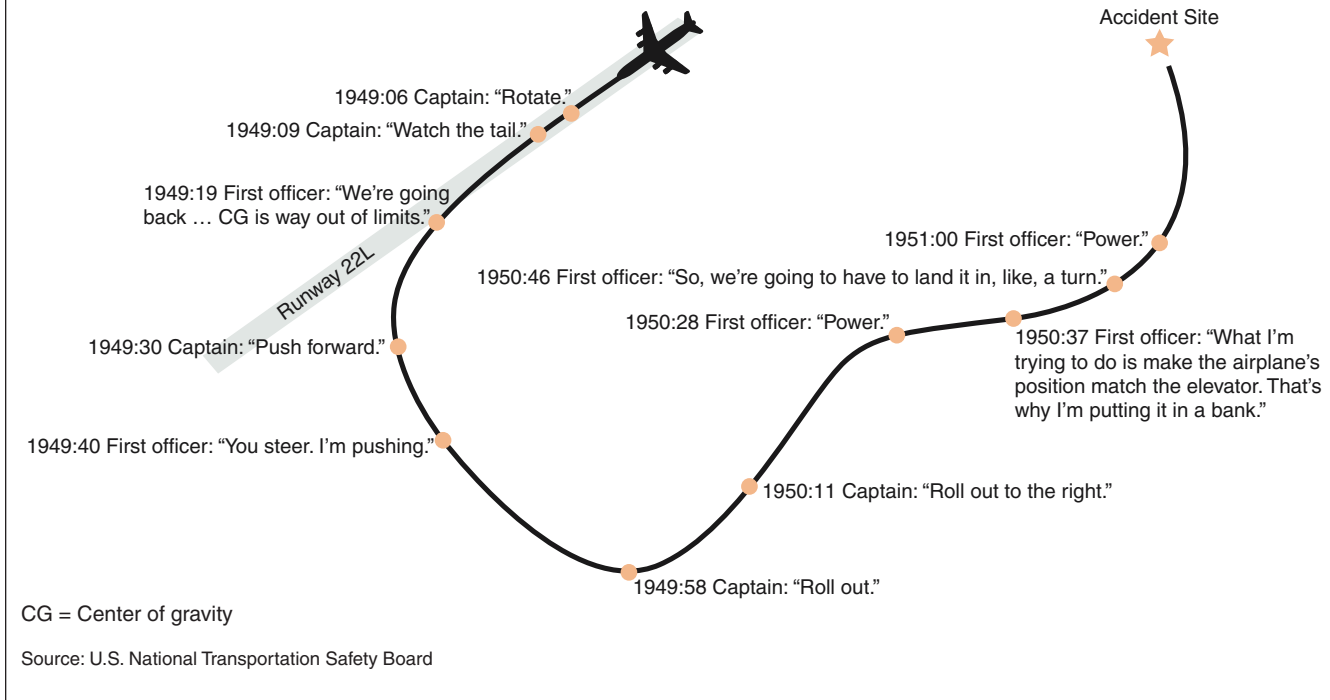
Figure 1

At 1949:02, the captain said, “V one.” V_1 (takeoff decision speed) was 126 knots. Four seconds later, he said, “Rotate” (Figure 1, page 4). Rotation speed was 146 knots.

The report said that flight data recorder (FDR) data and CVR data indicate that although neither pilot had moved his control column aft, the airplane began to pitch up before reaching rotation speed. About the time the airplane reached rotation speed, the first officer began to move his control column forward to counter the unusual pitch-up. About four seconds later, the first officer began to apply nose-down stabilizer trim.

**Ground Track and Selected Cockpit Voice Recordings;
Emery Worldwide Airlines Flight 17; McDonnell Douglas DC-8-71F;
Rancho Cordova, California, U.S.; Feb. 16, 2000**
