Collision with Antenna Guy Wire Severs Jet's Wing During Nonprecision Approach

—
FSF Editorial Staff

Editorial note: This article was adapted from a factual aviation report, identification no. MIA96FA051, prepared by the U.S. National Transportation Safety Board (NTSB) on Cessna 550, N91MJ, East Naples, Florida, Dec. 31, 1995.

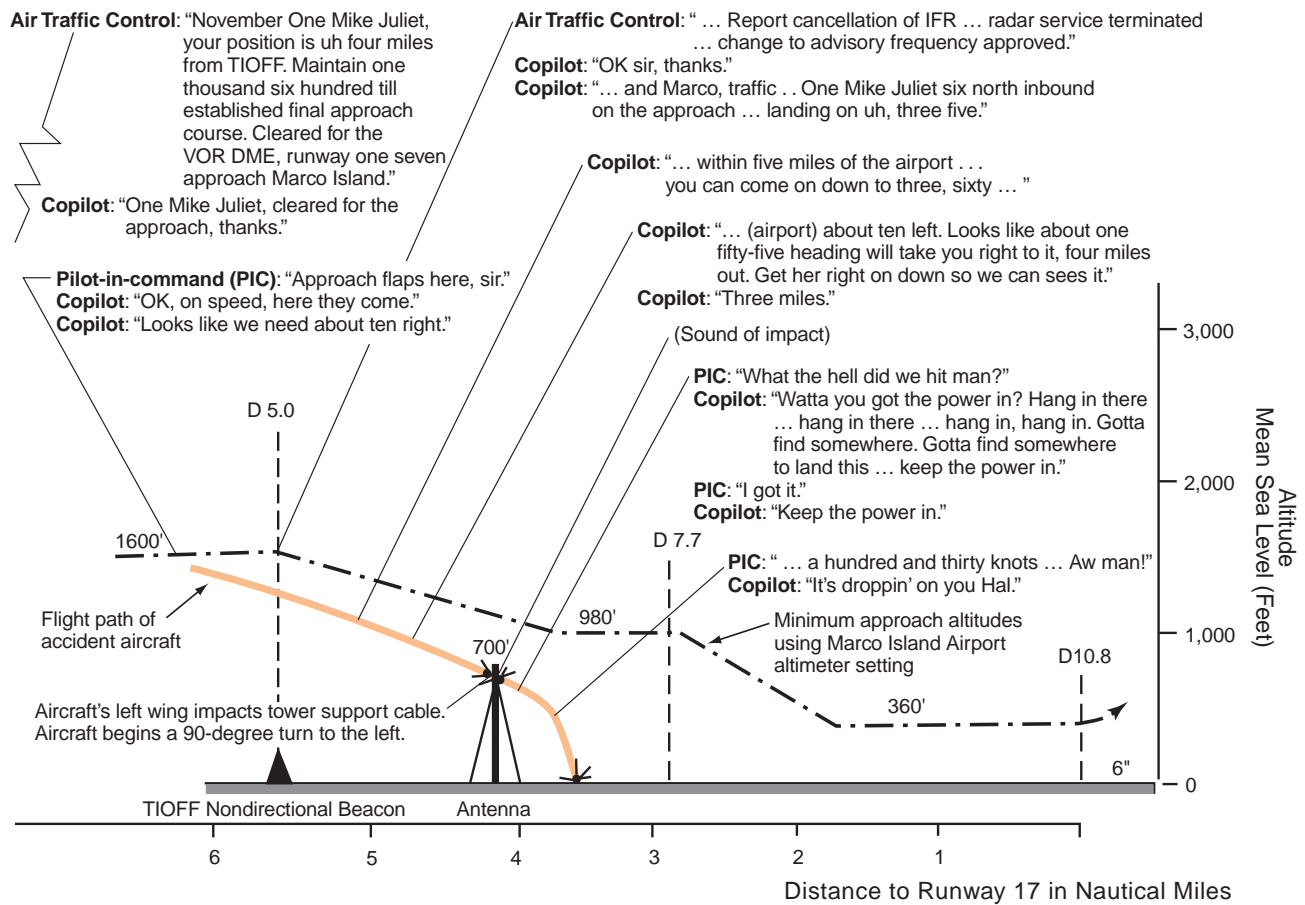
Figure 1

Flight Path Profile, Cessna 550 Citation II, Marco Island, Florida, U.S., Dec. 31, 1995

The VOR/DME approach to Runway 17 begins at the Cypress (CYY) VOR and is flown by following the CYY 148-degree radial at a minimum altitude of 488 meters (1,600 feet) until crossing TIOFF (the final approach fix) at 5.0 DME.

Minimum altitudes for the rest of the approach to KMKY vary with the altimeter setting used. If the local altimeter setting is used, the minimum altitude between TIOFF and the stepdown fix at 7.7 DME is 299 meters (980 feet), and after leaving 7.7 DME the straight-in MDA is 110 meters (360 feet).

If the Fort Myers altimeter setting is used, as it was in the accident aircraft, these minimums increase to 323 meters (1,060 feet) for the leg from TIOFF to DME 7.7 and 134 meters (440 feet) for the straight-in MDA.
