Cessna 404's Left Engine Fails on Takeoff, Captain Feathers Propeller on Right Engine

Fatigue cracks caused the teeth on the starter-motor gear to break, resulting in excessive damage to the left engine's accessory gear train. The progressive failure of the left engine and the feathering of the propeller on the right engine resulted in total loss of thrust. The aircraft stalled when the crew attempted to turn back and land at the departure airport.

Accident Prevention

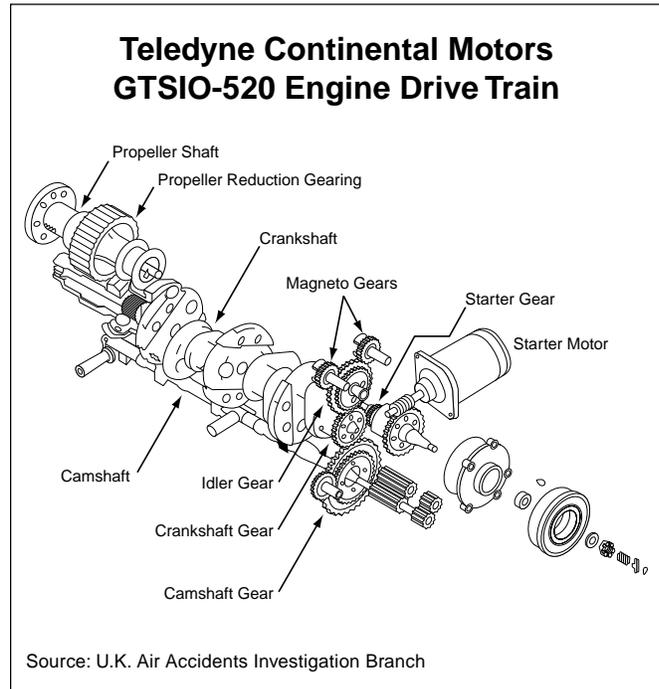
Figure 1

Postaccident examination of the left engine showed that the accessory gear train was damaged extensively. The report said that the damage was precipitated by failure of the starter motor adapter shaft gear (starter gear).

The accessory gear train, which is mounted in a gearbox at the rear of the engine, also includes a gear that drives the camshaft and an idler gear that drives the two magneto gears (see Figure 1). The accessory gear train is driven by a gear on the engine crankshaft.

Investigators found that all the teeth on the starter gear and all the teeth on the camshaft gear had broken off. Some teeth on the crankshaft gear and some teeth on the idler gear also had broken off.

“Examination of the starter gear revealed that there was evidence of fatigue cracking in some of the tooth failures,” the report said. “The presence of such progressive fatigue cracking in the starter gear, compared with the gross overloading which was seen in the other gears, indicated that the starter gear was the first gear to fail.”

A modified starter gear and a modified crankshaft gear were installed in the accident airplane’s left engine when the engine was remanufactured in July 1995. The engine had accumulated 1,030 service hours since the remanufacture when, in February 1999, the starter adapter assembly was removed for repair because of engine-starting problems. While the starter adapter assembly was being repaired, the left engine was operated for 38 hours with an unmodified starter gear.

“The mixing of modified [gears] and unmodified gears was not envisaged in the manufacturer’s service information, but there were no instructions which prohibited it,” the report said. “Given the nature of the modifications made to the gears (re-profiling to decrease backlash between the gears and shot peening of tooth root surfaces), it is considered that mixing the two modification standards would not have had a detrimental effect on, in this case, the crankshaft gear.”

“The crankshaft gear reportedly appeared satisfactory when the new starter gear was fitted, but the engine manufacturer considered that the distress suffered by the new starter gear within this relatively short period of time [i.e., the 255 hours of operation preceding the accident] could have been attributable, in part, to its meshing with a used gear which would have been worn to some extent.”

- “The U.S. Federal Aviation Administration [FAA] and the U.K. Civil Aviation Authority [CAA] should make mandatory the revised critical service bulletin, CSB94-4B, which requires a repetitive inspection of GTSIO-520 starter gears and crankshaft gears. [Recommendation 2000-12];¹
- “The CAA should take forward to the JAA [Joint Aviation Authorities] a proposal to re-examine the criteria for the carriage of flight recorders by
