Change of Plan

Learning From Experience
Incident No. 6

Sixth in a series focusing on approach and landing incidents that might have resulted in controlled flight into terrain but for timely warnings by TAWS.

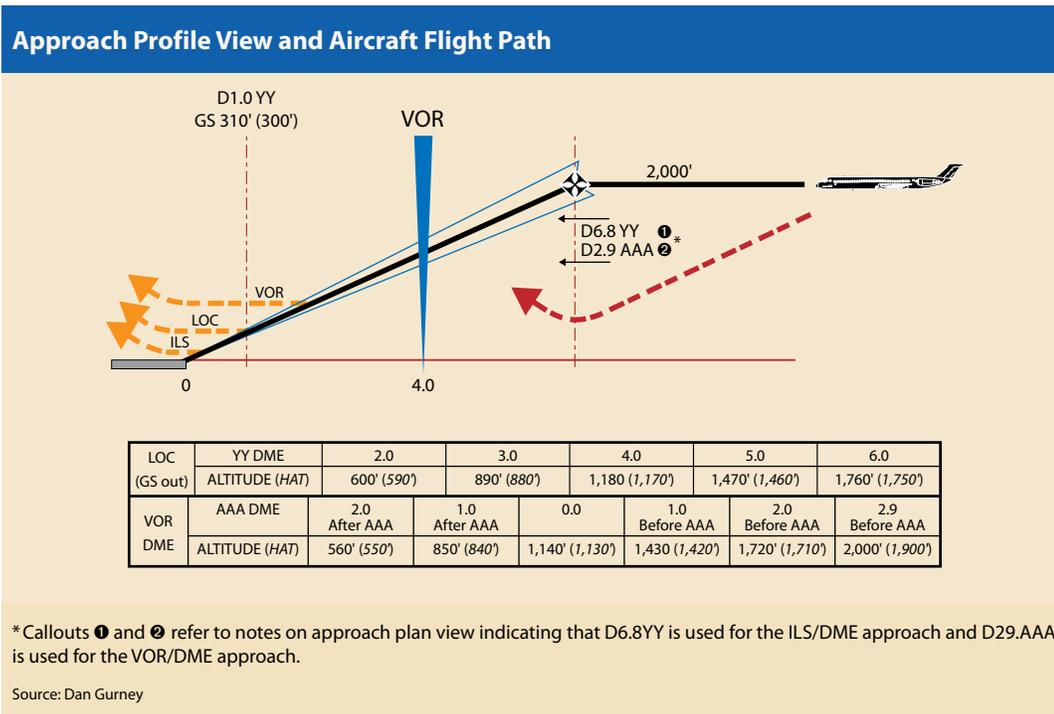
Figure 1

The chart identifies a common descent point at the final approach fix (FAF) for all three approach procedures by its distances from two DME ground stations: "D6.8 YY," or 6.8 nm from the DME ground station for the ILS/DME approach, and "D2.9 AAA," or 2.9 nm from the DME ground station for the VOR/DME approach (Figure 1). Next to each distance figure is a callout to a note identifying its respective approach procedure. The notes indicate that "D6.8 YY" should be used to identify the descent point while conducting the ILS/DME approach and that "D2.9 AAA" should be used to identify the FAF during the VOR/DME approach. The callouts are included in the chart's plan view and profile view; the notes, however, are included only in the plan view.

The altitude/range table also is an amalgamation of data from the CAA's master copies. Its format provides the opportunity for misreading the data and is a potential threat to safety. The table is divided horizontally into "LOC," or localizer, and "VOR/DME" sections, and the altitude and range data are shown together — in much smaller type

than appears in Figure 1. For each range figure, an altitude and a height above touchdown (HAT) are provided. This adds visual clutter that could slow data acquisition and increase mental workload. Similarly, the “After AAA” and “Before AAA” notations for the VOR/DME ranges also add complexity.

Moreover, the table shows the range values above the altitudes. As noted in the discussion of incident no. 2 in the August 2006 *Aviation Safety World*, it is essential to check altitude before range when monitoring the flight path. Thus, the table format, which is commonly used by chart providers, could bias the crew to check range before altitude, a procedure that could result in being at a dangerously low altitude at longer ranges.

- Late changes of plan and hurried briefings expose flight crews to seemingly innocuous threats and opportunities for errors. A rule of thumb to remember is: “Retuning frequencies always requires retuning the mental map.”
- Latent threats can originate from well-intentioned alterations of the chart format to simplify procedures or improve efficiency.
- Monitoring is only effective if the correct data are being used. Crews should take extra precautions when using amalgamated charts. ●
