Overrun

The crew applied reverse thrust too late.

at Midway

This article is based on NTSB Accident Report NTSB/AAR-07/06: “Runway Overrun and Collision; Southwest Airlines Flight 1248; Boeing 737-7H4, N471WN; Chicago Midway International Airport; Chicago, Illinois; December 8, 2005.”

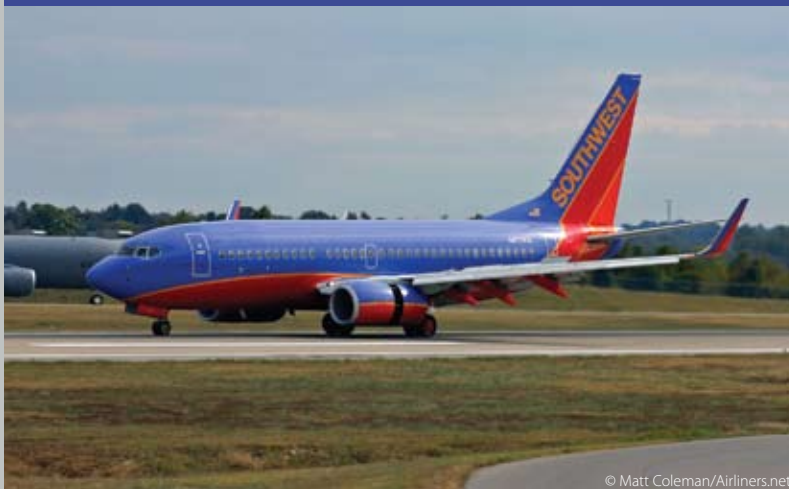
Boeing 737-400

The accident airplane, after repairs, is shown in the photo above.

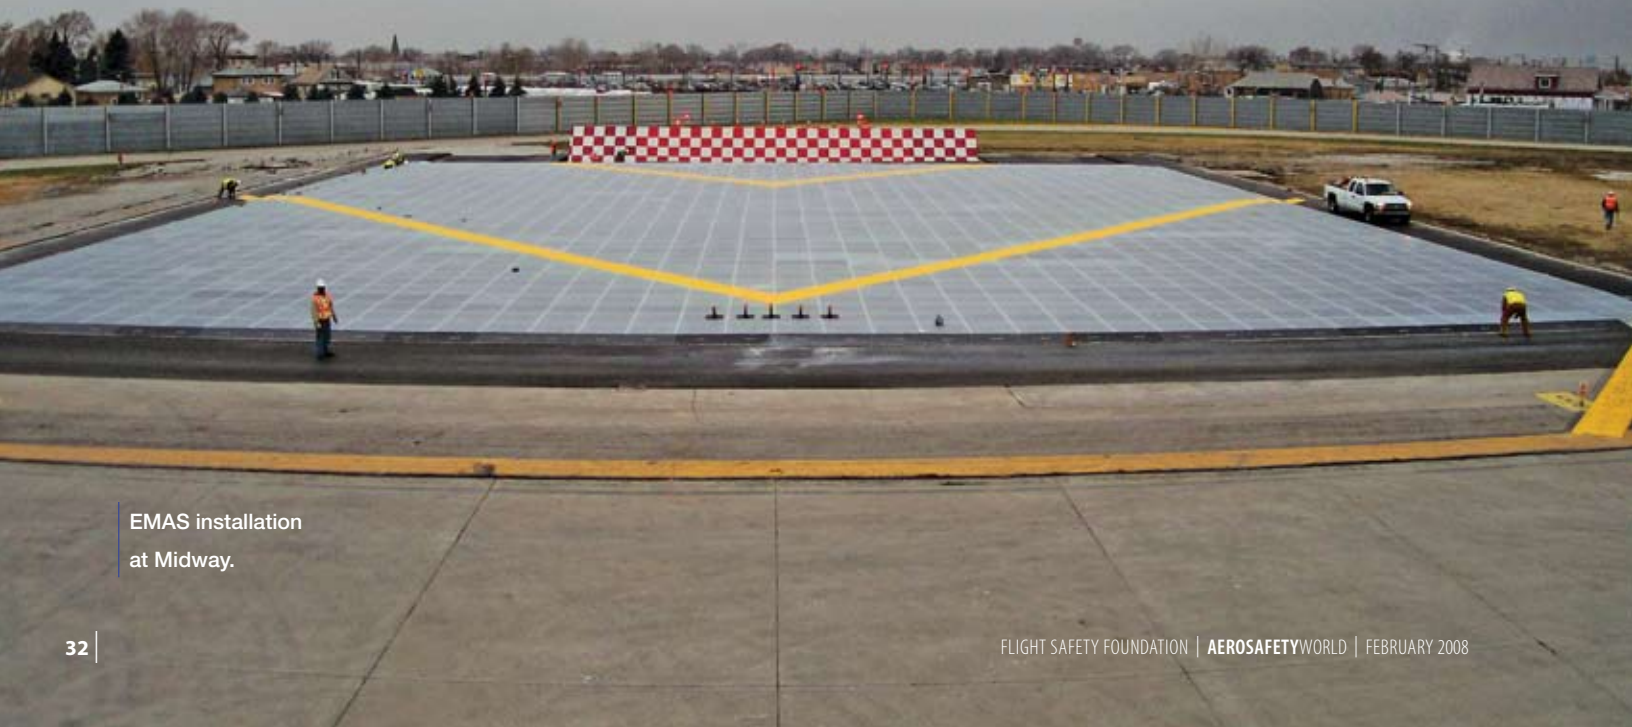
EMAS installation
at Midway.

The Chicago DOA also said that an alternative to enhance the RSA, installation of a standard 600-ft (183-m) EMAS arrestor bed, also would require shortening the runway. The FAA did not ask the airport operator to consider installation of a shorter, nonstandard EMAS bed.

Simulations conducted by an EMAS manufacturer “indicated that a non-standard EMAS installation would have stopped the accident airplane before it

departed airport property,” the report said. “After the accident, the FAA approved the installation of nonstandard EMAS beds at [Midway].”
