Close Call in Khartoum

BY MARK LACAGNINA

Confusion reigned when an A321 was flown below minimums in a sandstorm.

This article is based on U.K. AAIB Aircraft Incident Report No. 5/2007 (EW/C2005/03/02).

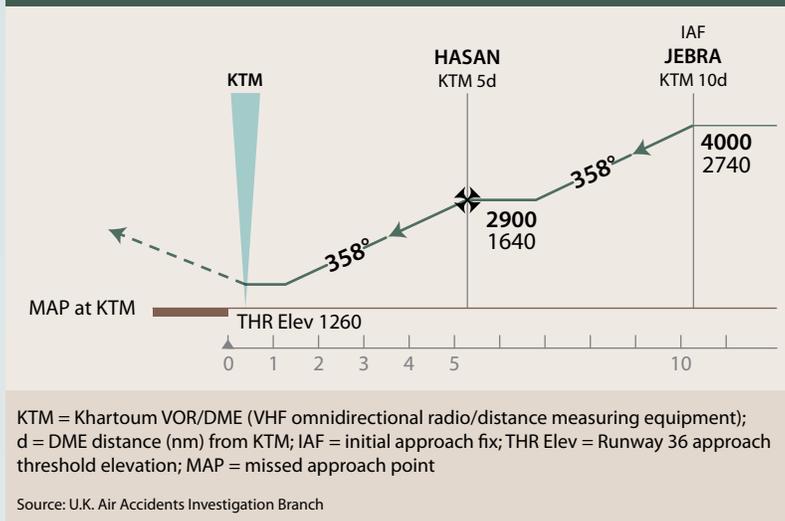
Figure 1

The pilots were not aware that a discrepancy existed between the location of the final approach fix (FAF) depicted on their approach chart and the location programmed in the FMGS database. Approach charts and FMGS database updates were provided by different commercial vendors. The chart depicted the FAF, called HASAN, at “KTM 5d” — that is, 5.0 nm DME from KTM (Figure 1). The report said that this location resulted from the 2002 Sudanese *Aeronautical Information Publication (AIP)*, which placed the FAF 5.0 nm from both the runway threshold and KTM. “By interpolating the depicted final approach gradient, the [chart vendor] determined that HASAN was actually 5.6 nm from the runway threshold,” the report said. “This coincided with the KTM 5 DME position.”

The FMGS database included a 2004 amendment to the *AIP* that placed the FAF 5.0 nm from the runway threshold and 4.4 nm DME from KTM.

“The pilots were unaware of [the] significant discrepancy between the approach parameters on the approach chart and those within the navigation database because they had not compared the two data sets before commencing the approach,” the report said, noting that this omission was partly the result of the absence

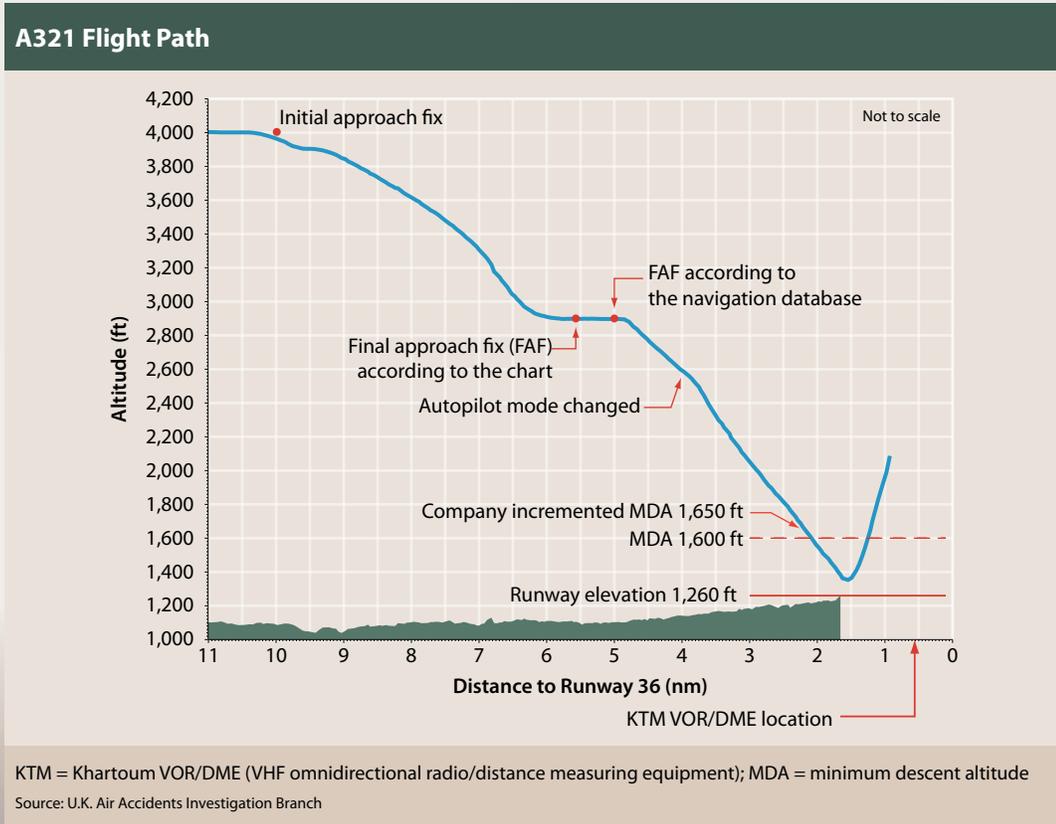
Figure 2

The managed approach was being conducted correctly by the autopilot based on the FMGS data. Thus, the aircraft did not begin the final descent at 5.0 DME, as the pilots expected (Figure 2). “The aircraft began its final descent 0.6 nm later than the pilots were expecting,” the report said. “Believing the aircraft was high on the approach, the handling pilot [the commander] changed the autopilot mode in order to select an increased rate of descent.”

The commander intended to establish the A321 on a 3.0-degree vertical flight path angle, which was equivalent to a descent rate of about 800 fpm at the selected airspeed. He mistakenly believed that the autopilot was in the track/flight path angle mode. The autopilot actually was in the heading/vertical speed mode, and the commander’s input caused the autopilot to command a descent rate of 300 fpm, rather than a 3.0-degree flight path angle.
