Many pilots and maintenance technicians don't realize that routine tire-pressure checks are crucial to safe operations.

PRESSURE CHECK

BY LINDA WERFELMAN

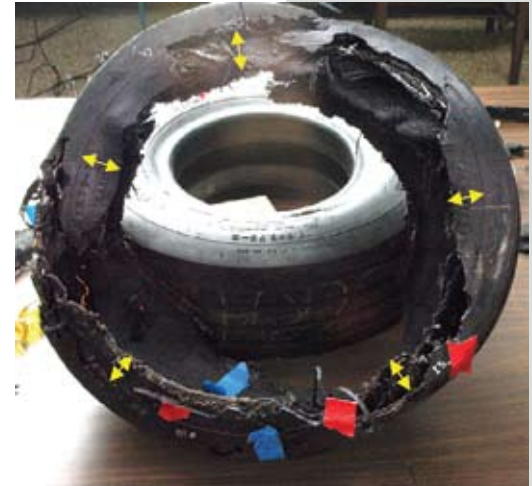
Subsequent tests showed that the MLG tires were under-inflated by about 36 percent. The NTSB report noted that the aircraft

“When a tire’s sidewalls over-deflect at the bottom of each rotation, the excessive flexing of the rubber can result in fatigue of the reinforcing fibers and the generation of higher internal temperatures at a faster rate than would be generated in a properly inflated, properly loaded tire,” the report said. “High temperatures can degrade the physical properties of the tire’s rubber compounds and melt the nylon threads in the plies; such damage can lead to tire failure.”

Reconstruction of a tire from the accident airplane shows outboard sidewall damage. The yellow arrows are intended to depict what the NTSB called “the generally uniform location of the damage.”
