In pre-dawn darkness, the Comair pilots chatted with each other as they inadvertently taxied their regional jet onto a runway that was half as long as the runway assigned for takeoff. The Bombardier CRJ100ER was destroyed in the subsequent overrun at Blue Grass Airport in Lexington, Kentucky, U.S. The captain, flight attendant and 47 passengers were killed; the first officer was seriously injured.

In its final report on the Aug. 27, 2006, accident, the U.S. National Transportation Safety Board (NTSB) said that the probable causes were “the flight crewmembers’ failure to use available cues and aids to identify the airplane’s location on the airport surface during taxi and their failure to cross-check and verify that the airplane was on the correct runway before takeoff.”

IDENTITY

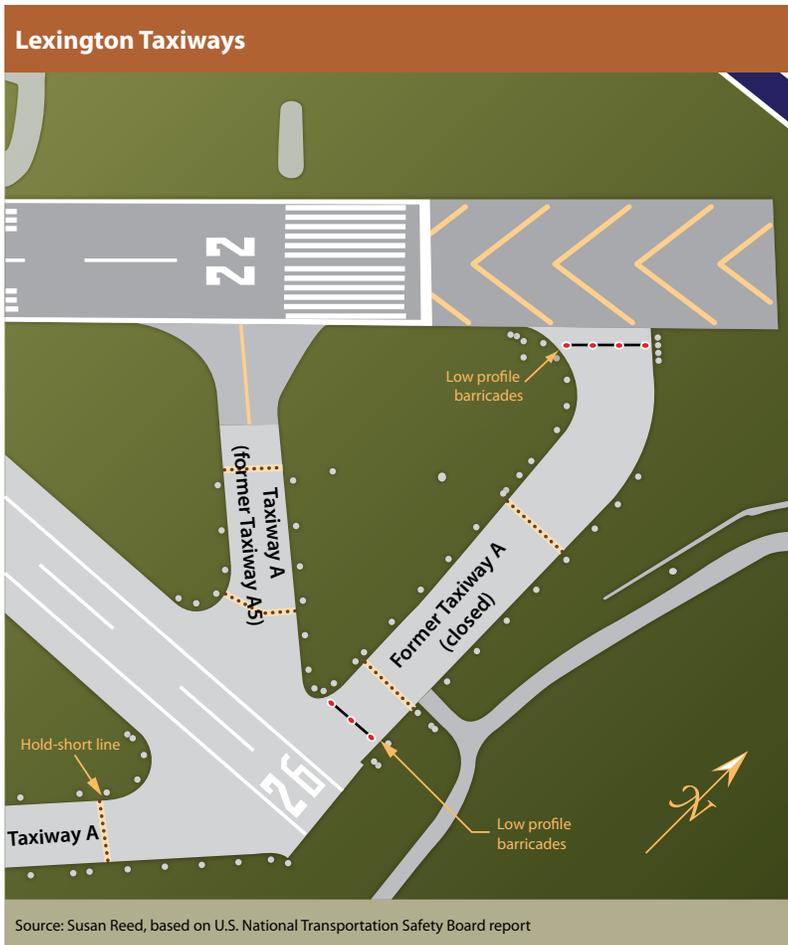
Figure 1

The report said that because of ongoing construction at the airport, there were discrepancies in the airport diagrams produced by the FAA and by Jeppesen. The diagrams did not show that Taxiway A north of Runway 26 had been closed and barricaded, or that Taxiway A5 had been redesignated as Taxiway A (Figure 1). The closure of Taxiway A also was the subject of a NOTAM that was not included in the crew’s flight release paperwork. However, the report said that these factors did not affect the crew’s ability to find their way to the correct runway. “The navigational task ... was

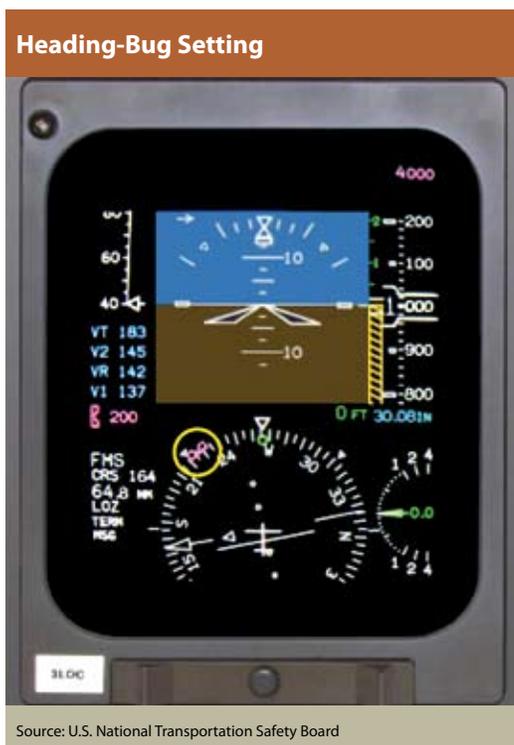
Figure 2 is an approximation of the captain’s primary flight display when the takeoff was begun. The display likely showed a nearly 40-degree difference between the heading-bug setting and the indicated magnetic heading. “The CVR did not record any awareness by the flight crewmembers about this offset ... or any discussion about the need to cross-check the airplane’s position on the runway,” the report said.

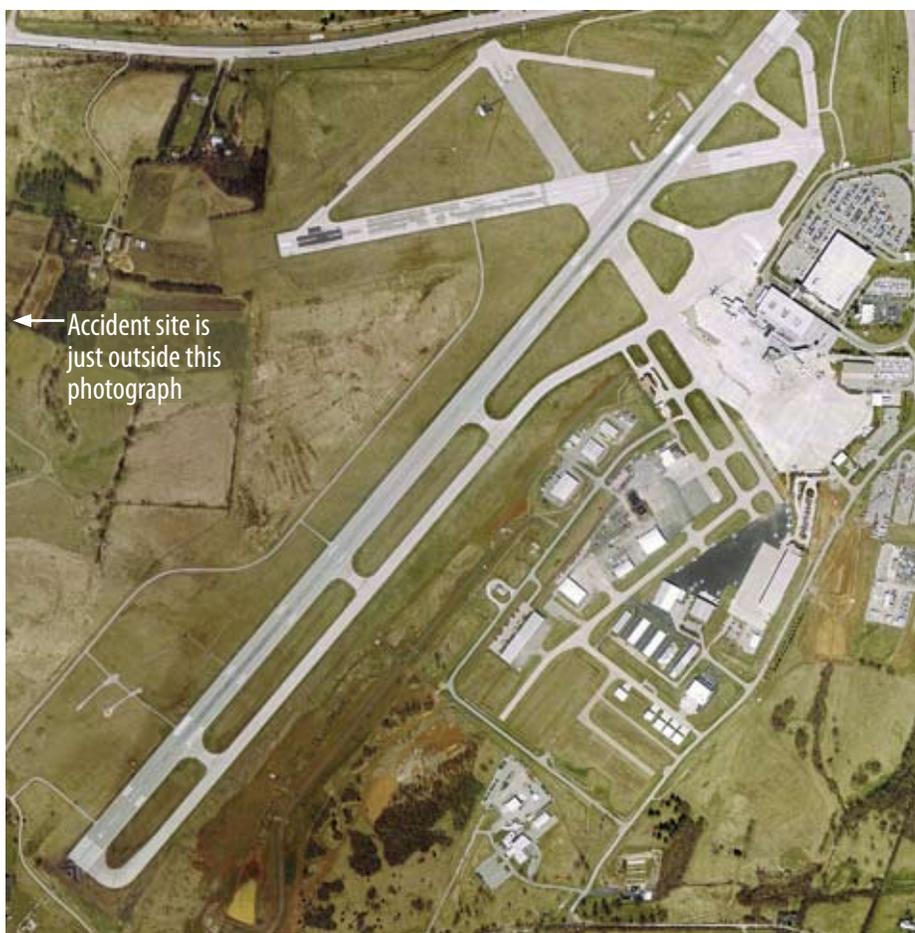
The CRJ struck a berm and several trees before coming to a stop about 1,800 feet (549 m) from the runway.
