Communication Problems Contribute to Misperceptions of Evacuation Urgency

Inadequate procedures to ensure collection and evaluation of all relevant information — including the cabin crew’s post-accident observations of damage to the Boeing 747 — were among cabin safety issues identified by the Australian Transport Safety Bureau after the runway overrun in Bangkok, Thailand.

Cabin Crew Safety

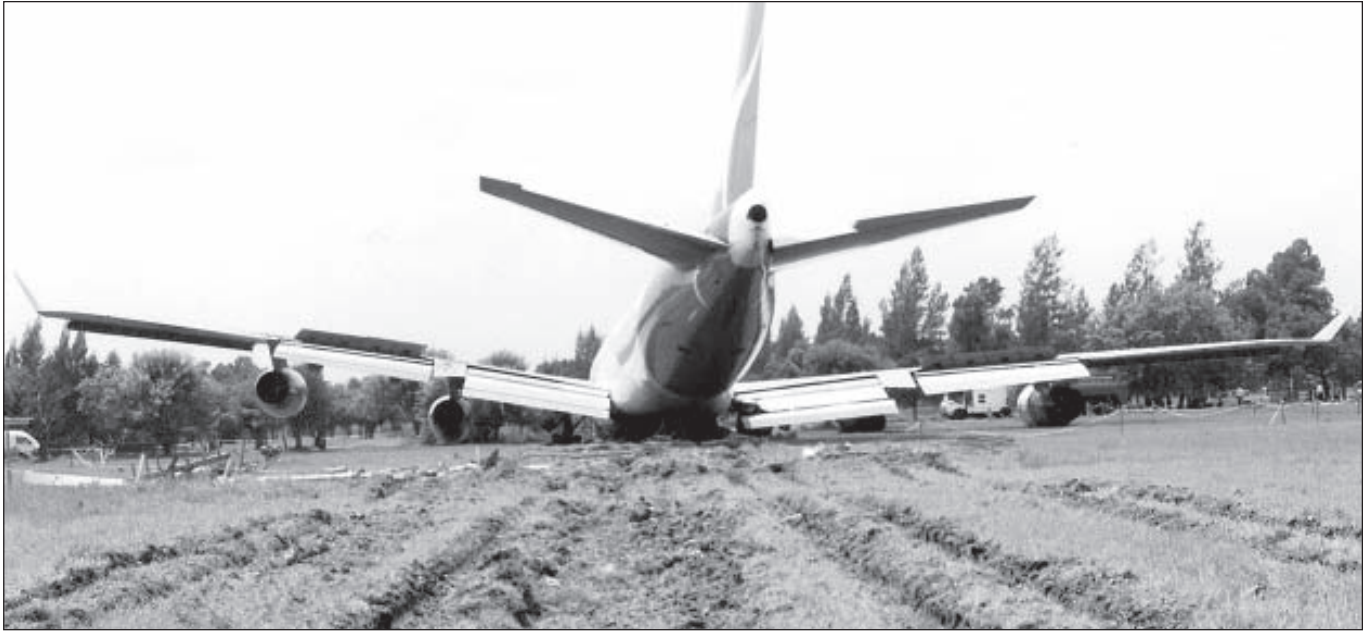
Externally, the collision initiated the collapse of the nose landing gear and the right-wing landing gear. Inside the aircraft cabin, some ceiling panels, passenger service units (PSUs) and lavatory fittings were dislodged and/or damaged.² Four passengers later said that they had been struck by PSUs, and various objects from overhead bins, galleys and various storage locations littered the cabin floor.³

Substantial damage to the Boeing 747-400 during the runway overrun included collapse of the nose gear and the right-wing landing gear. The aircraft was in a nose-low position and a slightly right-wing-low position during the precautionary disembarkation. (Australian Transport Safety Bureau Photo)

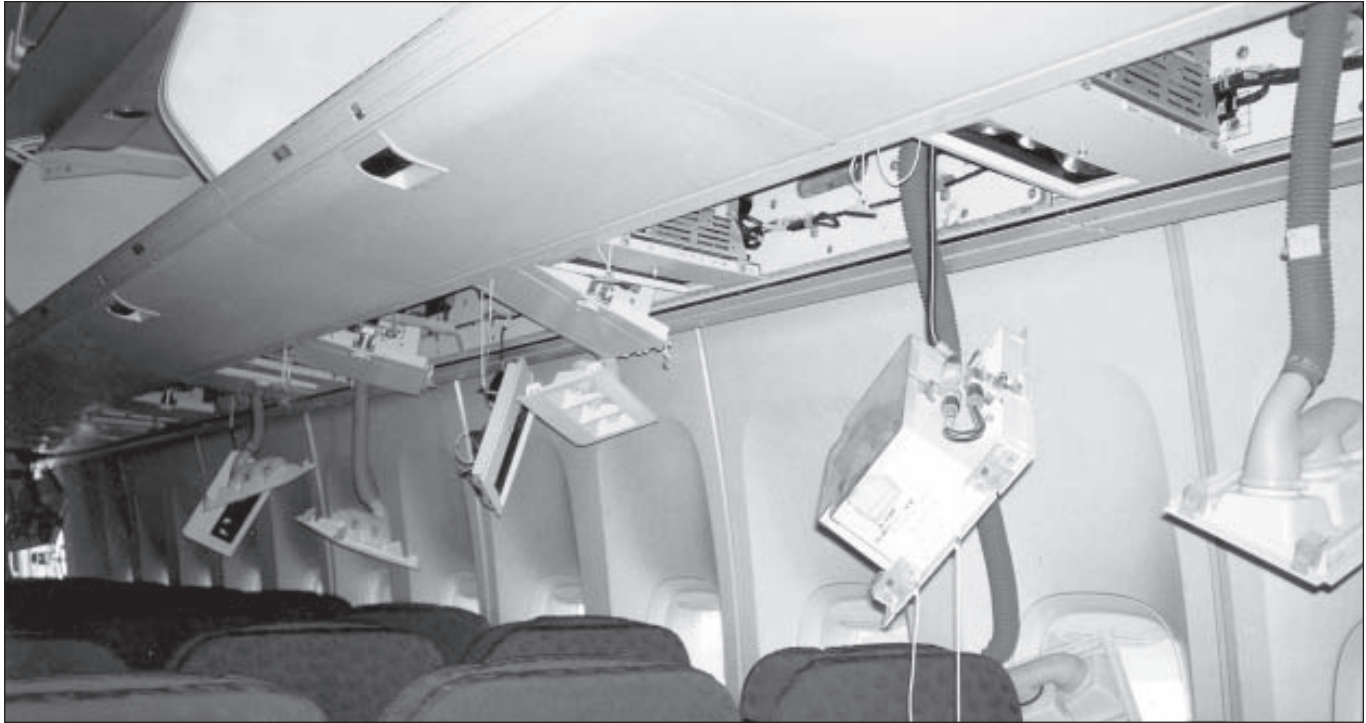
Four passengers in the cabin of the Boeing 747-400 said that they were struck by dislodged passenger service units (PSUs) that dropped below overhead bins. Only minor injuries occurred among 38 passengers who reported injuries. (Australian Transport Safety Bureau Photo)

3. The ATSB report said, “Five ceiling panels on the left side of the aircraft between rows 48 and 54 were dislodged during the [impact] sequence. One panel fell and blocked the aisle while the others were misaligned. ... The panels were made of composite material. They measured approximately 1.0 [meters] by 1.7 meters [3.3 feet by 5.6 feet] and weighed approximately 3.5 kilograms [7.7 pounds]. ... Boeing advised that the damage to the panels indicated that deceleration loads and fuselage deformation, associated with separation of the nose [landing gear] and right-wing landing gears, caused the panels to move inboard against the [mounting] rail. The load transferred to the latches on the outboard side, breaking the hooks and allowing one panel to fall down. ... Most of the dislodged PSUs ... remained hanging from their respective cables and feed lines. However, the length of cables and feed lines allowed some PSUs to be close to level with the top of the seat back, making them a possible source of injury and hindrance during the [precautionary] disembarkation. ... Boeing advised that the probable reason for the PSUs being released was flexing of the [mounting] rails during the impact sequence.”
