Analysis of Evacuation-slide Problems Calls Attention to Recurrent Issues

Gerard van Es and Hans Post
National Aerospace Laboratory (NLR)–Netherlands

Cabin Crew Safety

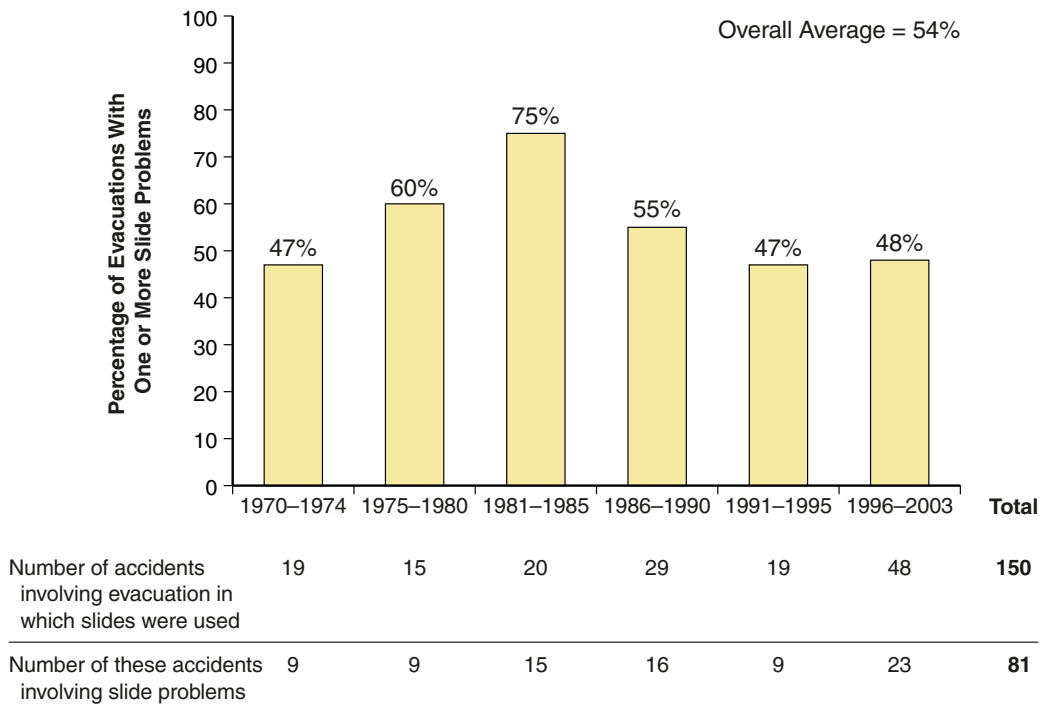
Figure 1

- Examination of NLR’s study sample of 150 survivable aircraft accidents in which slides were used during 1970–2003 showed that in 81 (54 percent), one or more slides did not function properly;

NLR Incidence of Evacuations¹ With One or More Evacuation-slide Problems, 1970–2003
