CoreLock

Investigators consider possibility of a condition that could prevent an in-flight restart.

BY MARK LACAGNINA

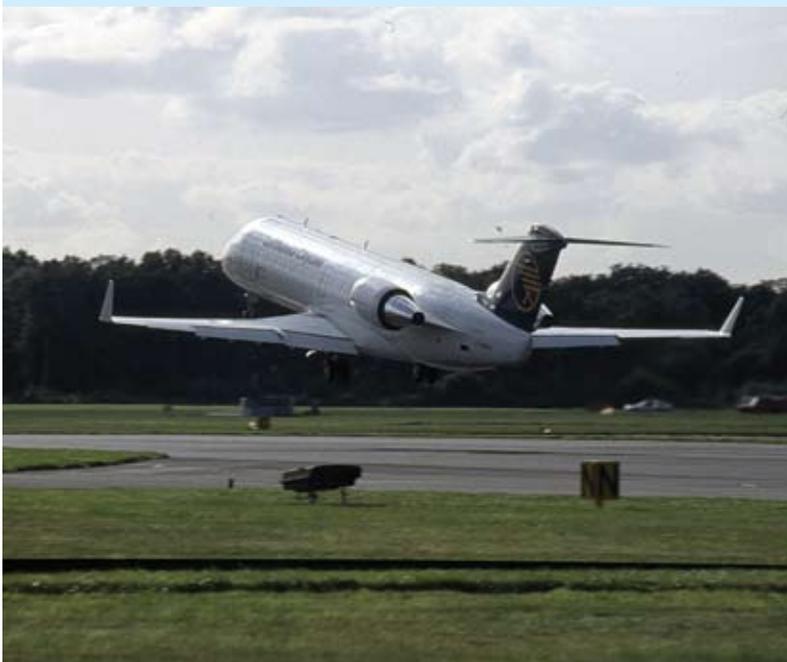
FDR data indicate that the engine cores were beginning to break free just before the impact.
